ภาคผนวก 8

การตรวจสภาพอุปกรณ์ป้องกันอันตรายส่วนบุคคล
เครื่องมือ เครื่องจักร และเครื่องยนต์

Doc. No.: PP4-HS-REP-0006 (Reporting Period: 26 Feb.2022 ~ 25 Mar.2022)	Rev. 0

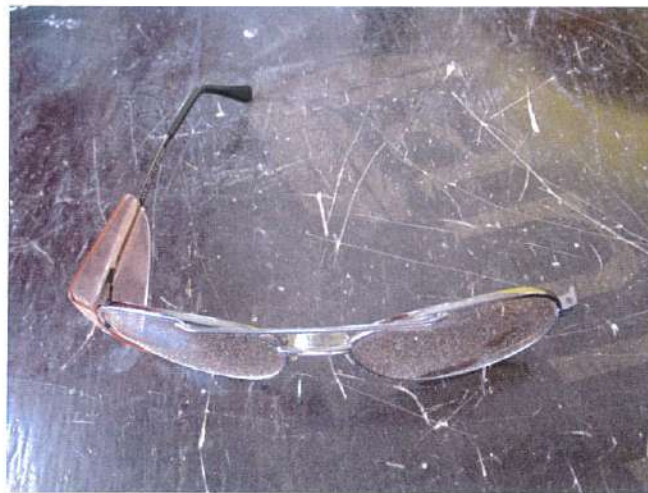
รูปอุปกรณ์คุ้มครองความปลอดภัยส่วนบุคคลที่ชำรุด

ลำดับ	รายการ PPE ที่ทำการตรวจ	ผลการตรวจสอบ		
		สภาพดี	สภาพไม่ดี	หน่วย
1	หมวกนิรภัย	425	-	ใบ
2	ที่รองในหมวก	425	-	อัน
3	ที่ครอบหู	160	-	คู่
4	แว่นตานิรภัย	424	1	อัน
5	รองเท้าเซฟตี้บูท	125	-	คู่
6	Fresh shield	75	-	อัน

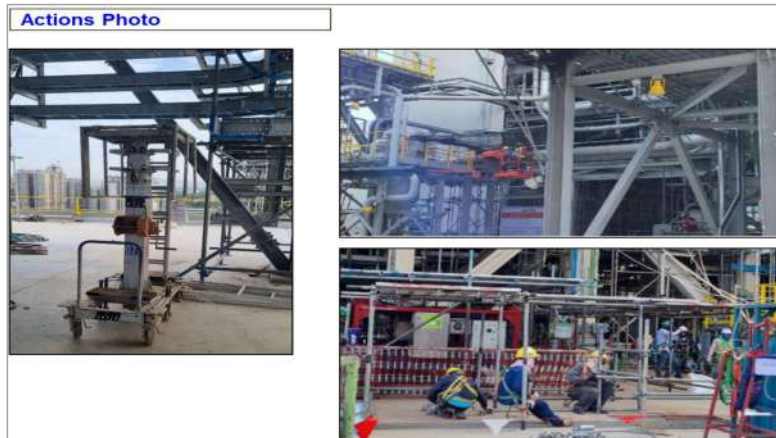
1.3.7 Near Miss(#7)

<p>Description of the Incident</p> <p>On 27th of May, 2022 the "Total solution company" hired by STEC had started their duty at North of Extrusion from 7:30 am. The metal sheet (W=1m, L=8.5m) was lifting by crane and the sheet was properly hanging with crane hook during installation time before lunch. However, the Total solution company CM observed the sheet was in little wrong position and instructed his workforce to adjust that sheet to right position after lunch.</p> <p>At around 14:30pm, Mr. Khunchang Plinboon (Technician) tried to loosen all bolts one by one in order to adjust the sheet. There were no fixed bolts left, but the last remaining bolt loosened by an unintentional mistake causing the sheet to fall down to ground (H=24m about). No one and property was damaged. Immediately stopped the activity and was informed to all relevant management.</p>	
<p>Photo of Incident</p>

<p>Corrective Action</p> <ol style="list-style-type: none"> 1. Adequate work method is organized for installation of the metal sheet. The installation and adjustment of the sheet shall be conducted with the crane support. The Total solution workforce were properly trained by GS HSE to avoid similar incident reoccurrence. 2. The east entrance of the Extrusion area was closed and guided the workers to access other routes. 3. The pre-job meeting was conducted by GS, STEC and the team 4. Expand safety net of Extruder east to ensure the falling object do not reach to the workers on ground 5. Rearrange the safety net of Extruder north 6. Protect the upper part of the worker access way of the Reactor east with a scaffolding board. 7. Protect the upper part of the worker access way of the Reactor north 8. The Simultaneous operation between top and bottom are strictly disapproved. <p>The PTW shall also be closely controlled by the permit coordinator.</p>

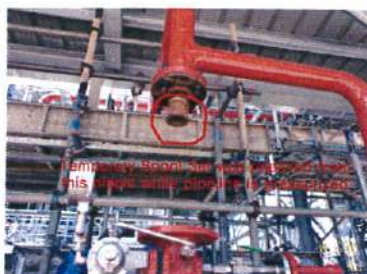
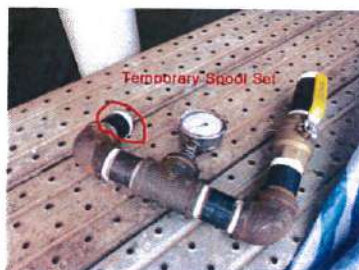
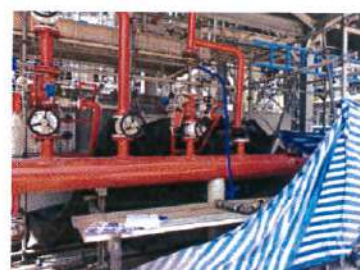
Photos: Incident Scene and Re-enactment

The below incident scene provides detailed incident scene.

- The injured person didn't tighten a temporary spool set properly.
- A supervisor and foreman didn't inspect tightness of the temporary spool set after preparation work.
- Other workers didn't conduct blowing activity with the injured person who worked alone.

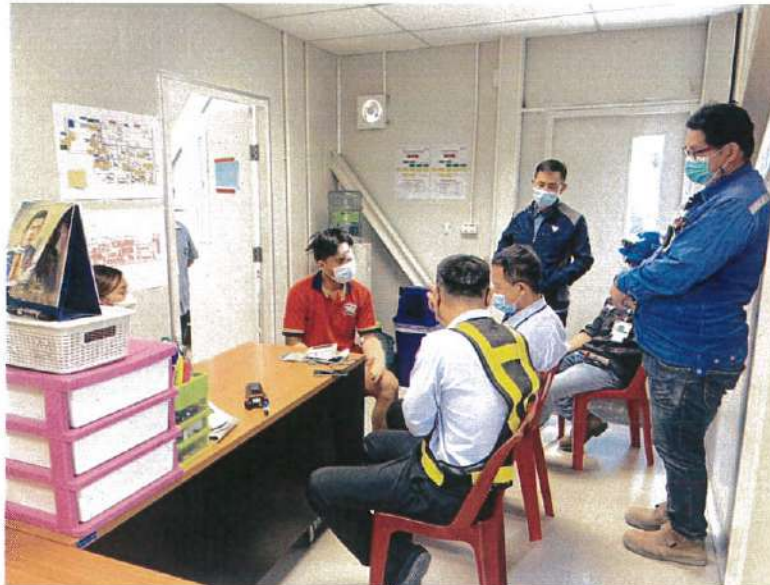
- The IP presented at the investigation meeting
- He stated that he could not remember what happened at the moment of incident
- He has 3 year experience for pre-commissioning activities and working in this project from the beginning of Air Blowing for 3 months
- There were 4 times air blowing carried out on the day at the point and then it happened
- The detailed recording of the interview is in the **Attachment 4**

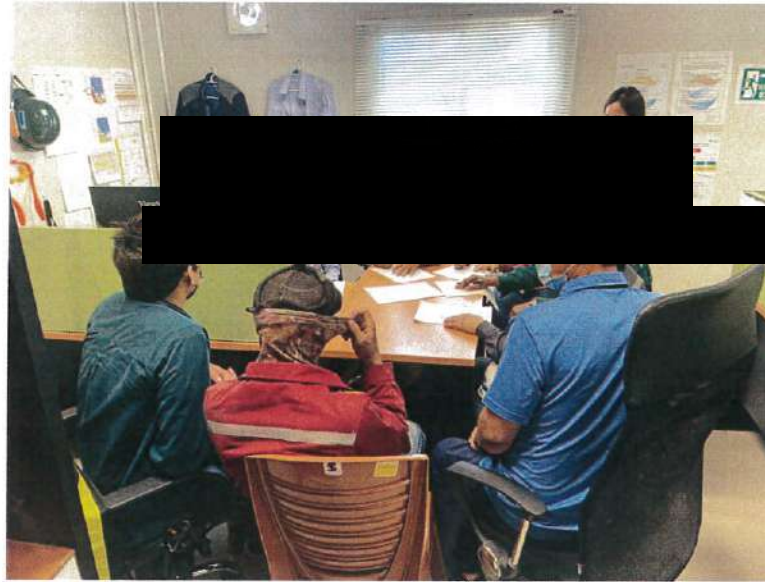
- The team stated that they implement the air blowing with 5 bar only in this project, never over 5 bar pressure.
- Work Method Statement (WMS) and Task Risk Assessment (TRA) for the air blowing are in the **Attachment 9**
