รายงานการตรวจสอบอาคารทำเทียบเรือสินค้า

ทำเทียบเรือหมายเลข BI-1, BI-2, BI-3 และ MBM

โรงกลั่นน้ำมันเอสโซ่ ศรีราชา

รายงานผลการตรวจสอบอาคารตามมาตรา 32 ทวิ
อาคารทำเทียบเรือสินค้าขนาดมากกว่า 500 ตันกรอสต์

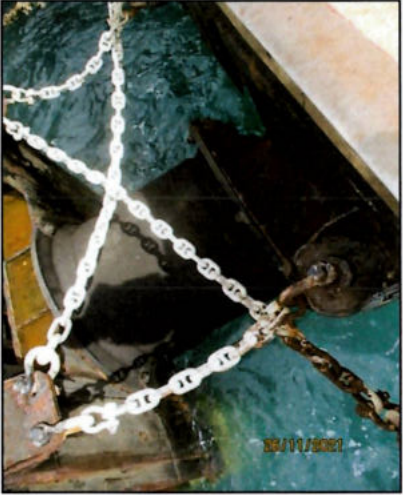
<p data-bbox="443 779 1343 813">ตัวโครงสร้างเหล็กมีการสึกกร่อน แนะนำให้ทำการซ่อมแซมและทำสีใหม่ป้องกันการผุกร่อนเพิ่มเติม</p>
2

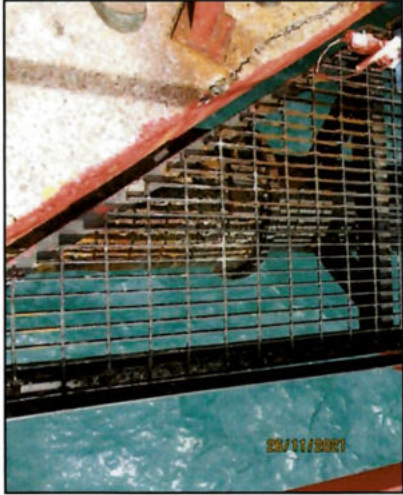
<p data-bbox="443 1350 1343 1384">ตัวโครงสร้างเหล็กมีการสึกกร่อน แนะนำให้ทำการซ่อมแซมและทำสีใหม่ป้องกันการผุกร่อนเพิ่มเติม</p>

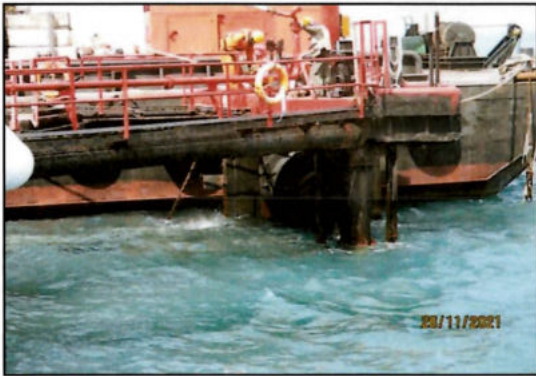
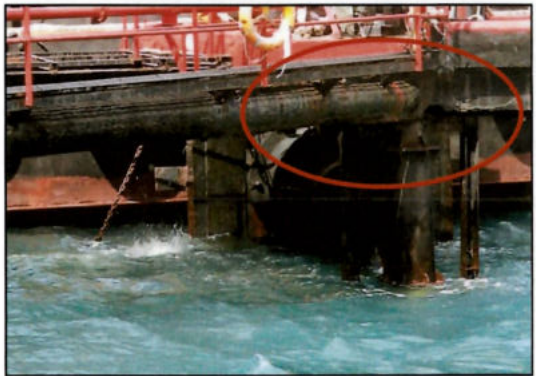
<p data-bbox="411 680 1374 725">โครงสร้าง เสา/คาน เริ่มเกิดการผุกร่อน แนะนำให้กำจัดการบสนิมและทำสีใหม่ป้องกันการผุกร่อนเพิ่มเติม</p>
2

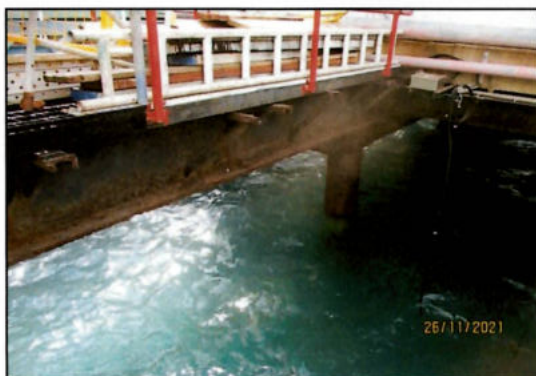
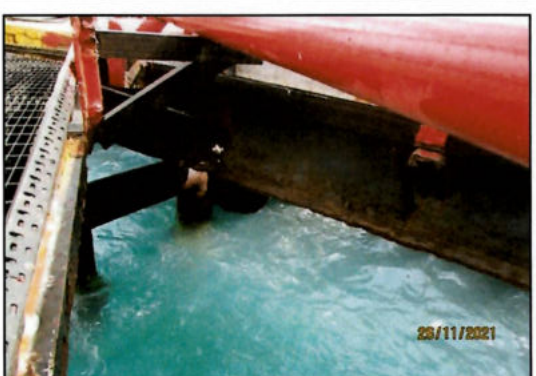
<p data-bbox="432 1187 1358 1232">โครงสร้าง คาน เริ่มเกิดการผุกร่อน แนะนำให้กำจัดการบสนิมและทำสีใหม่ป้องกันการผุกร่อนเพิ่มเติม</p>
3

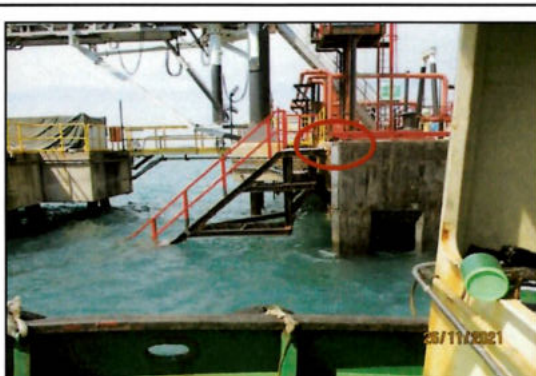
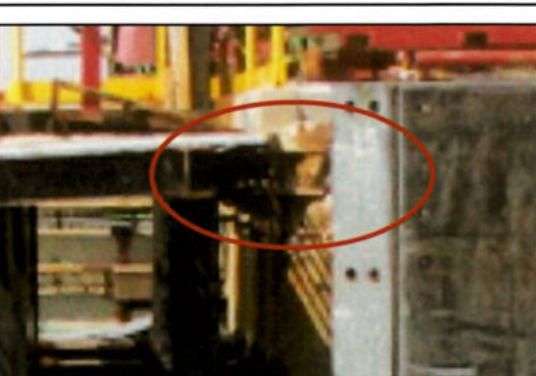
<p data-bbox="347 1697 1444 1778">คอนกรีตเกร้าท์ของ gangway แตกร้าว แนะนำให้ทำการซ่อมแซมโดยการสกัดคอนกรีตเกร้าท์เก่าออก แล้วทำการเกร้าท์ใหม่</p>

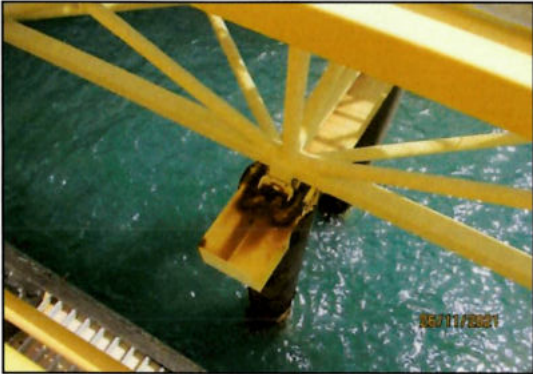
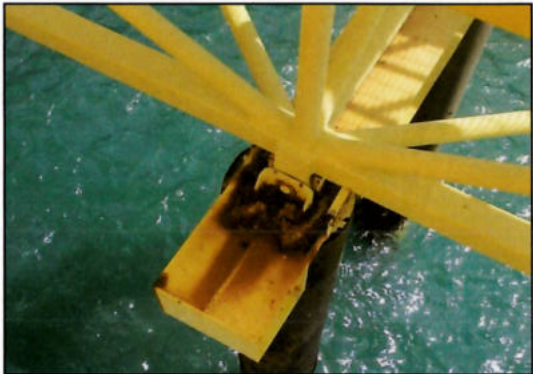
</div> <p data-bbox="336 629 1453 707">โครงสร้าง truss ทางเชื่อม BI-1 และ BI-2 บริเวณ Support มีการร้าวร่อน แนะนำให้ทำการซ่อมแซมและทำสีใหม่ป้องกัน การผุกร่อนเพิ่มเติม</p>

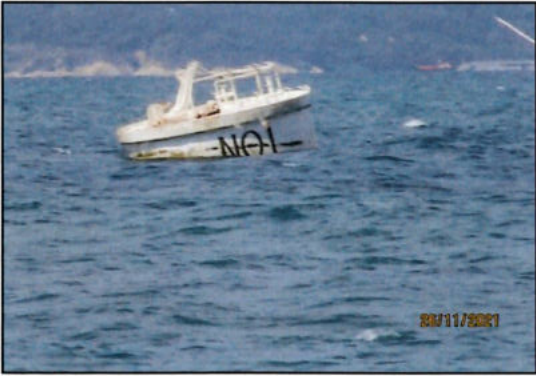
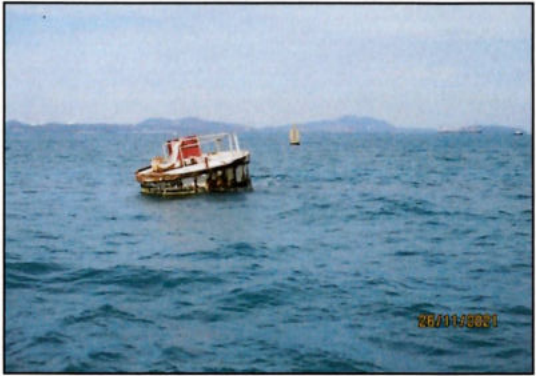
</div> <p data-bbox="419 680 1374 725">หุ่นลอยผูกยึดเรือ No. 1 และ 2 ยังมีสภาพที่ใช้งานได้ เนื่องจากจะมีการรอบการซ่อมบำรุงอย่างสม่ำเสมอ</p>	
2	<div data-bbox="341 748 879 1122">

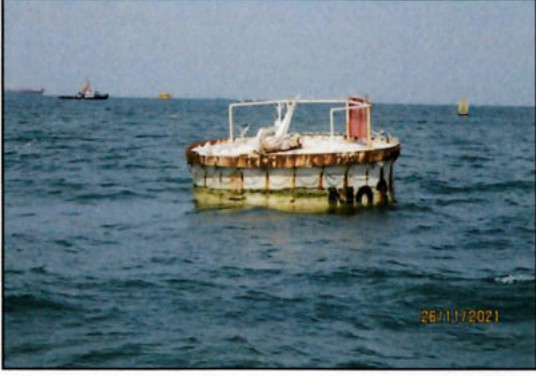
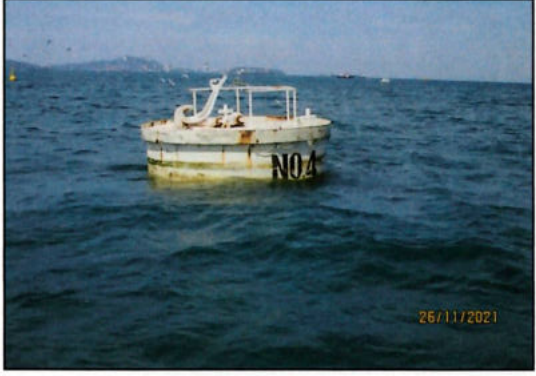
</div> <p data-bbox="419 1151 1374 1196">หุ่นลอยผูกยึดเรือ No. 3 และ 4 ยังมีสภาพที่ใช้งานได้ เนื่องจากจะมีการรอบการซ่อมบำรุงอย่างสม่ำเสมอ</p>	
3	<div data-bbox="341 1218 879 1592">

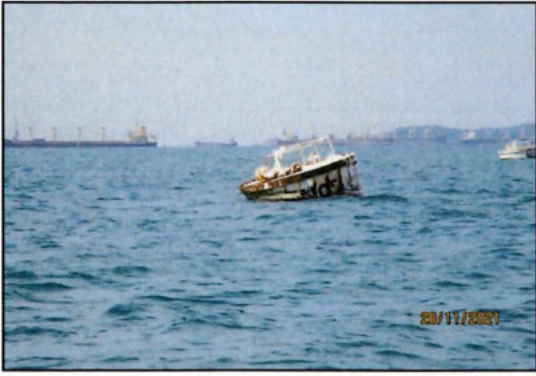
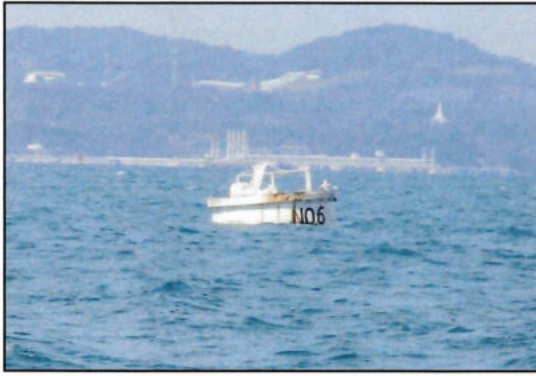
</div> <p data-bbox="419 1621 1374 1666">หุ่นลอยผูกยึดเรือ No. 5 และ 6 ยังมีสภาพที่ใช้งานได้ เนื่องจากจะมีการรอบการซ่อมบำรุงอย่างสม่ำเสมอ</p>
