รายงานการตรวจสอบสภาพและความหนาของระบบท่อ

PIPING INSPECTION SUMMARY REPORT

Report/ Project	Sheet
			2112012	S 1/1
STT-CC-001-02-01 (TRL 001 G-Base 95 Tank Receiving line (Jetty to Tank No.1,2,3))

Date of inspections: 24 December 2021

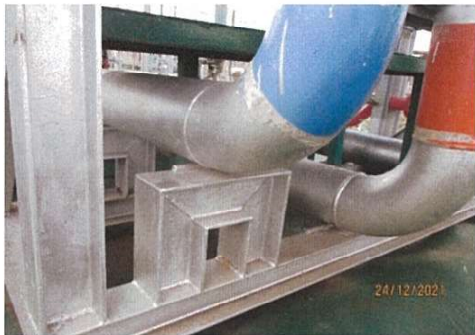
Name of part / Location		Findings		Name of part / Location		Findings	
TRL 001 Tank Receiving line (Jetty to Tank No.3,10)		Still in normal condition		TRL 001 Tank Receiving line (Jetty to Tank No.3,10)		Still in normal condition

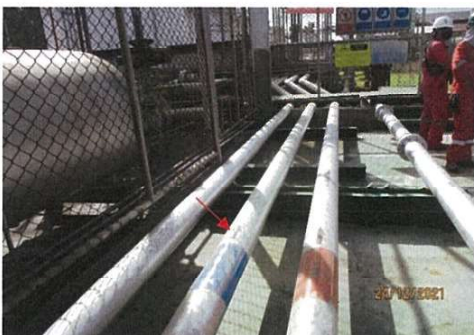
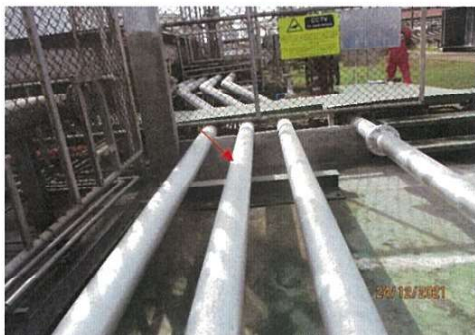
Name of part / Location		Findings		Name of part / Location		Findings	
TRL 001 Tank Receiving line (Jetty to Tank No.3,10)		Still in normal condition		TRL 001 Tank Receiving line (Jetty to Tank No.3,10)		Still in normal condition

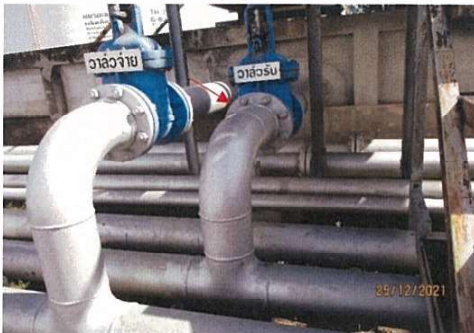
Name of part / Location		Findings		Name of part / Location		Findings	
TRL 001 Tank Receiving line (Jetty to Tank No.3,10)		Still in normal condition		TRL 001 Tank Receiving line (Jetty to Tank No.3,10)		Still in normal condition

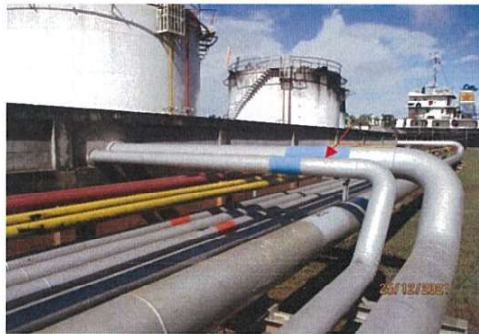
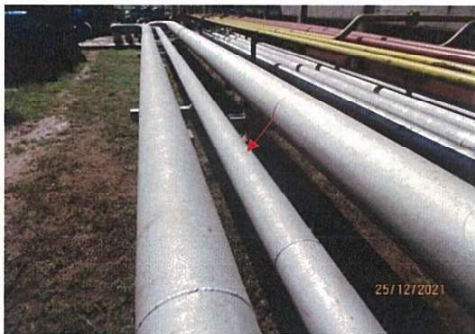
Name of part / Location		Findings		Name of part / Location		Findings	
TRL 001 Tank Receiving line (Jetty to Tank No.3,10)		Still in normal condition		TRL 001 Tank Receiving line (Jetty to Tank No.3,10)		Still in normal condition

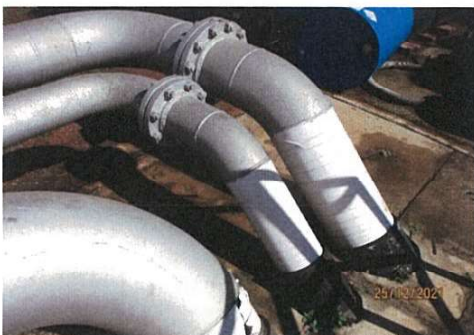
Name of part / Location		Findings		Name of part / Location		Findings	
TRL 001 Tank Receiving line (Jetty to Tank No.3,10)		Still in normal condition		TRL 001 Tank Receiving line (Jetty to Tank No.3,10)		Still in normal condition

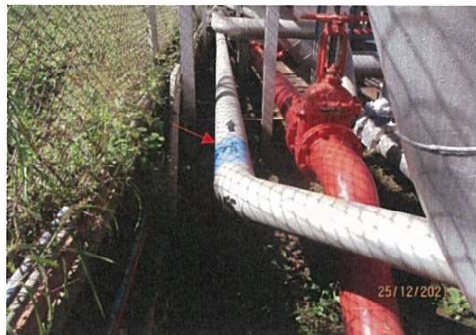
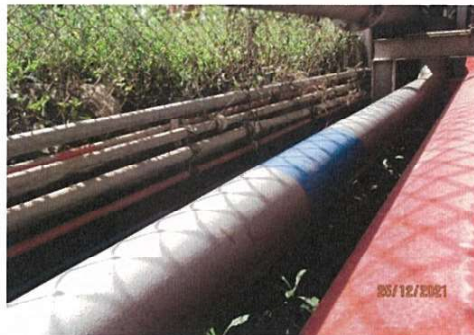
Name of part / Location		Findings	Name of part / Location		Findings
TRL 001 Tank Receiving line (Jetty to Tank No.3,10)		Still in normal condition	TRL 001 Tank Receiving line (Jetty to Tank No.3,10)		Still in normal condition

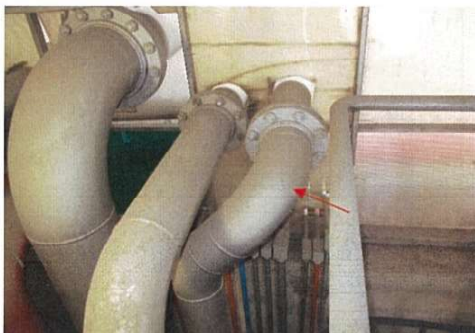
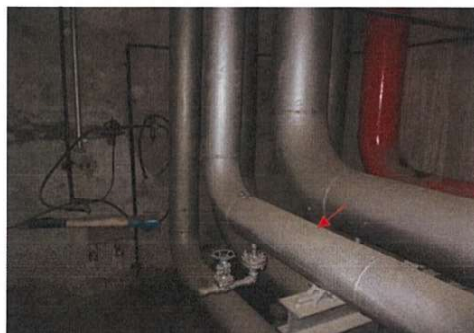
Name of part / Location		Findings	Name of part / Location		Findings
TRL 001 Tank Receiving line (Jetty to Tank No.3,10)		Still in normal condition	TRL 001 Tank Receiving line (Jetty to Tank No.3,10)		Still in normal condition

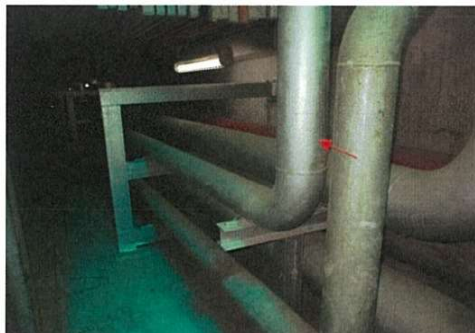
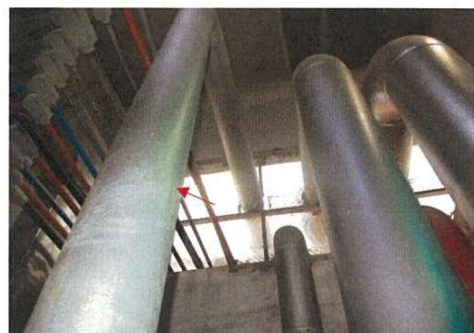
Name of part / Location		Findings	Name of part / Location		Findings
TRL 001 Tank Receiving line (Jetty to Tank No.3,10)		Still in normal condition	TRL 001 Tank Receiving line (Jetty to Tank No.3,10)		Still in normal condition

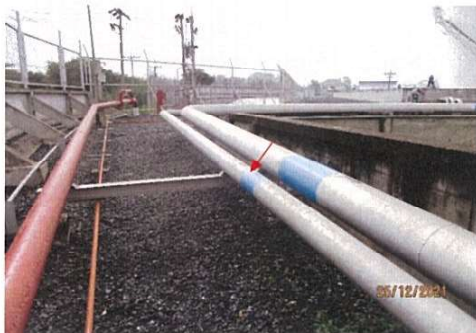
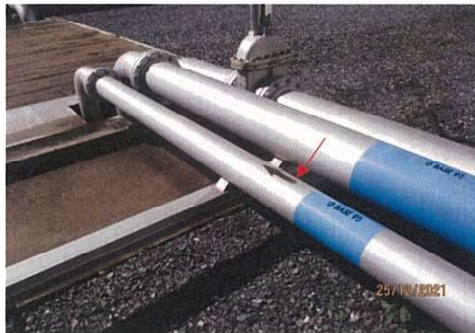
Name of part / Location			Findings		Name of part / Location			Findings	
TRL 001 Tank Receiving line (Jetty to Tank No.3,10)			Still in normal condition		TRL 001 Tank Receiving line (Jetty to Tank No.3,10)			Still in normal condition

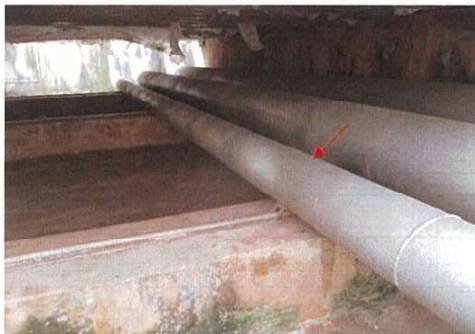
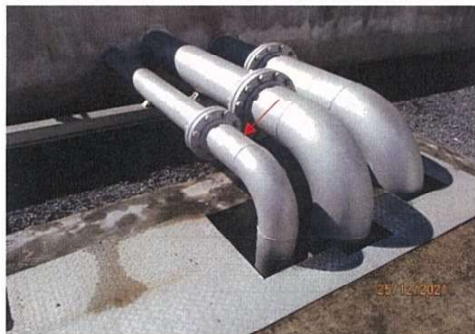
Name of part / Location			Findings		Name of part / Location			Findings	
TRL 001 Tank Receiving line (Jetty to Tank No.3,10)			Still in normal condition		TRL 001 Tank Receiving line (Jetty to Tank No.3,10)			Still in normal condition

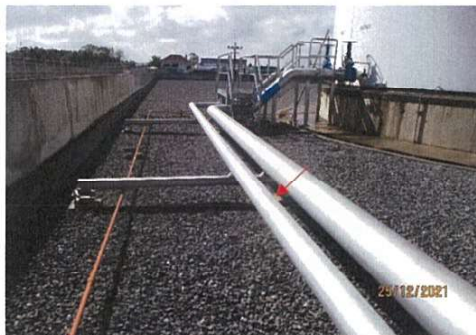
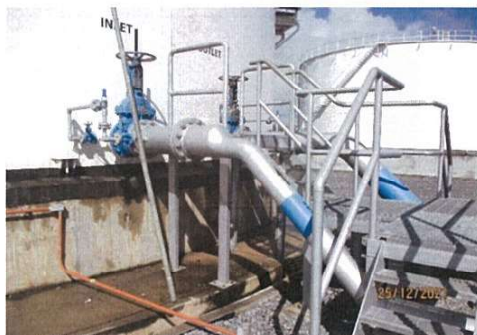
Name of part / Location			Findings		Name of part / Location			Findings	
TRL 001 Tank Receiving line (Jetty to Tank No.3,10)			Still in normal condition		TRL 001 Tank Receiving line (Jetty to Tank No.3,10)			Still in normal condition

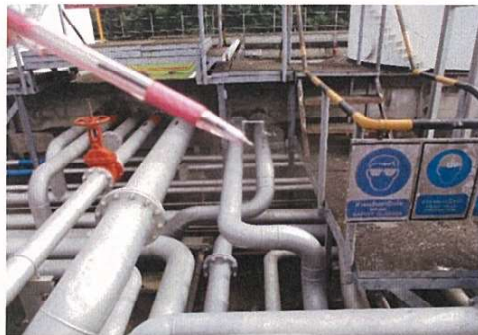
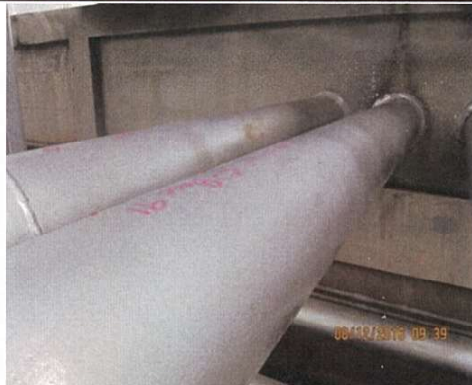
Name of part / Location			Findings		Name of part / Location			Findings	
TRL 002 G-Base 91 Tank Receiving line (Jetty to Tank No.9&Tank No.2)			Still in normal condition		TRL 002 G-Base 91 Tank Receiving line (Jetty to Tank No.9&Tank No.2)			Still in normal condition

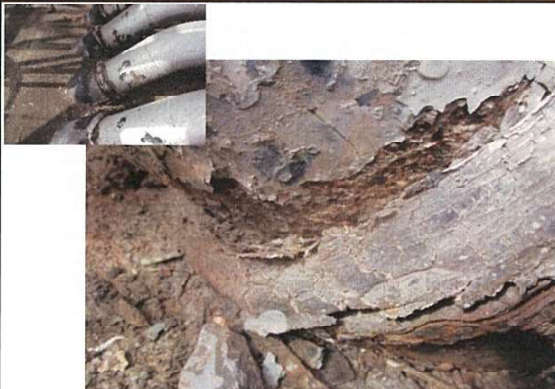
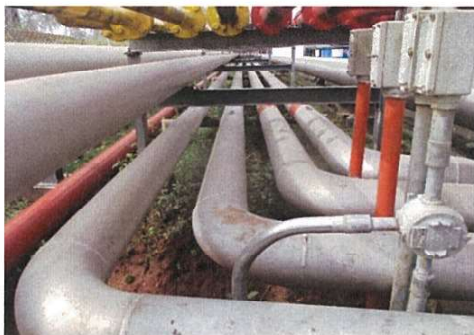
Name of part / Location		Name of part / Location		Findings
TRL 002 G-Base 91 Tank Receiving line (Jetty to Tank No.9&Tank No.2)		TRL 002 G-Base 91 Tank Receiving line (Jetty to Tank No.9&Tank No.2)		Still in normal condition

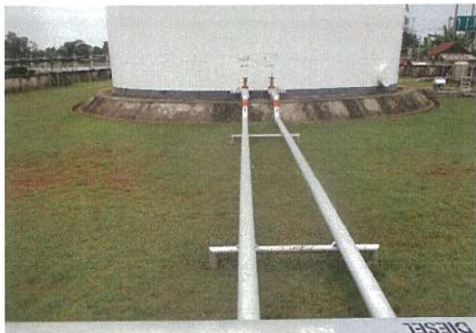
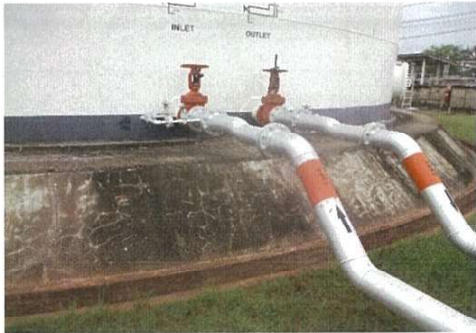
Name of part / Location		Findings		Name of part / Location		Findings	
TRL 002 G-Base 91 Tank Receiving line (Jetty to Tank No.9&Tank No.2)		Still in normal condition		TRL 002 G-Base 91 Tank Receiving line (Jetty to Tank No.9&Tank No.2)		Still in normal condition

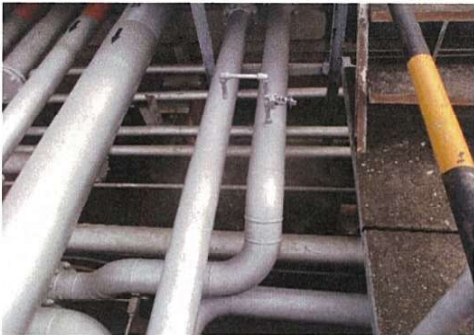
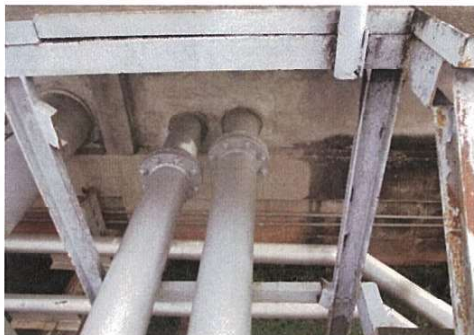
Name of part / Location		Findings		Name of part / Location		Findings	
TRL 002 G-Base 91 Tank Receiving line (Jetty to Tank No.9&Tank No.2)		Still in normal condition		TRL 002 G-Base 91 Tank Receiving line (Jetty to Tank No.9&Tank No.2)		Still in normal condition

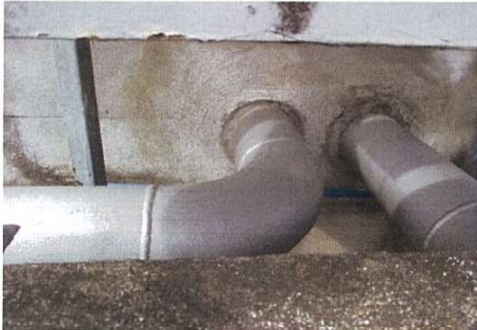
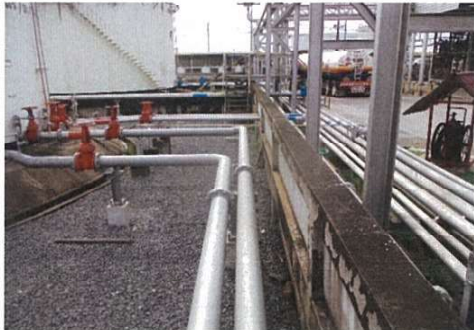
Name of part / Location		Findings		Name of part / Location		Findings	
TRL 002 G-Base 91 Tank Receiving line (Jetty to Tank No.9&Tank No.2)		Still in normal condition		TRL 002 G-Base 91 Tank Receiving line (Jetty to Tank No.9&Tank No.2)		Still in normal condition

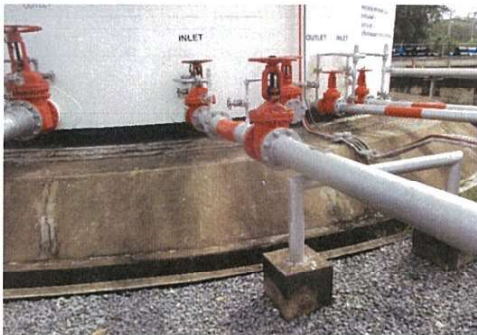
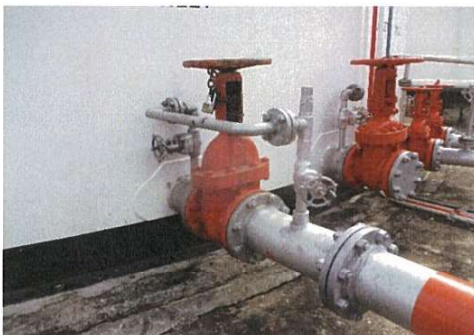
Name of part / Location		Findings		Name of part / Location		Findings	
TRL 002 G-Base 91 Tank Receiving line (Jetty to Tank No.9&Tank No.2)		Still in normal condition		TRL 002 G-Base 91 Tank Receiving line (Jetty to Tank No.9&Tank No.2)		Still in normal condition

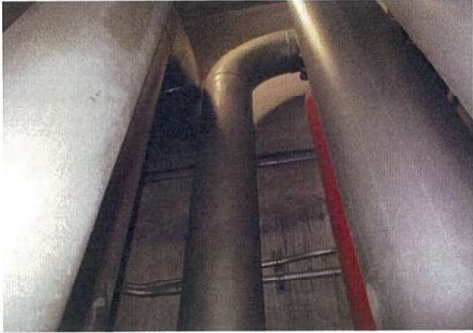
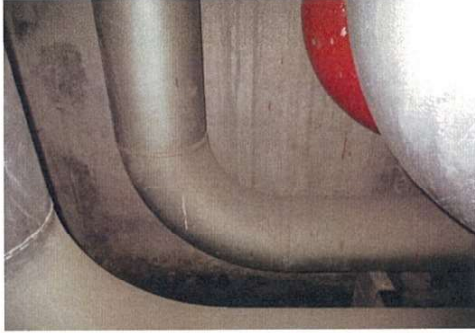
Name of part / Location		Findings		Name of part / Location		Findings	
TRL 002 G-Base 91 Tank Receiving line (Under road)		Still in normal condition		TRL 002 G-Base 91 Tank Receiving line (Under road)		Still in normal condition

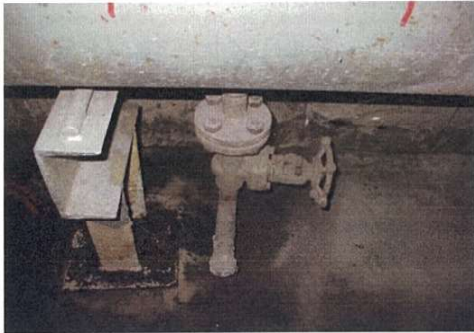
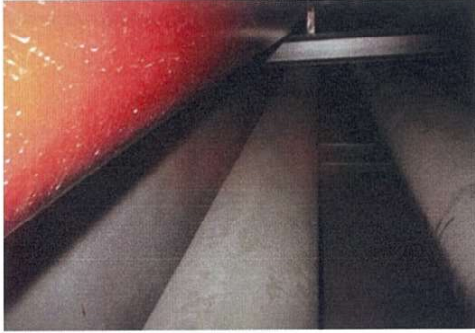
Name of part / Location		Findings		Name of part / Location		Findings	
TRL 002 G-Base 91 Tank Receiving line (Jetty to Tank No.9&Tank No.2)		Still in normal condition		TRL 002 G-Base 91 Tank Receiving line (Jetty to Tank No.9&Tank No.2)		Still in normal condition
