รายงานการตรวจสอบสภาพและความหนาของระบบท่อ

PIPING INSPECTION SUMMARY REPORT

Report/ Project	Sheet
			2112012	S 1/1
STT-CC-001-02-01 (TRL 001 G-Base 95 Tank Receiving line (Jetty to Tank No.1,2,3))

Date of inspections: 24 December 2021

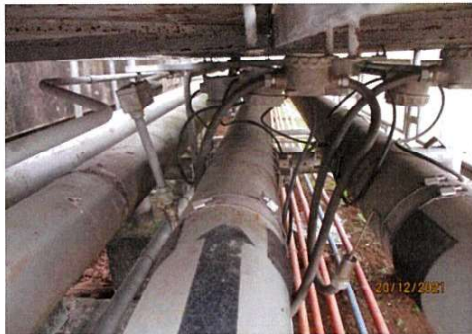
TRL 001 Tank Receiving line
(Jetty to Tank No.3,10)
Anomaly no : 2.1Painting deterioration and
general corrosion on pipe

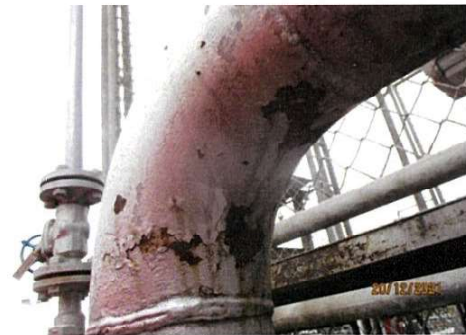
TRL 001 Tank Receiving line
(Jetty to Tank No.3,10)
Anomaly no : 2.2Painting deterioration and
general corrosion on elbow

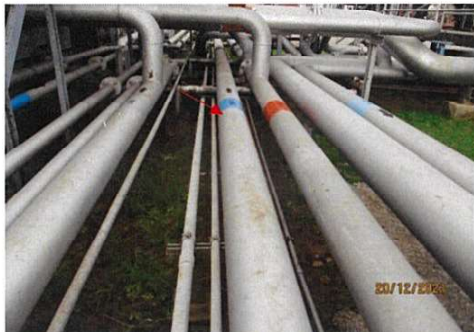
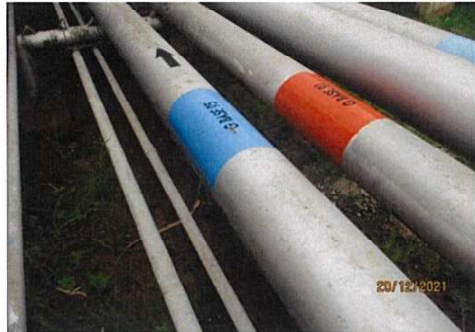
Name of part / Location		Findings	Name of part / Location		Findings
TRL 001 Tank Receiving line (Jetty to Tank No.3,10)		Still in normal condition	TRL 001 Tank Receiving line (Jetty to Tank No.3,10)		Still in normal condition

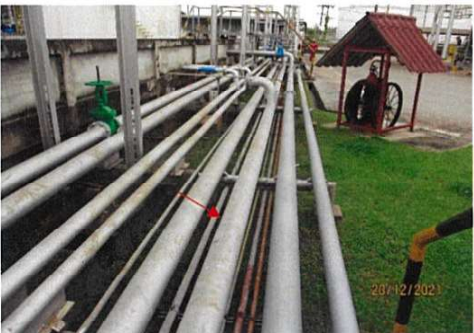
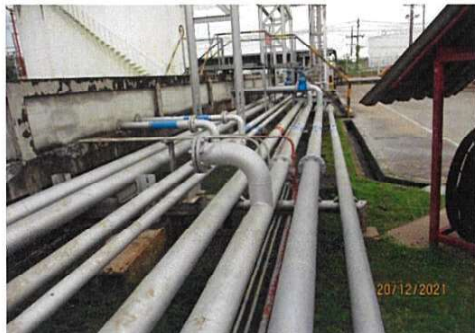
Name of part / Location		Findings	Name of part / Location		Findings
TRL 001 Tank Receiving line (Jetty to Tank No.3,10)		Still in normal condition	TRL 001 Tank Receiving line (Jetty to Tank No.3,10)		Still in normal condition

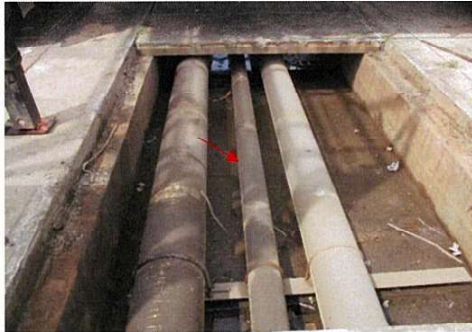
Name of part / Location	Findings	Name of part / Location	Findings
TRL 001 Tank Receiving line (Jetty to Tank No.3,10) Anomaly no : 6.1	general corrosion on U-bolt support	TRL 001 Tank Receiving line (Jetty to Tank No.3,10) Anomaly no : 6.1	general corrosion on U-bolt support

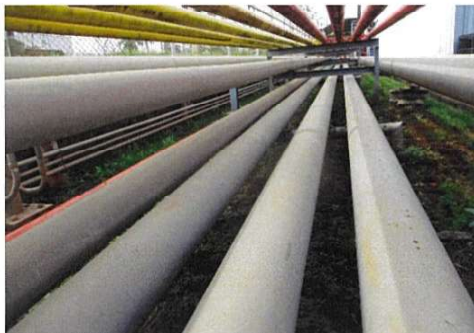
Name of part / Location		Findings	
TRL 002 G-Base 91 Tank Receiving line (Jetty to Tank No.9&Tank No.2)		Still in normal condition		TRL 002 G-Base 91 Tank Receiving line (Jetty to Tank No.9&Tank No.2)		Painting deterioration (9)

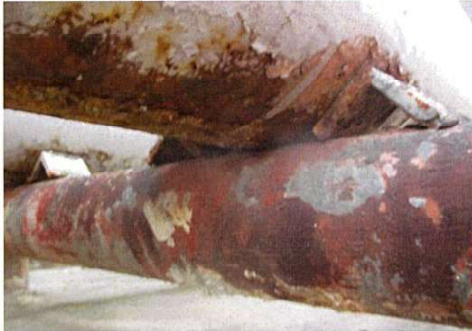
Name of part / Location		Findings		Name of part / Location		Findings	
TRL 002 G-Base 91 Tank Receiving line (Jetty to Tank No.9&Tank No.2)		Painting deterioration (13)		TRL 002 G-Base 91 Tank Receiving line (Jetty to Tank No.9&Tank No.2)		Still in normal condition

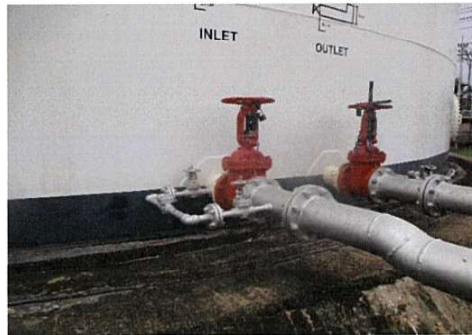
Name of part / Location		Findings		Name of part / Location		Findings	
TRL 002 G-Base 91 Tank Receiving line (Jetty to Tank No.9)		Painting deterioration (14)		TRL 002 G-Base 91 Tank Receiving line (Jetty to Tank No.9)		Still in normal condition
