เอกสารประกอบการปฏิบัติตาม
มาตรการป้องกันและแก้ไขผลกระทบสิ่งแวดล้อม

Star Petroleum Refining Public Company Limited (SPRC)

Ocean Works Asia (Thailand) Co., Ltd. has been requested by Star Petroleum Refining Company (SPRC) for the provision of ROV services, to carry out an inspection of the Map Ta Phut 48" Subsea Crude Import Pipeline. The inspection is part of the ongoing inspection, repair and maintenance (IRM) contract for the SPM off Map Ta Phut, Thailand.

Visual Inspection

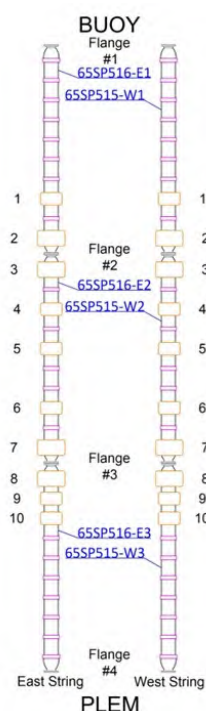
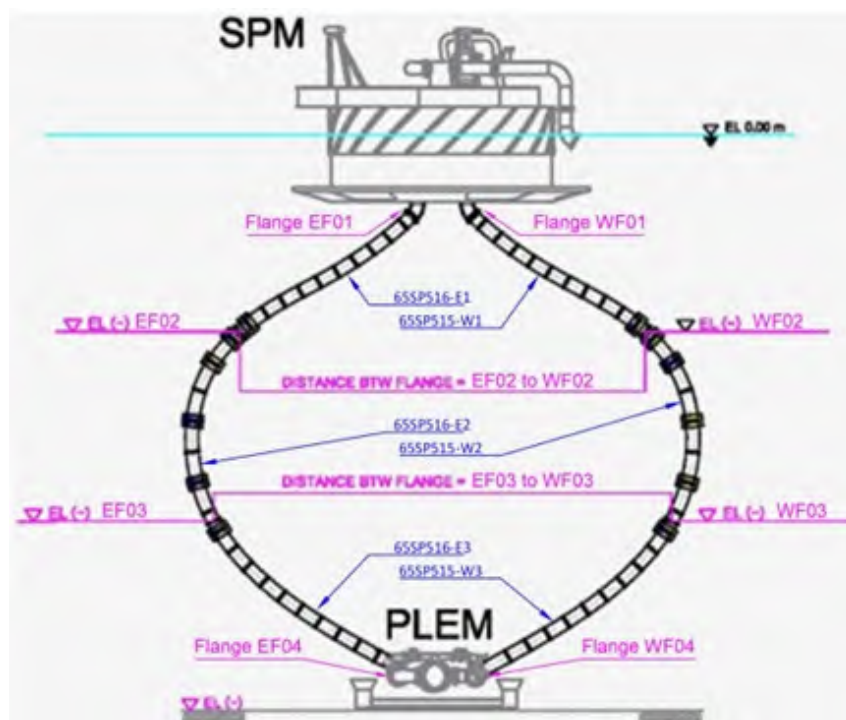
The inspection on the subsea hose(s) was carried out on both hoses from the SPM connection to the PLEM connection. The inspection consists of;

- Hose bead inspection
- Hose configuration measurements
- Flange and nipple connections

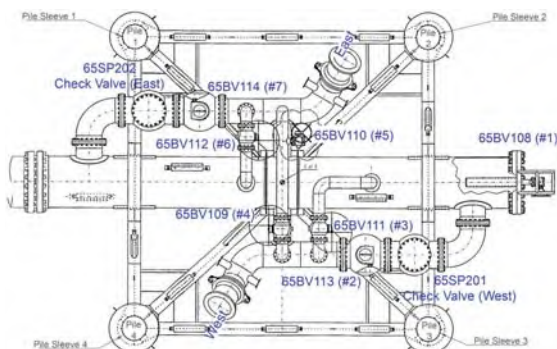
- There was no signs of damage or distortion
- No signs of leaks
- Valves appeared to be in good condition
- Apart from valve #7 which was slightly "stiff" (slightly tight to turn/cycle) during exercising all other valves exercised well

Note: There was no requirement to exercise valve #1 & #5.

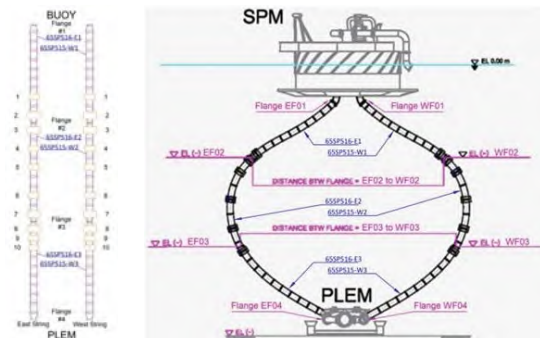
The inspection on the subsea hose(s) was carried out on both hoses from the SPM connection to the PLEM connection. The inspection consists of;

- Hose bead inspection
- Hose configuration measurements
- Flange and nipple connections

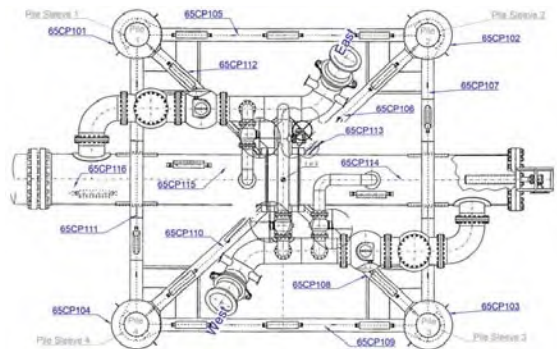
CP readings were taken on the PLEM at selected locations ranged between (-)1070V and (-)1062V.

Location	Reading (-V)	Location	Reading (-V)
65CP101	1.063	65CP111	1.069
65CP102	1.062	65CP112	1.070
65CP103	1.066	65CP113	1.063
65CP104	1.065	65CP114	1.064
65CP105	1.067	65CP115	1.068
65CP106	1.067	65CP116	1.066
65CP107	1.063	Pile 1	0.651
65CP108	1.070	Pile 2	0.655
65CP109	1.070	Pile 3	0.650
65CP110	1.067	Pile 4	0.643

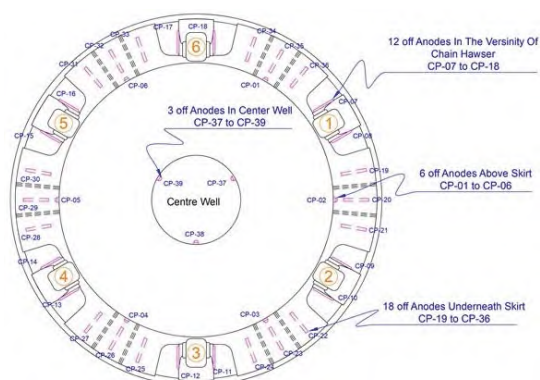
5.2 Cathodic Potential (CP) Readings on Buoy

CP readings were taken on the buoy at the anode locations and in the moonpool area. CP readings on the buoy structure ranged between (-)957mV and (-)1020mV.

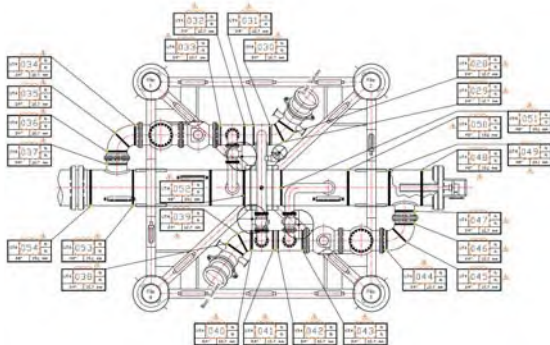
6.1 Ultrasonic Thickness Gauging (UTG) on the PLEM

Ultrasonic Thickness Gauging (UTG) was carried out on sections of pipework on PLEM and readings ranged between 12.7mm and 20.7mm

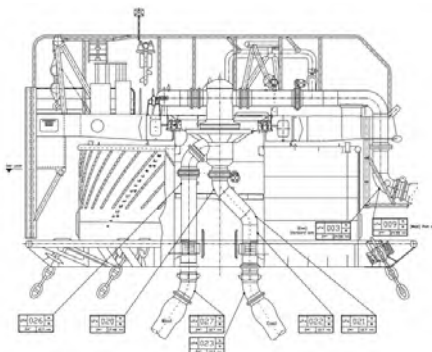
6.2 Ultrasonic Thickness Gauging (UTG) on the Buoy

Ultrasonic Thickness Gauging (UTG) was carried out on sections of pipework on PLEM and readings ranged between 8.9mm and 44.2mm

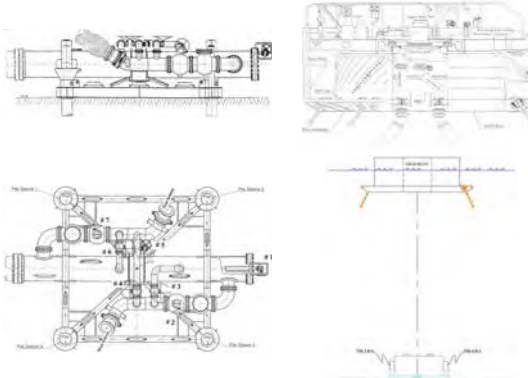
8.0 General Visual Inspection of the Buoy and PLEM

- The Mainline & Flanges were inspected and there was no signs of damage and the flanges appeared to be secure with no signs of leaks.
- There were no signs of any significant scour or gap at the sand slit area around the base of the PLEM. Base frame partially buried in areas.
- There was no significant debris noted on or around the PLEM structure

- There was no damage or debris noted on the buoy and skirt
- Buoy position measurements relative to the PLEM was taken
- The Overall coating condition was good with scattered areas of paint coat flaking/peeling
- There was approximately 30-40% overall marine growth coverage

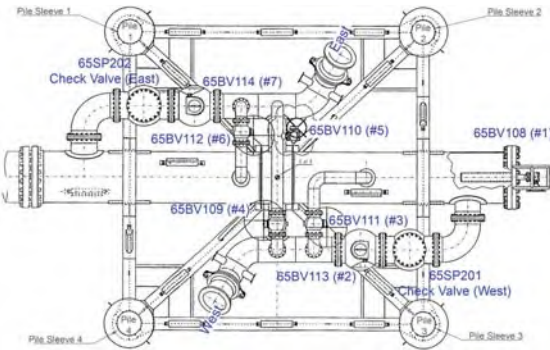
- Valve # 7 - Outer-Right nipple found leaking. Remedial action taken by tightening and re-wrapping nipple.
- There was no signs of damage or distortion
- Apart from the no Valve #7 no other signs of leaks were noted
- Valves appeared to be in good condition
- Apart from valve #7 which was slightly "stiff" (slightly tight to turn/cycle) during exercising all other valves exercised well

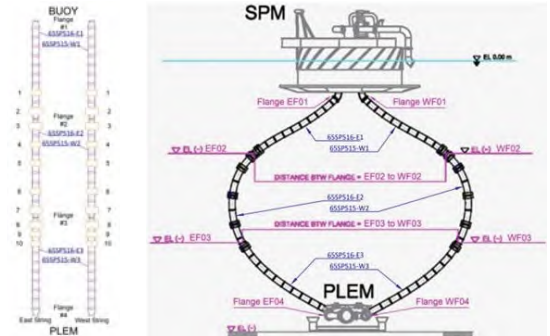
- All the securing bolts and nuts on the bead float were present.
- The bead floats were secure with no signs of slippage noted.
- There were no signs of damage
- Overall there was 60-80% marine growth coverage of approximately 30mm thickness

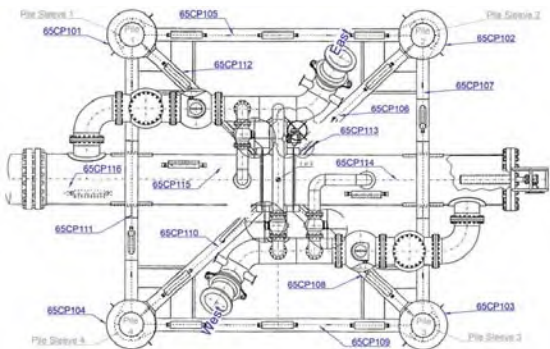
CP readings were taken on the PLEM at selected locations ranged between (-)1.072V and (-)1.062V.

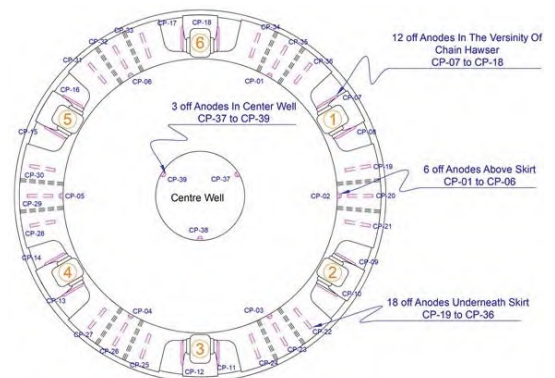
5.2 Cathodic Potential (CP) Readings on Buoy

CP readings on the buoy structure ranged between (-)1.043V and (-)0.957V.

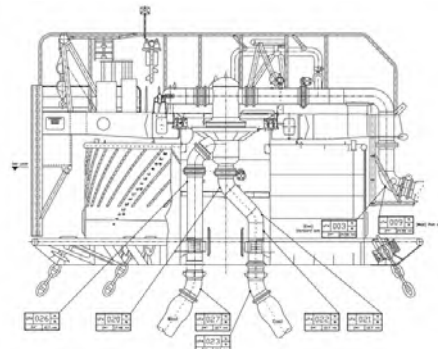
6.2 Ultrasonic Thickness Gauging (UTG) on the Buoy

Ultrasonic Thickness Gauging (UTG) was carried out at an earlier stage on a previous inspection on sections of pipework on PLEM and readings at the time ranged between 8.9mm and 44.2mm

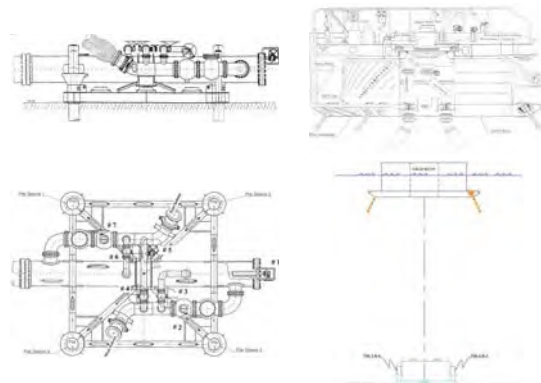
8.0 General Visual Inspection of the Buoy and PLEM

- The Mainline & Flanges were inspected and there was no signs of damage and the flanges appeared to be secure with no signs of leaks.
- There were no signs of any significant scour or gap at the sand slit area around the base of the PLEM. Base frame partially buried in areas.
- There was no significant debris noted on or around the PLEM structure

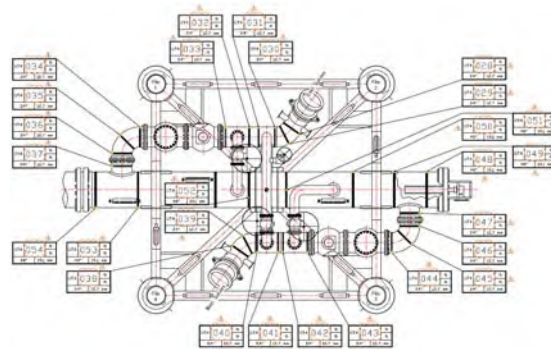
Ultrasonic Thickness Measurement

Location	Nominal Wt (mm)	Reading				Remarks
		12o/c	3o/c	6o/c	9o/c	
040	12.7	20.3	18.7	18.5	18.9	-
041	12.7	20.1	19.0	18.4	19.1	-
042	12.7	20.5	19.5	18.8	18.7	-
043	12.7	20.0	18.9	19.1	18.9	-
044	12.7	14.1	13.7	15.0	14.0	-
045	12.7	13.8	13.4	14.1	13.6	-
046	12.7	14.2	14.1	15.6	15.1	-
047	12.7	12.8	13.1	13.1	13.0	-
048	19.1	19.0	18.9	19.0	19.0	-
049	19.1	19.2	19.1	19.0	19.1	-
050	19.1	19.1	19.2	19.0	18.8	-
051	19.1	19.1	19.1	18.9	19.1	-
052	19.1	19.1	19.1	19.1	19.1	-
053	19.1	19.0	19.0	19.1	19.1	-
054	19.1	18.9	19.1	19.1	19.2	-

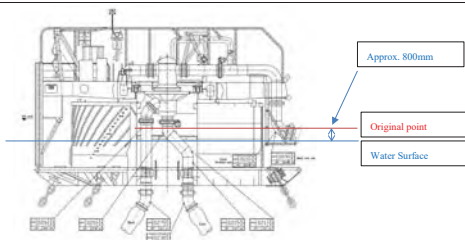
Location	Nominal Wt (mm)	Reading				Remarks
		12o/c	3o/c	6o/c	9o/c	
003	12.7	42.7 42.5 42.6	41.8 41.7 41.9	37.5 37.8 37.9	39.0 39.4 39.2	Position of clock was facing to floating hose.
009	12.7	42.2 42.1 42.4	39.2 39.2 39.1	38.6 38.4 38.3	41.0 40.7 40.7	
020	12.7	14.5 14.2 14.0	15.2 14.7 15.1	13.9 13.9 13.8	14.9 15.1 15.1	6o/c - Side closest to wall
021	12.7	12.8 13.0 13.1	14.1 14.1 14.0	14.8 14.9 14.8	13.8 13.7 13.6	
022	12.7	11.0 11.0 11.3	11.0 10.9 11.2	9.3 9.4 9.3	10.5 10.6 10.7	
023	12.7	21.7 21.7 21.7	21.5 21.8 21.7	20.7 20.7 20.8	21.5 21.5 21.3	
026	12.7	10.5 10.6 10.5	9.0 9.2 9.0	9.7 10.0 9.9	9.9 10.1 9.9	6o/c - Side closest to wall
027	12.7	20.7 20.9 20.9	20.9 21.1 21.0	22.1 21.8 21.8	22.0 22.1 22.0

Note: Locations 001 & 002, 004 to 008, 010 to 019, 024 & 025 and 028 to 030 are not within the scope of the underwater inspection

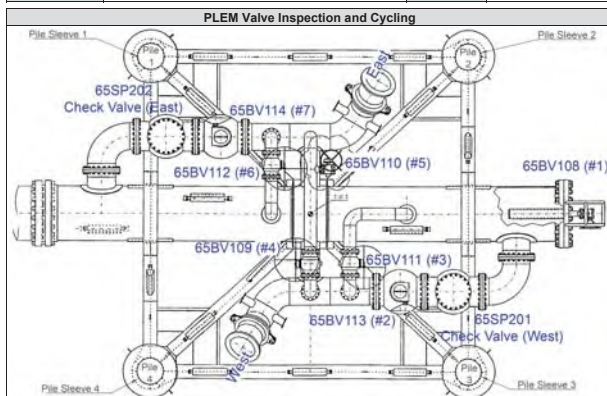
Visual Inspection

Item No.	Tag No	Description	As Found	Task Performed / Inspection Findings	As Left
1	65BV108	4" BALL VALVE #1	Open / Closed	No Valve exercising required	Open / Closed
2	65BV113	24" BALL VALVE #2	Open / Closed	Valve exercised	Open / Closed
3	65BV111	10" BALL VALVE #3	Open / Closed	Valve exercised	Open / Closed
4	65BV109	10" BALL VALVE #4	Open / Closed	Valve exercised	Open / Closed
5	65BV110	4" VENT BALL Valve #5	Open / Closed	No Valve exercising required	Open / Closed
6	65BV112	10" BALL VALVE #6	Open / Closed	Valve exercised	Open / Closed
7	65BV114	24" BALL VALVE #7	Open / Closed	Valve exercised	Open / Closed

- Valve #7 which was slightly tight to turn/cycle, all other valves cycled easily.
- Valve # 7 - Outer-Right nipple found leaking. Remedial action taken by tightening and re-wrapping nipple.
- All Valves covered with 5-80% marine growth
- Valve #1 - 6 - No signs of leaks or damage

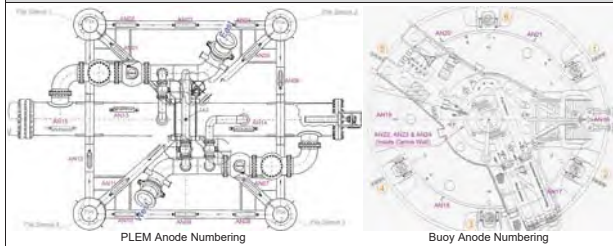
General Visual Inspection (GVI) on the PLEM & Buoy Anodes

Anode	% Depletion	Secure	Dimension		Marine Growth %	Anode	% Depletion	Secure	Dimension		Marine Growth %
			L (mm)	Ø (mm)					L (mm)	Ø (mm)	
AN01	25-50	Yes / No	1200	450	50	AN13	50	Yes / No	1200	400	50
AN02	25-50	Yes / No	1230	110	50	AN14	50	Yes / No	1200	390	50
AN03	25-50	Yes / No	1210	120	50	AN15	50	Yes / No	1240	480	10
AN04	0-25	Yes / No	690	150	5	AN16	0 (New)	Yes / No	930	430	10
AN05	0-25	Yes / No	690	150	10	AN17	50	Yes / No	920	400	100
AN06	50	Yes / No	1230	160	50	AN18	0 (New)	Yes / No	900	390	5
AN07	50	Yes / No	1210	440	50	AN19	0 (New)	Yes / No	910	400	0
AN08	50	Yes / No	1220	420	50	AN20	0 (New)	Yes / No	900	390	0
AN09	0-25	Yes / No	690	620	10	AN21	0 (New)	Yes / No	920	400	5
AN10	0-25	Yes / No	690	600	10	AN22	50	Yes / No	610	540	100
AN11	50	Yes / No	1250	450	10	AN23	50	Yes / No	900	410	100
AN12	50	Yes / No	1200	450	10	AN24	50	Yes / No	650	620	100

Comments
Anode Numbers: 4, 5, 9, 10, 16, 18 – 21 have been recently installed

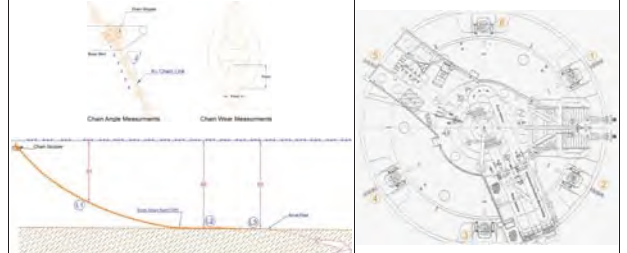
General Visual Inspection (GVI) Chain Angle & Wear

Chain No	Chain Angle (XX°)	Chain Wear (mm)				Kenter Shackles Chain Wear (mm)							
		Chain Stopper	X	Y	TDP	Location 1 (L1)	D1	X	Y	Location 2 (L2)	D2	X	Y
1	46	219	106	-	-	-	-	-	-	-	-	-	-
2	48	215	107	-	-	-	-	-	-	-	-	-	-
3	45	217	104	-	-	-	-	-	-	-	-	-	-
4	48	215	103	-	-	-	-	-	-	-	-	-	-
5	48	216	102	-	-	-	-	-	-	-	-	-	-
6	44	218	103	-	-	-	-	-	-	-	-	-	-

Note:
Chain angle measurements to be taken on the 6th link down from the chain stopper.

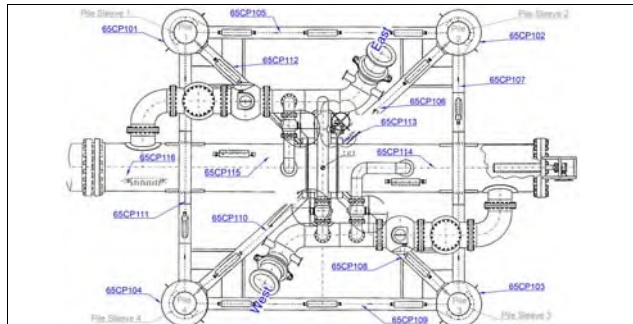
Location	Reading (-V)	Location	Reading (-V)
65CP101	1.066	65CP111	1.072
65CP102	1.066	65CP112	1.070
65CP103	1.067	65CP113	1.062
65CP104	1.067	65CP114	1.063
65CP105	1.067	65CP115	1.065
65CP106	1.067	65CP116	1.067
65CP107	1.066	Pile 1	0.652
65CP108	1.070	Pile 2	0.652
65CP109	1.070	Pile 3	0.650
65CP110	1.071	Pile 4	0.564

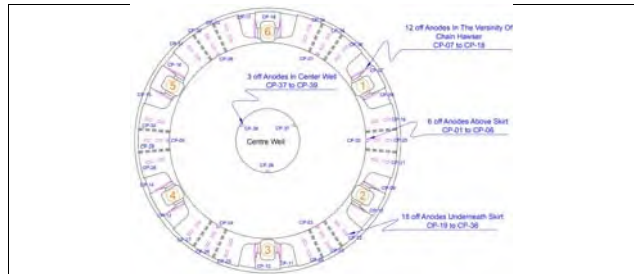
Location	Reading (-V)	Location	Reading (-V)	Location	Reading (-V)
CP-01	1.013	CP-14	0.983	CP-27	0.981
CP-02	1.024	CP-15	0.975	CP-28	0.984
CP-03	1.004	CP-16	0.981	CP-29	0.982
CP-04	1.024	CP-17	0.980	CP-30	0.979
CP-05	1.043	CP-18	0.981	CP-31	0.991
CP-06	1.038	CP-19	0.983	CP-32	0.992
CP-07	0.977	CP-20	0.984	CP-33	0.989
CP-08	0.980	CP-21	0.980	CP-34	0.984
CP-09	0.959	CP-22	0.975	CP-35	0.983
CP-10	0.979	CP-23	0.972	CP-36	0.983
CP-11	0.980	CP-24	0.978	CP-37	1.026
CP-12	0.957	CP-25	0.985	CP-38	1.026
CP-13	0.975	CP-26	0.984	CP-39	1.009
