รายงานการตรวจสอบสภาพและความหนาของระบบท่อ

DAICON		PIPING INSPECTION SUMMARY REPORT		Chevron		Report/ Project	Sheet
						2112012	S 1/1
STT-CC-001-02-01 (TRL 001 G-Base 95 Tank Receiving line (Jetty to Tank No.1,2,3))							
Date of inspection: 24 December 2021							
Piping data							
Line ID :	TRL 001 Tank Receiving line			Line Description :	Jetty to Tank No.3,10		
Product :	G-Base 95			Diameter/Schedule :	6 inch, Sch. STD. T nom : 7.11 mm.		
Material :	API 5L GR.B			Insulation :	N/A		
Design and calculations							
Design Pressure P :	285 psi		Tmin (measured) :	0.84 mm.			
Diameter D :	6 inch		Tmat (Table 9 API 579) :	3.3 mm.	T struc :	2.8 mm.	
Stress S (Table A1) :	20.0 ksi	Tmin = PD 2(SE+PY)	T minimum measured :	5.96 mm.			
Q factor E (Table A2 or A3) :	1		Service life (from last reading) :	1965 / 51 years			
Coefficient Y: (Table 10A, B, C) :	0.4		Corrosion Rate :	0.347 mm./year			
The estimated remaining life for this line is: 10.04 years

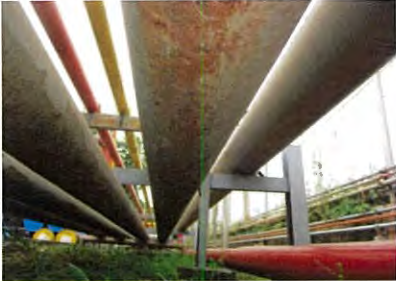
PIPING INSPECTION PICTURE LOG		Report/ Project	Sheet
		2112012	PL 6/7
STT-CC-003-01-01 (TRL 003 Diesel Tank Receiving Line (Jetty to Tank No.6,8))

Name of part / Location	Findings	Name of part / Location	Findings
TRL 003 Diesel Tank Receiving Line (Jetty to Tank No.6,8)	Still in normal condition	TRL 003 Diesel Tank Receiving Line (Jetty to Tank No.6,8)	Still in normal condition

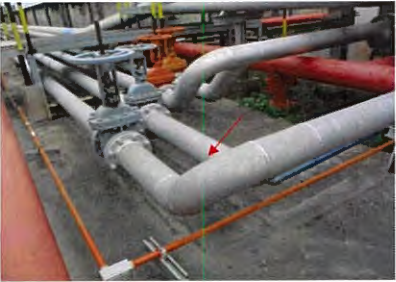
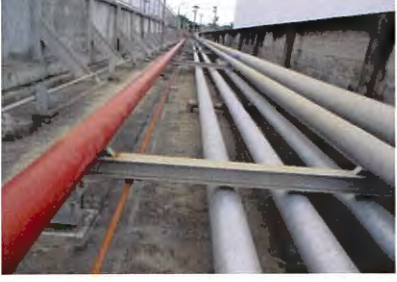
Name of part / Location	Findings	Name of part / Location	Findings
TRL 003 Diesel Tank Receiving Line (Jetty to Tank No.6,8)	Still in normal condition	TRL 003 Diesel Tank Receiving Line (Jetty to Tank No.6,8)	Still in normal condition
