Equipment Name : O-RISER,8"GAS(B9150) AT BEWB

Equipment No. : BE-8BEPLD1-RS-BEWB AT Receiver Tag No. ZAQ-(B9150)
Equipment Name : O-RISER,8"GAS(B9150) AT BEWB

1.1 GENERAL CONDITION

The pipeline survey of the 8in BEPLG1 from BEWA to BEWG riser tie-in flange confirmed the as-laid route with no significant deviation observed. The as-found pipeline was found to be in good general condition with no significant damage observed along the length of the pipe.

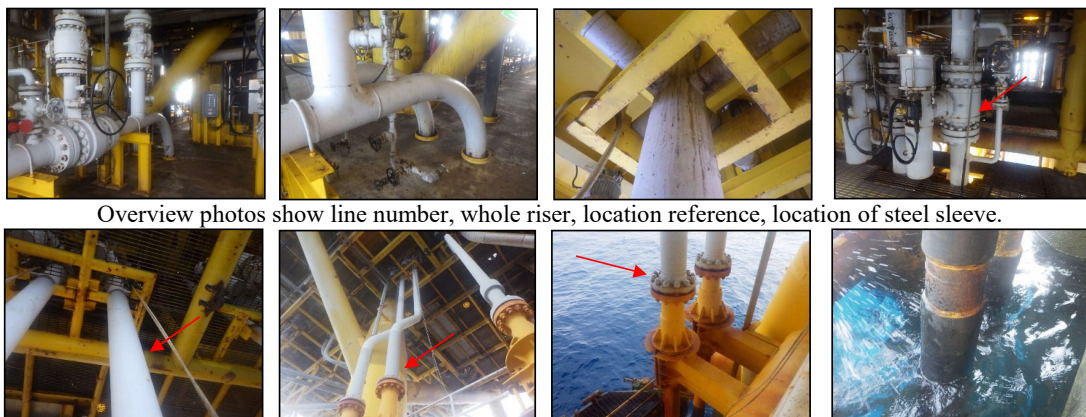
- 1) Visual inspection for External corrosion along riser from block valve of Launcher/Receiver down to Riser section above water.
