# **Surveying Report**

**(Condition of Property)**

## **The Andaman Cove Condominium**

### **Condition of building of The Amandaman Cove Condominium Project**

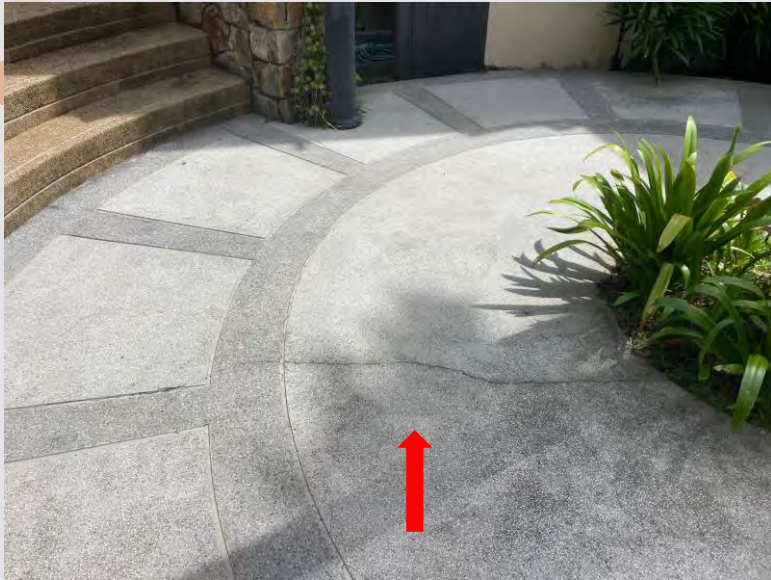
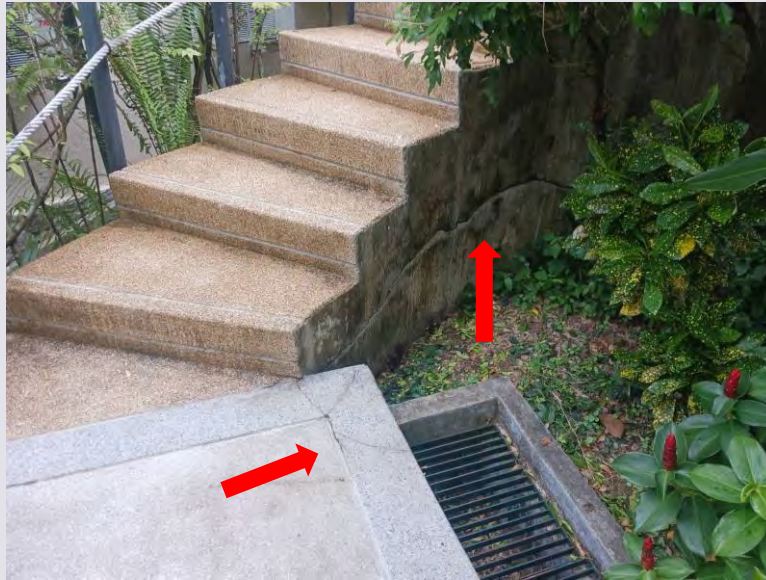
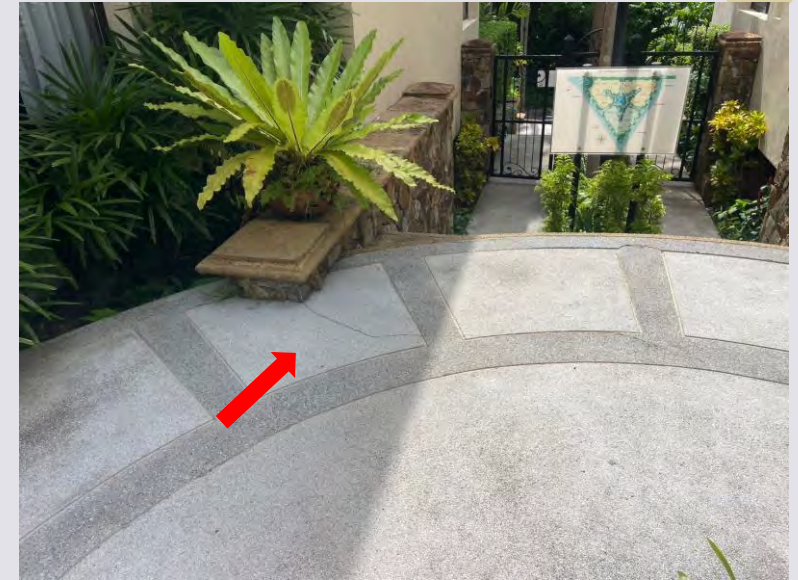
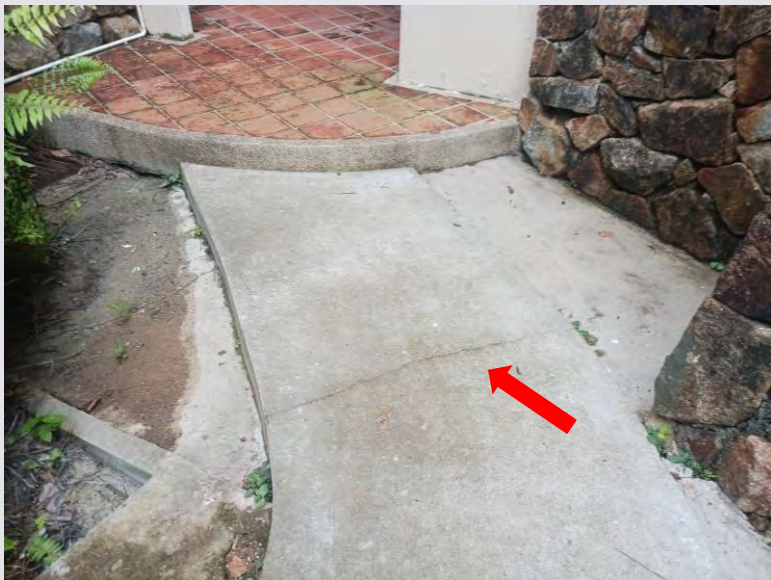
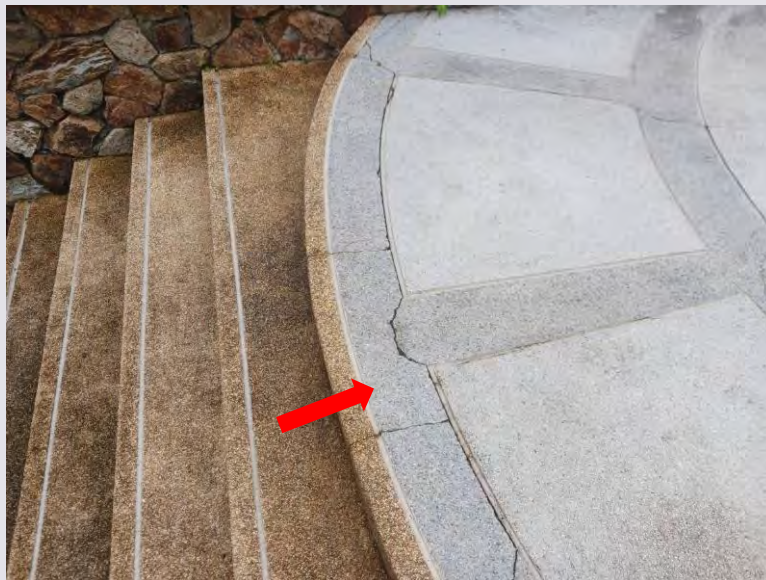
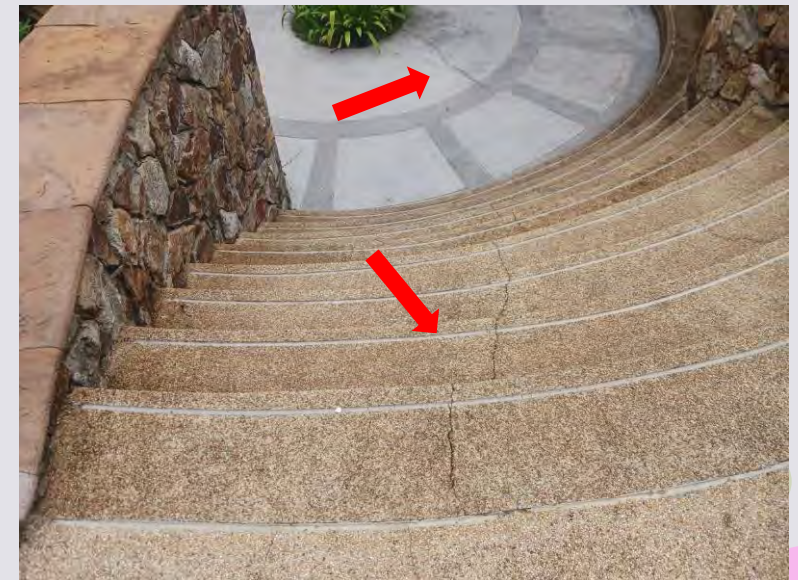
## Swimming Pool (2)

- 1. Swimming pool, retention tank septic tank and water tank no signal shown it is leakage. All area around them is dry.**
- 2. Have some room that reported in item A have water leak , on proceed to fix**

1. **This property have no sign that shown the structural failure. water tank ,swimming pool and septic tank is in suitable condition no anything have leakage.**
2. **All crack line that see is come from poor skill worker and deteriorated material.**
3. **Have 10 unit have some water leak on the date of surveying.**
