รายงานการตรวจสอบสภาพและความหนาของระบบท่อ

<b>PIPING INSPECTION SUMMARY REPORT</b>

Report/ Project	Sheet
			2112012	S 1/1
<b>STT-CC-001-02-01 (TRL 001 G-Base 95 Tank Receiving line (Jetty to Tank No.1,2,3))</b>

Date of inspections: 24 December 2021

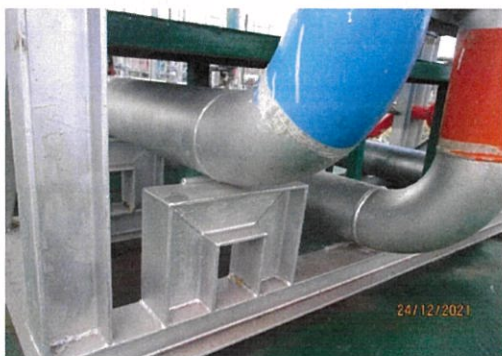
Name of part / Location		Findings	Name of part / Location		Findings
TRL 001 Tank Receiving line (Jetty to Tank No.3,10)		Still in normal condition	TRL 001 Tank Receiving line (Jetty to Tank No.3,10)		Still in normal condition

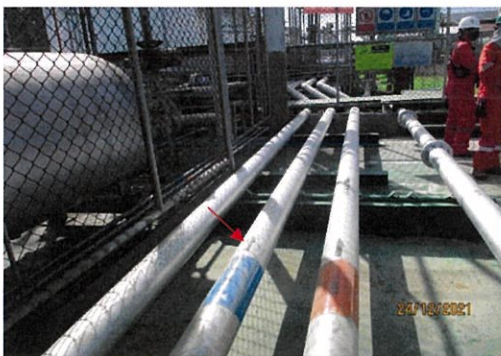
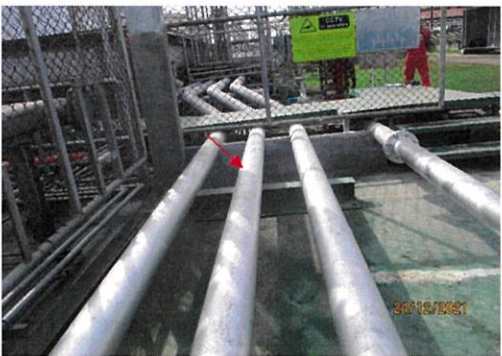
Name of part / Location		Findings	Name of part / Location		Findings
TRL 001 Tank Receiving line (Jetty to Tank No.3,10)		Still in normal condition	TRL 001 Tank Receiving line (Jetty to Tank No.3,10)		Still in normal condition

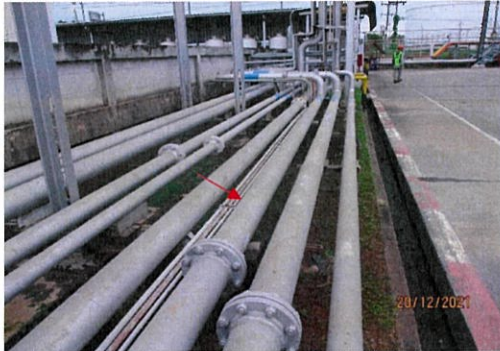
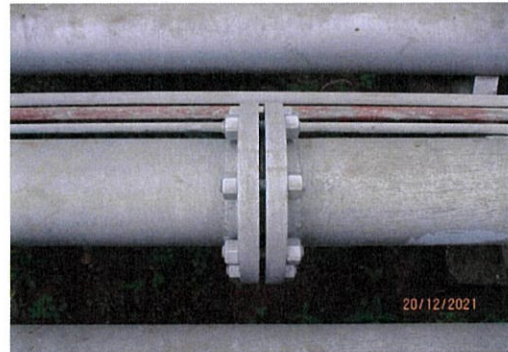
Name of part / Location	Findings	Name of part / Location	Findings
TRL 001 Tank Receiving line (Jetty to Tank No.3,10)	Still in normal condition	TRL 001 Tank Receiving line (Jetty to Tank No.3,10)	Still in normal condition

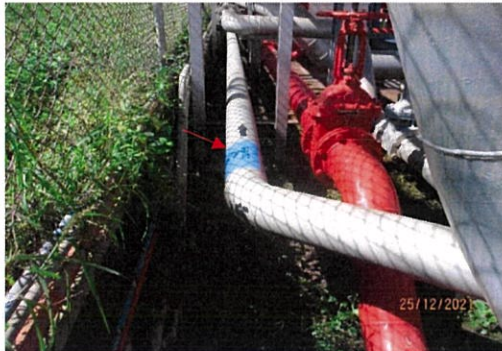
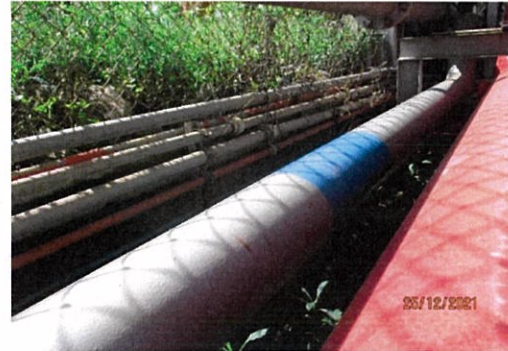
Name of part / Location	Findings	Name of part / Location	Findings
TRL 001 Tank Receiving line (Jetty to Tank No.3,10)	Still in normal condition	TRL 001 Tank Receiving line (Jetty to Tank No.3,10)	Still in normal condition

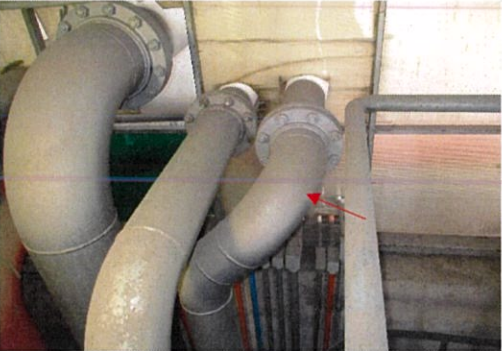
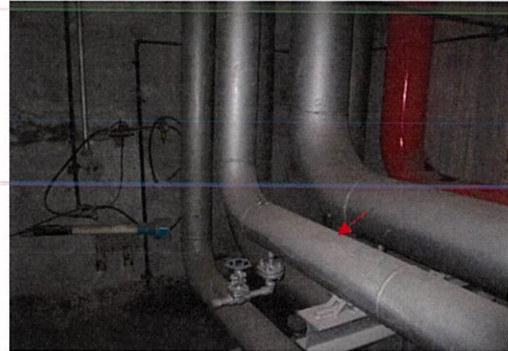
Name of part / Location	Findings	Name of part / Location	Findings
TRL 001 Tank Receiving line (Jetty to Tank No.3,10)	Still in normal condition	TRL 001 Tank Receiving line (Jetty to Tank No.3,10)	Still in normal condition

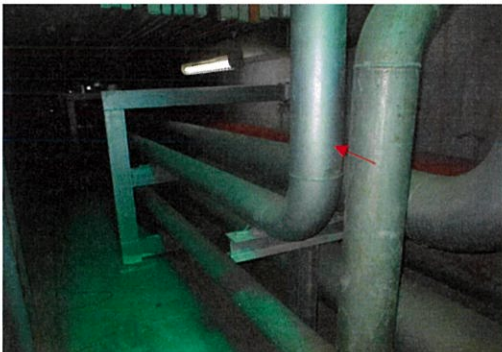
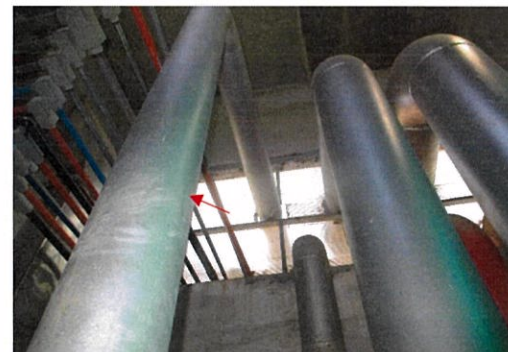
Name of part / Location	Findings	Name of part / Location	Findings
TRL 001 Tank Receiving line (Jetty to Tank No.3,10)	Still in normal condition	TRL 001 Tank Receiving line (Jetty to Tank No.3,10)	Still in normal condition

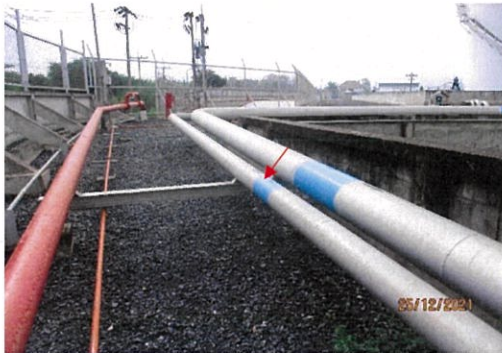
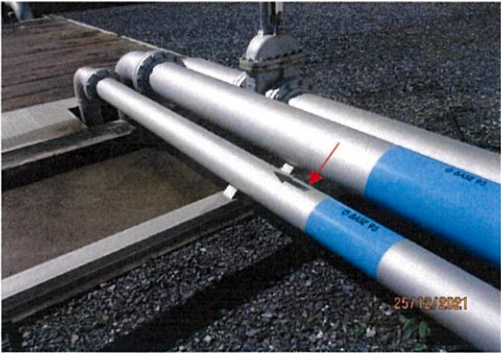
Name of part / Location			Findings		Name of part / Location			Findings	
TRL 001 Tank Receiving line (Jetty to Tank No.3,10)			Still in normal condition		TRL 001 Tank Receiving line (Jetty to Tank No.3,10)			Still in normal condition

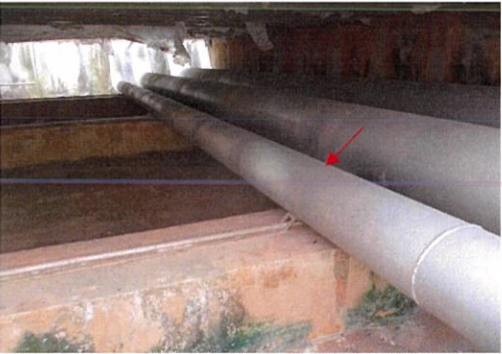
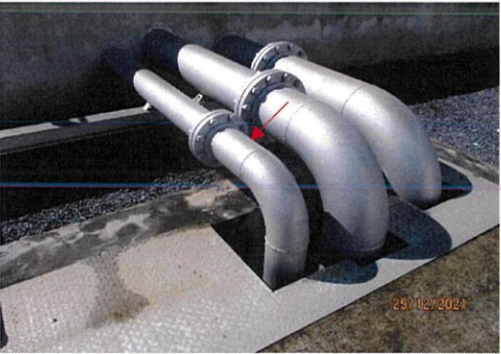
Name of part / Location			Findings		Name of part / Location			Findings	
TRL 001 Tank Receiving line (Jetty to Tank No.3,10)			Still in normal condition		TRL 001 Tank Receiving line (Jetty to Tank No.3,10)			Still in normal condition

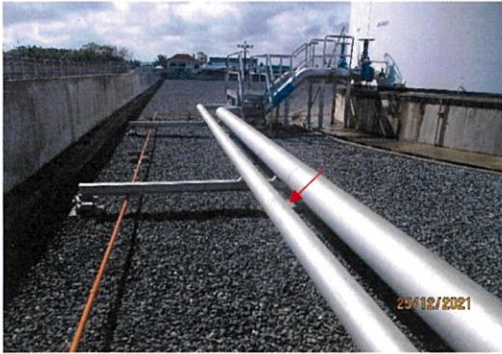
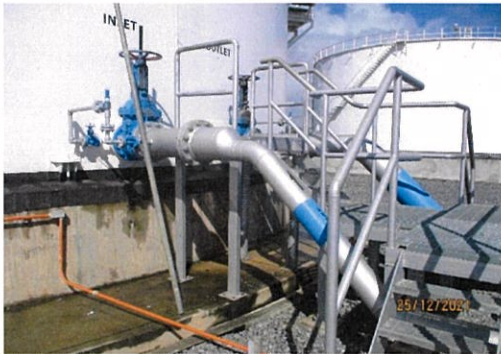
Name of part / Location			Findings		Name of part / Location			Findings	
TRL 001 Tank Receiving line (Jetty to Tank No.3,10)			Still in normal condition		TRL 001 Tank Receiving line (Jetty to Tank No.3,10)			Still in normal condition

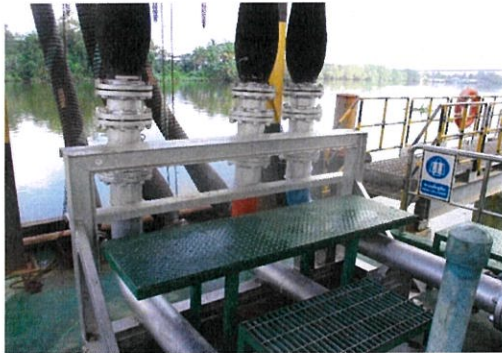
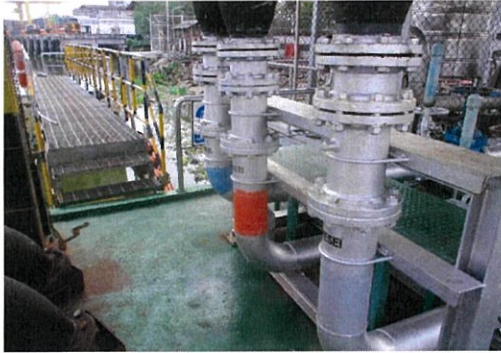
Name of part / Location		Findings	Name of part / Location		Findings
TRL 002 G-Base 91 Tank Receiving line (Jetty to Tank No.9&Tank No.2)		Still in normal condition	TRL 002 G-Base 91 Tank Receiving line (Jetty to Tank No.9&Tank No.2)		Still in normal condition

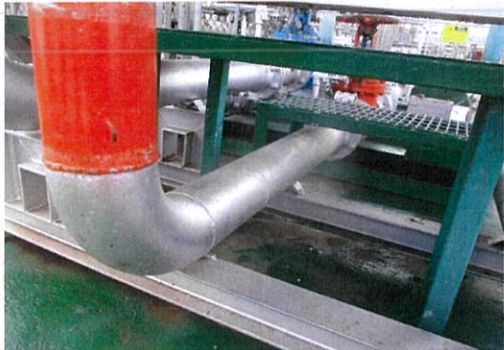
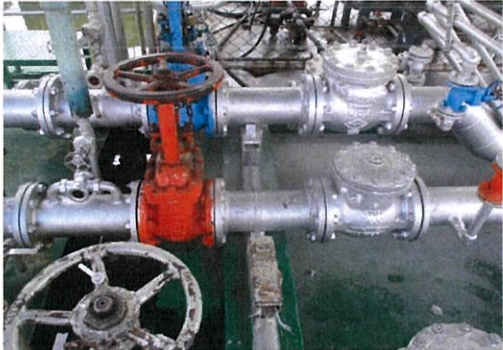
Name of part / Location		Findings	Name of part / Location		Findings
TRL 002 G-Base 91 Tank Receiving line (Jetty to Tank No.9&Tank No.2)		Still in normal condition	TRL 002 G-Base 91 Tank Receiving line (Jetty to Tank No.9&Tank No.2)		Still in normal condition

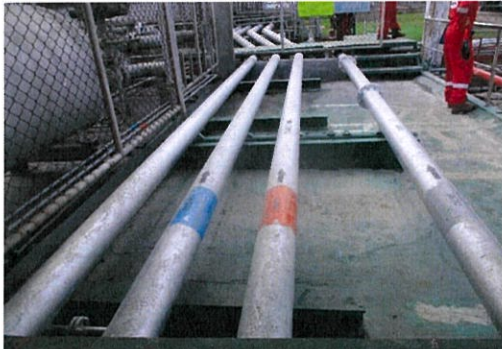
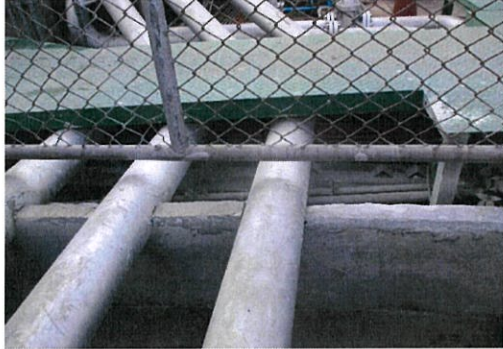
Name of part / Location		Findings	Name of part / Location		Findings
TRL 002 G-Base 91 Tank Receiving line (Jetty to Tank No.9&Tank No.2)		Still in normal condition	TRL 002 G-Base 91 Tank Receiving line (Jetty to Tank No.9&Tank No.2)		Still in normal condition

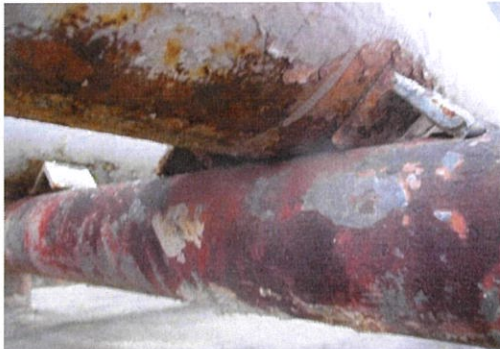
Name of part / Location		Findings		Name of part / Location		Findings	
TRL 002 G-Base 91 Tank Receiving line (Jetty to Tank No.9&Tank No.2)		Painting deterioration (13)		TRL 002 G-Base 91 Tank Receiving line (Jetty to Tank No.9&Tank No.2)		Still in normal condition

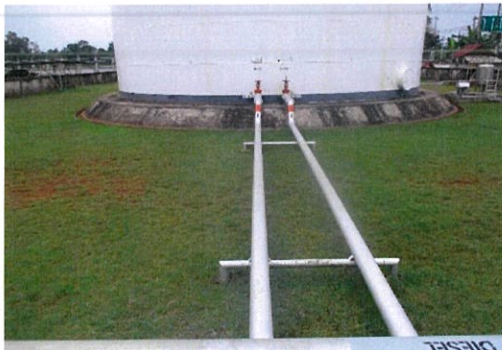
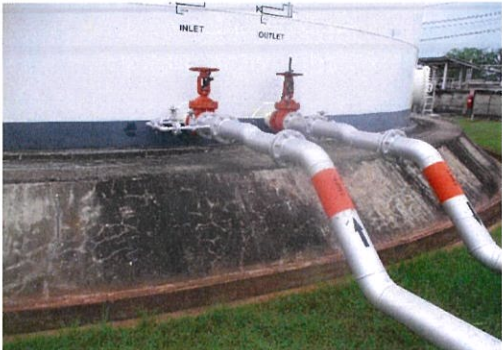
Name of part / Location		Findings		Name of part / Location		Findings	
TRL 002 G-Base 91 Tank Receiving line (Jetty to Tank No.9&Tank No.2)		Still in normal condition		TRL 002 G-Base 91 Tank Receiving line (Jetty to Tank No.9&Tank No.2)		Still in normal condition

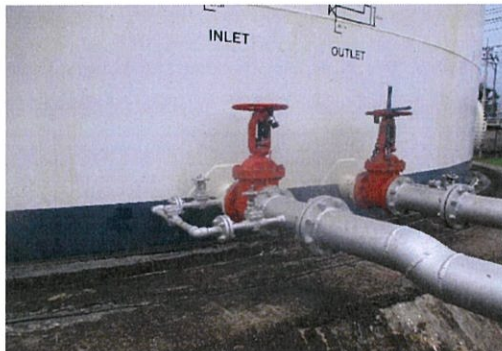
Name of part / Location		Findings		Name of part / Location		Findings	
TRL 002 G-Base 91 Tank Receiving line (Jetty to Tank No.9)		Painting deterioration (14)		TRL 002 G-Base 91 Tank Receiving line (Jetty to Tank No.9)		Still in normal condition

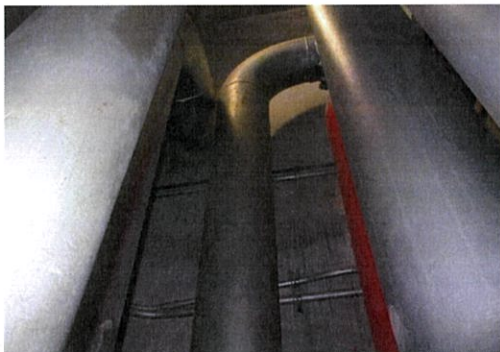
TRL 002 G-Base 91 Tank  
Receiving line (Under road)

Still in normal condition

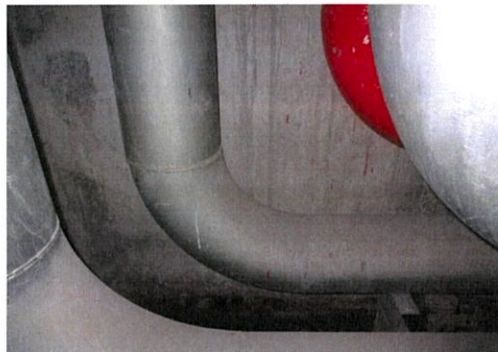
TRL 002 G-Base 91 Tank  
Receiving line (Under road)

Still in normal condition

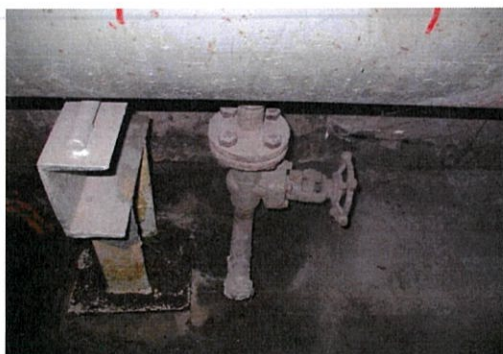
TRL 002 G-Base 91 Tank  
Receiving line (Jetty to Tank  
No.9&Tank No.2)

Still in normal condition

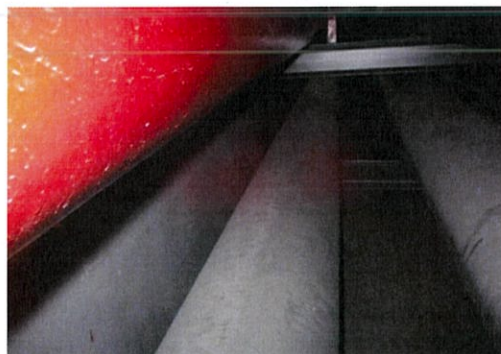
TRL 002 G-Base 91 Tank  
Receiving line (Jetty to Tank  
No.9&Tank No.2)

Slight corrosion on pipe. (15)

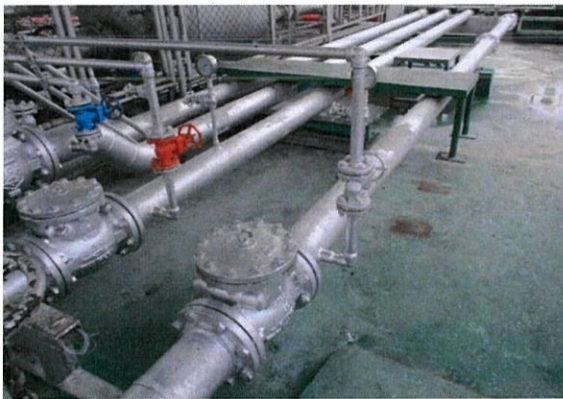
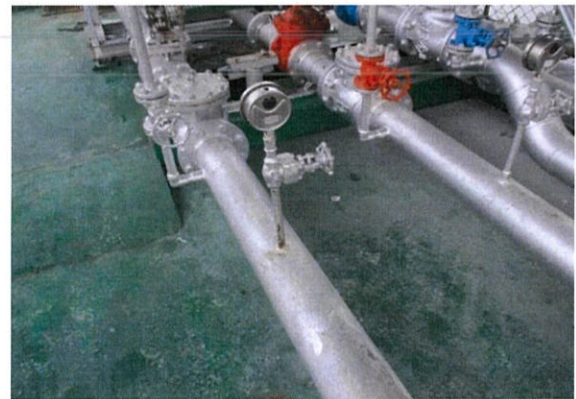
TRL 003 Diesel Tank Receiving Line (Jetty to Tank No.6,8)

Still in normal condition

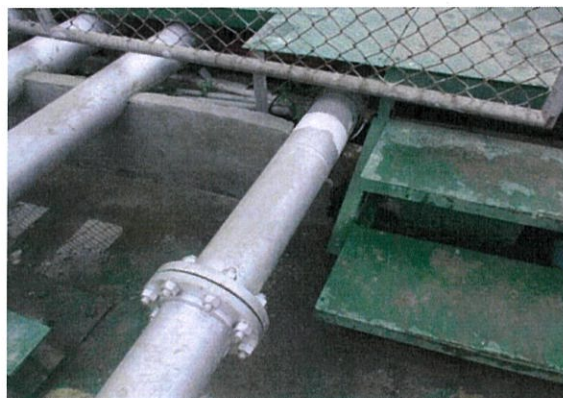
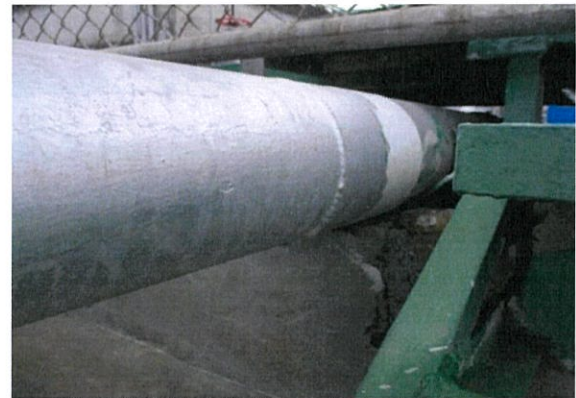
TRL 003 Diesel Tank Receiving Line (Jetty to Tank No.6,8)

Still in normal condition

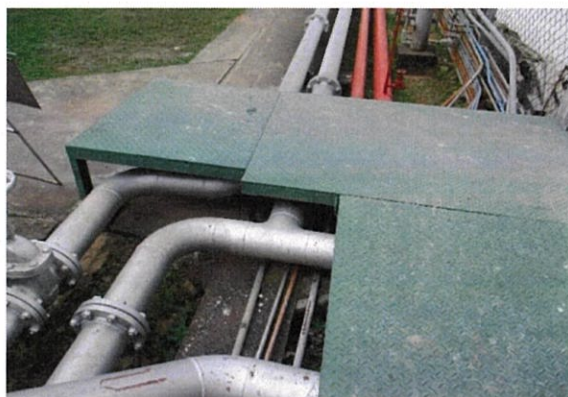
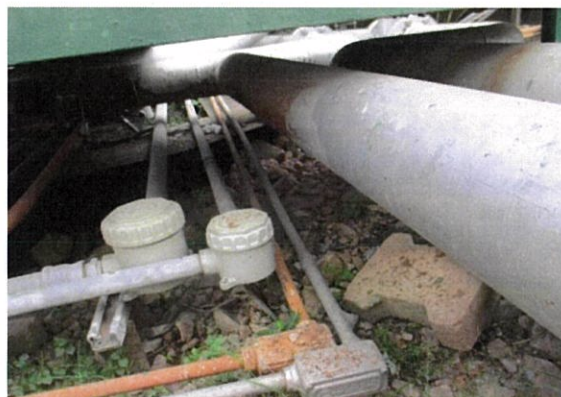
Still in normal condition

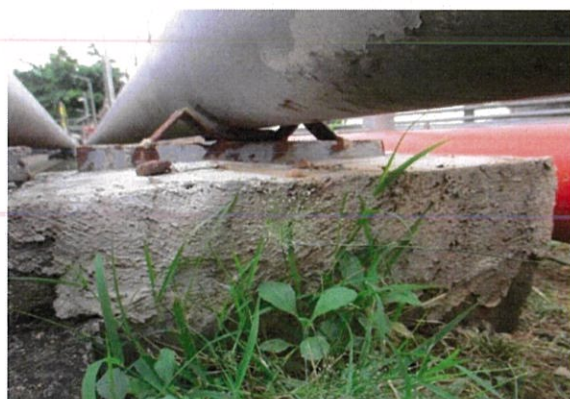
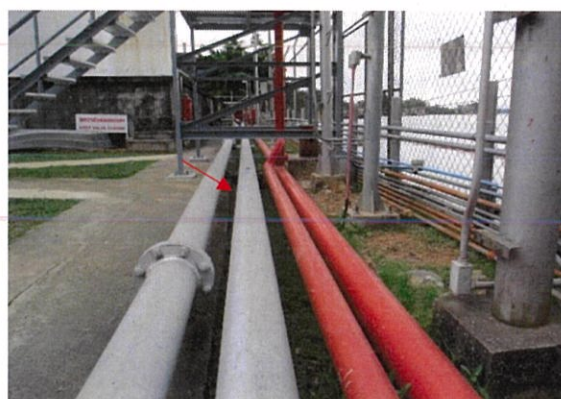
TRL 003 Diesel Tank Receiving Line (Jetty to Tank No.6,8)

Still in normal condition

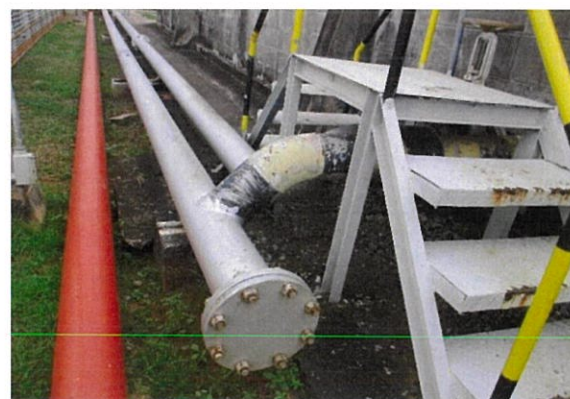
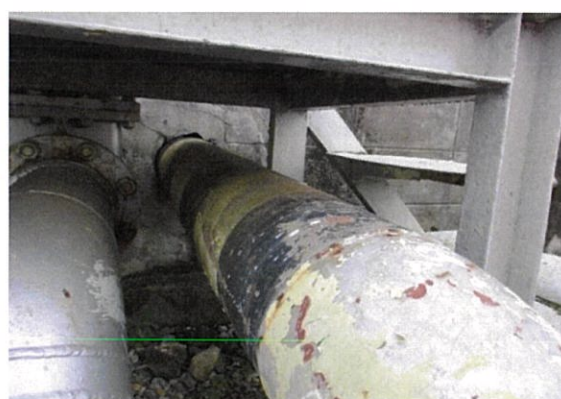
TRL 003 Diesel Tank Receiving Line (Jetty to Tank No.6,8)

Still in normal condition

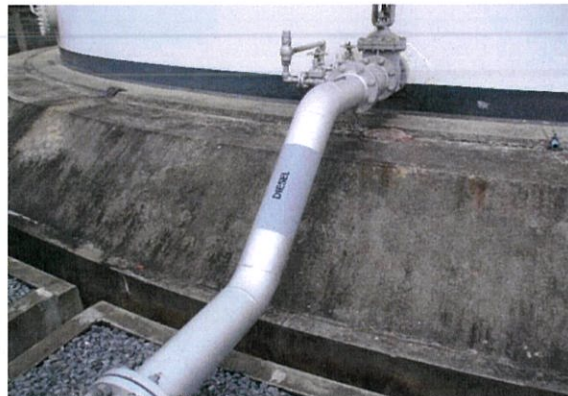
Name of part / Location		Findings		
TRL 003 Diesel Tank Receiving Line (Jetty to Tank No.6,8)		Still in normal condition

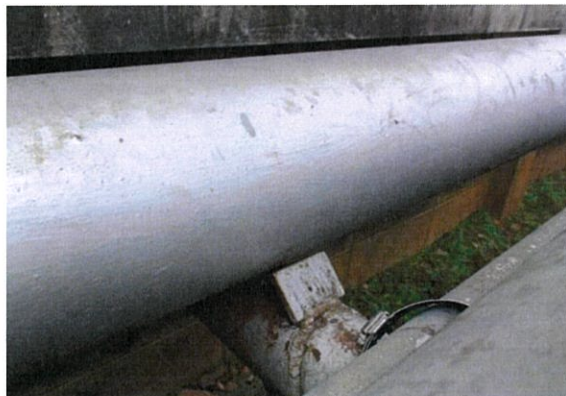
Name of part / Location		Findings		
TRL 003 Diesel Tank Receiving Line (Jetty to Tank No.6,8)		Still in normal condition

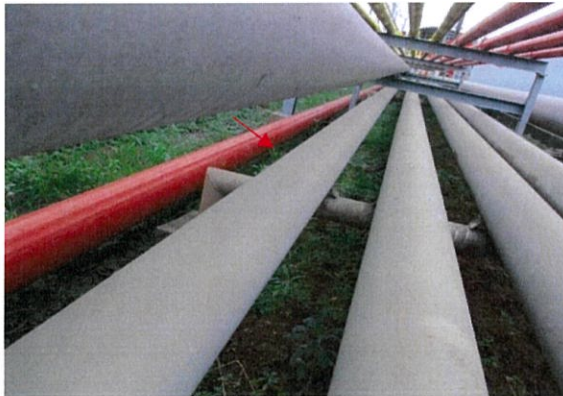
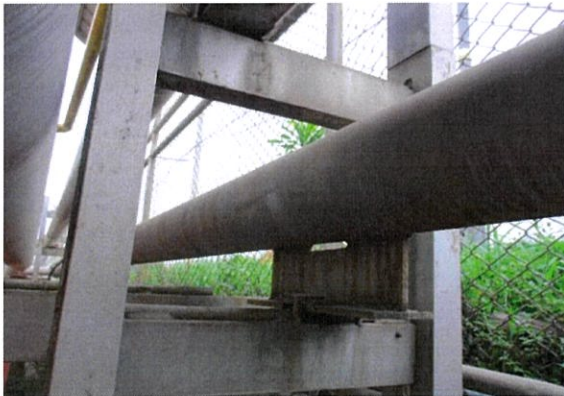
Name of part / Location	Findings	Name of part / Location	Findings	
TRL 003 Diesel Tank Receiving Line (Jetty to Tank No.6,8)	Sealing sleeve underground pipe was found degradation, damage and corrosion under sleeve underground pipe.	TRL 003 Diesel Tank Receiving Line (Jetty to Tank No.6,8)	Sealing sleeve underground pipe was found degradation, damage and corrosion under sleeve underground pipe.

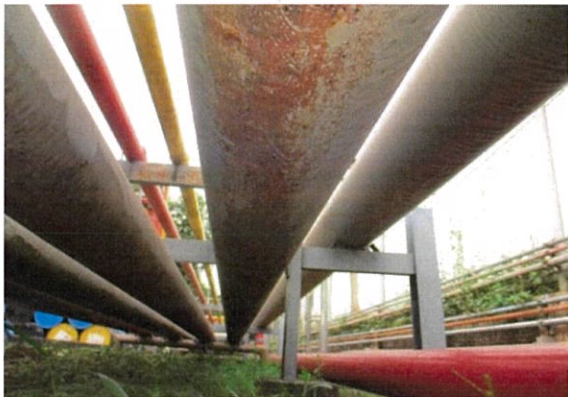
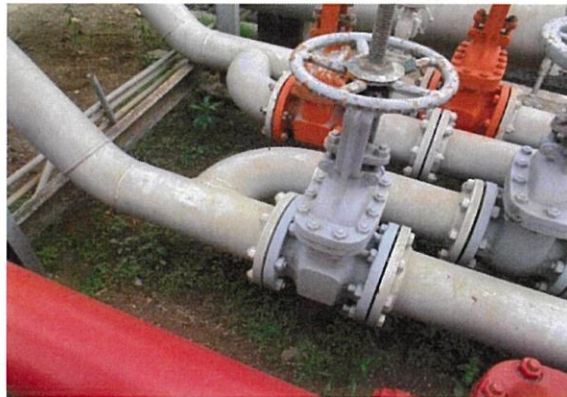
Name of part / Location	Findings	Name of part / Location	Findings	
TRL 003 Diesel Tank Receiving Line (Jetty to Tank No.6,8)	Still in normal condition	TRL 003 Diesel Tank Receiving Line (Jetty to Tank No.6,8)	Still in normal condition

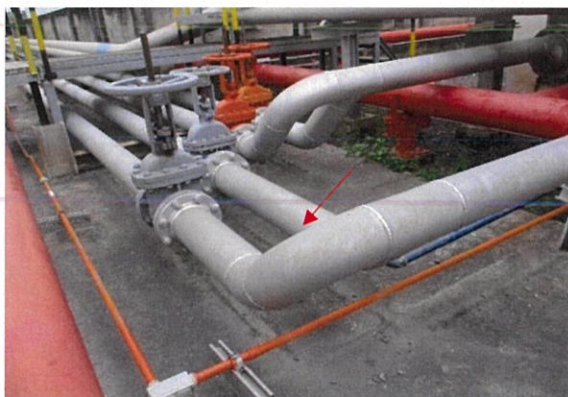
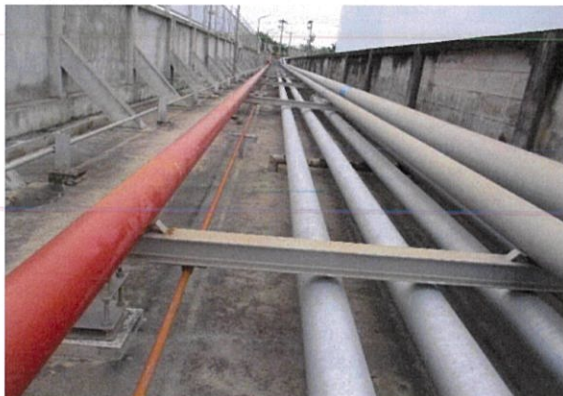
Name of part / Location	Findings	Name of part / Location	Findings	
TRL 003 Diesel Tank Receiving Line (Jetty to Tank No.6,8)	Still in normal condition	TRL 003 Diesel Tank Receiving Line (Jetty to Tank No.6,8)	Still in normal condition

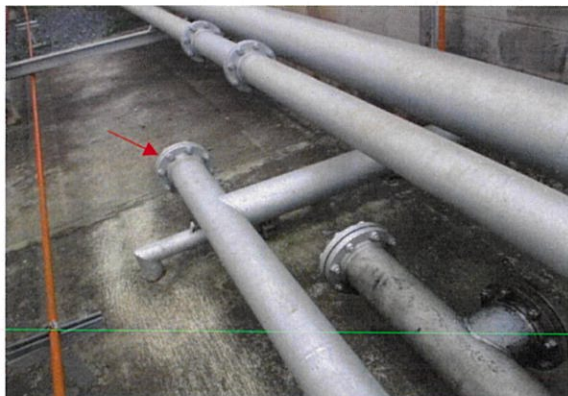
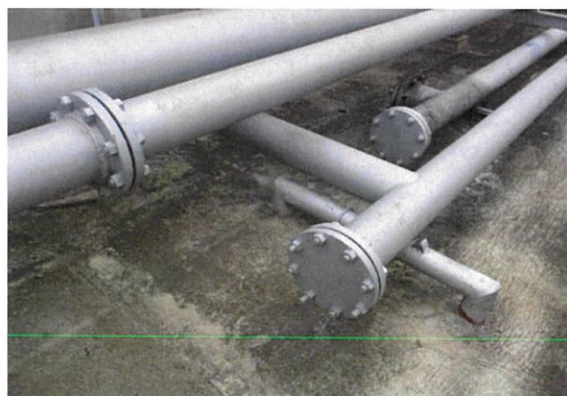
Name of part / Location	Findings	Name of part / Location	Findings	
TRL 003 Diesel Tank Receiving Line (Jetty to Tank No.6,8)	Still in normal condition	TRL 003 Diesel Tank Receiving Line (Jetty to Tank No.6,8)	Still in normal condition

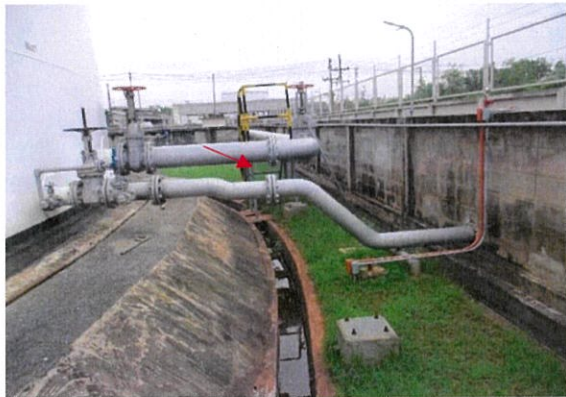
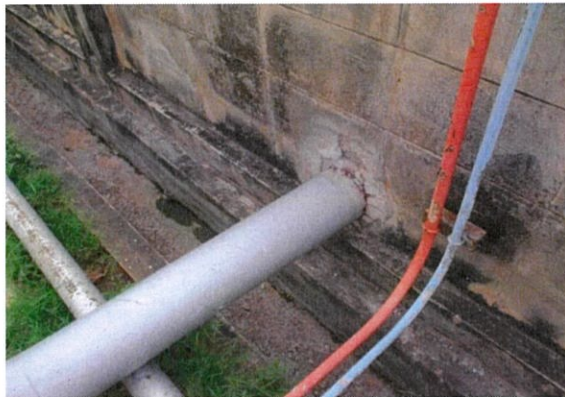
Name of part / Location	Findings	Name of part / Location	Findings	
TRL 003 Diesel Tank Receiving Line (Jetty to Tank No.6,8)	Still in normal condition	TRL 003 Diesel Tank Receiving Line (Jetty to Tank No.6,8)	Still in normal condition

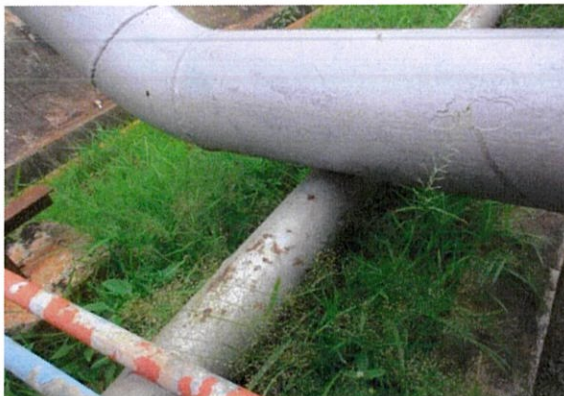
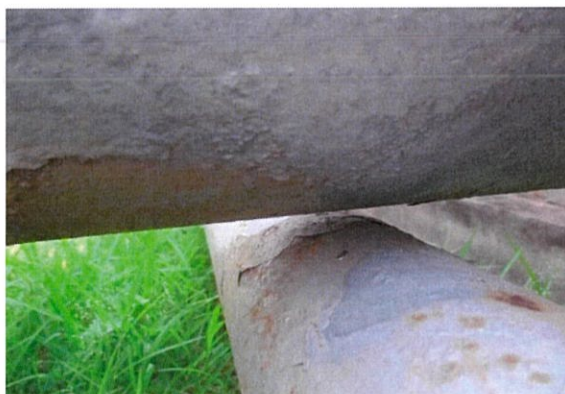
Name of part / Location	Findings	Name of part / Location	Findings	
TRL 003 Diesel Tank Receiving Line (Jetty to Tank No.6,8)	Still in normal condition	TRL 003 Diesel Tank Receiving Line (Jetty to Tank No.6,8)	Still in normal condition

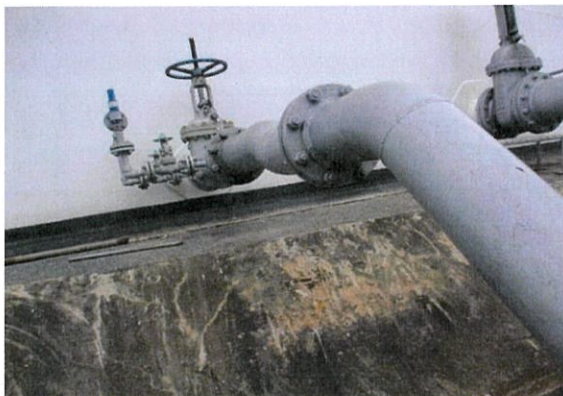
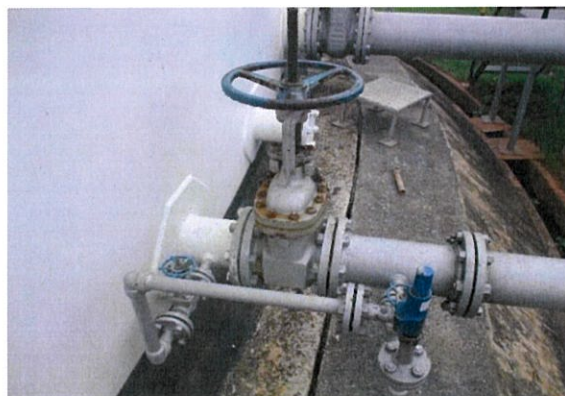
Name of part / Location	Findings	Name of part / Location	Findings	
TRL 003 Diesel Tank Receiving Line (Jetty to Tank No.6,8)	Still in normal condition	TRL 003 Diesel Tank Receiving Line (Jetty to Tank No.6,8)	Still in normal condition
