ภาคผนวกที่ 2-9  
รายงานสรุปผลการทำงานของระบบบำบัดน้ำเสีย  
(ทส1,ทส2)

## รายงานสรุปผลการทำงานของระบบบำบัดน้ำเสีย

The objective of this preventive maintenance is to ensure that all tested electrical equipment still are in good condition and to find out any damaged and / or unsafe condition.

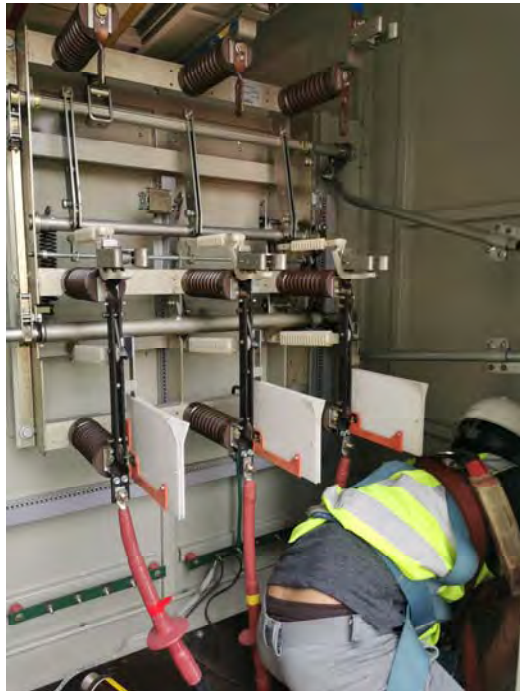
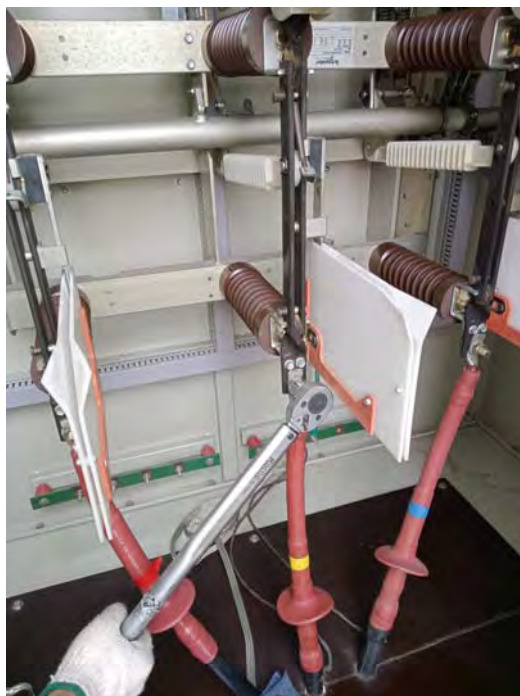
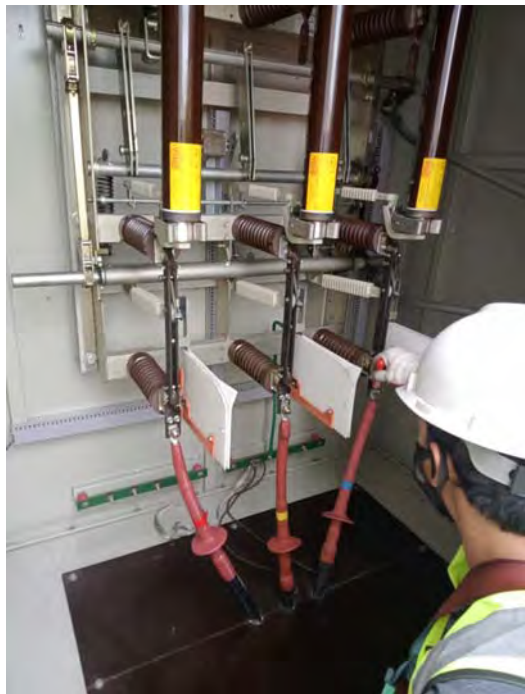
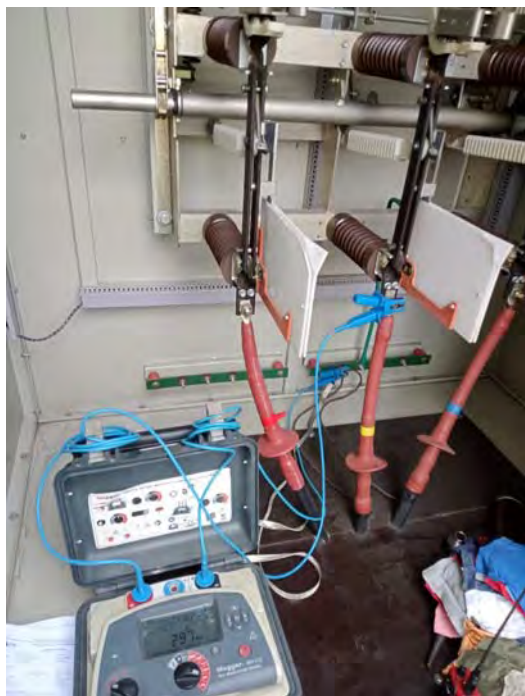
Photo 1-2-3-4 : ภาพของการทำความสะอาดและทดสอบ

Load Break Switch

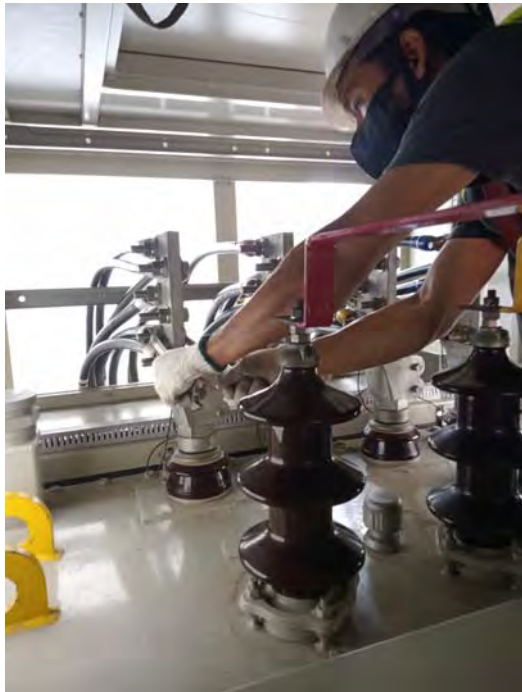
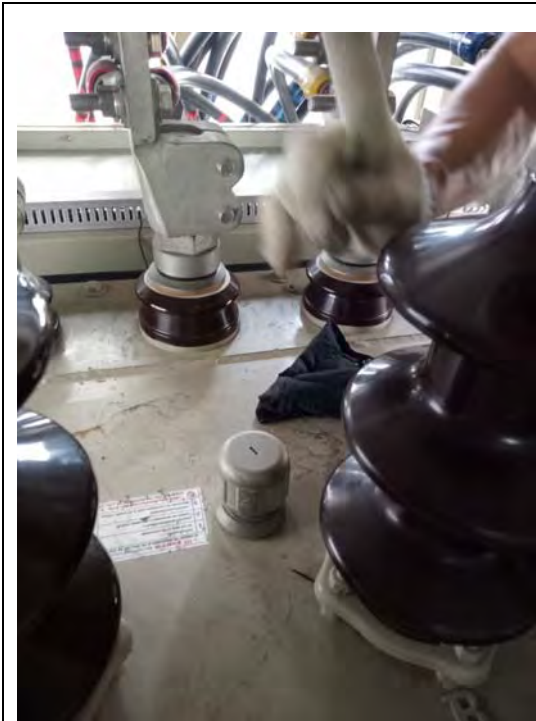
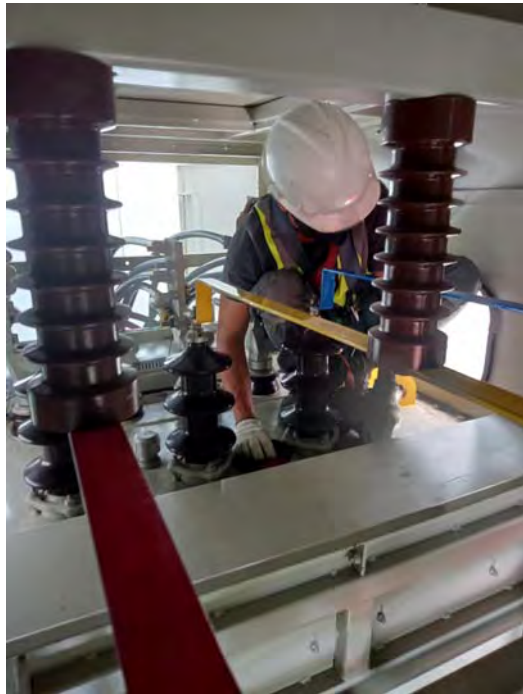
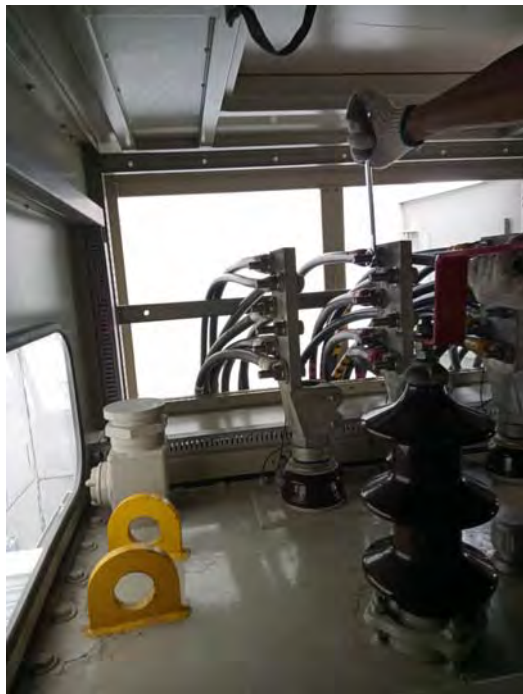
Photo 5-6-7-8-9-10 : ภาพแสดงการตรวจสอบและทำความสะอาดของหม้อแปลง, การทดสอบ Insulation Resistance ของหม้อแปลงขณะทำ Preventive Maintenance

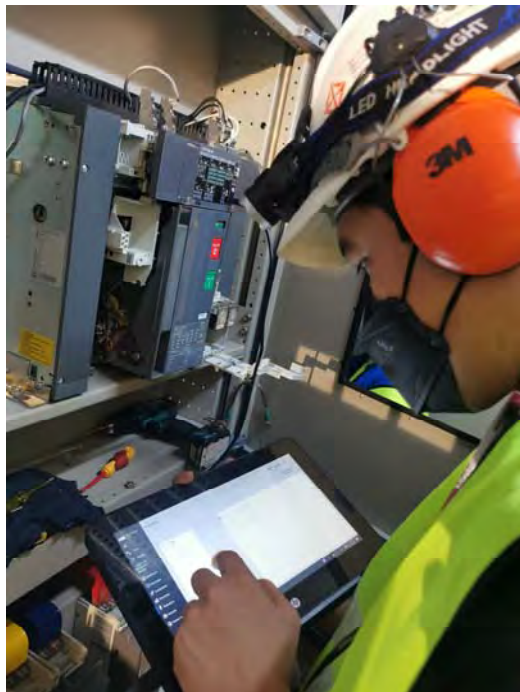
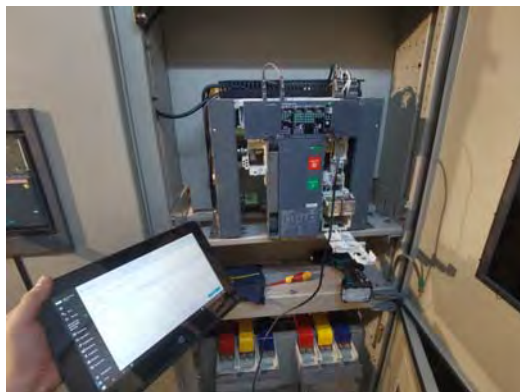
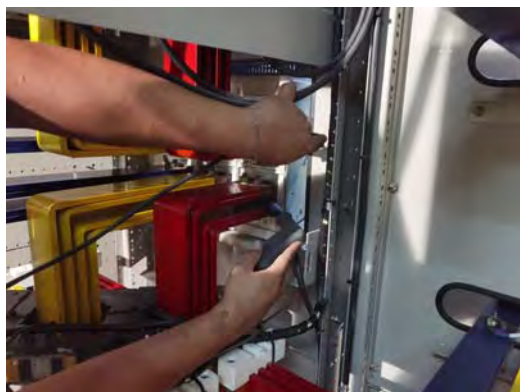
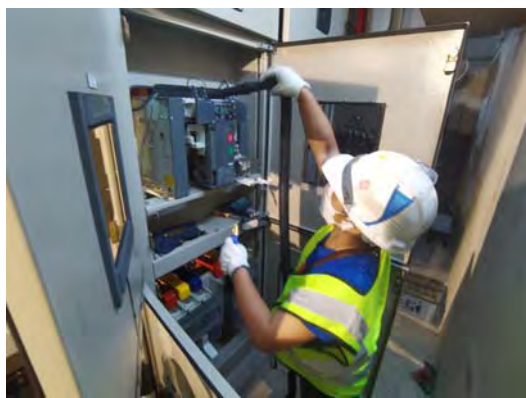
Photo 11-12-13-14-15 : ภาพแสดงการทำความสะอาดและ  
ทำการทดสอบ Trip unit, Contact Resistance ของ Air  
Circuit Breaker

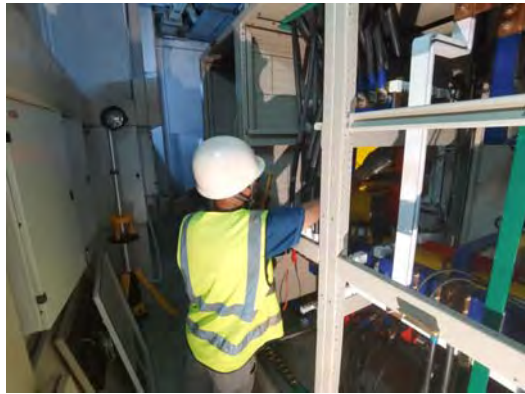
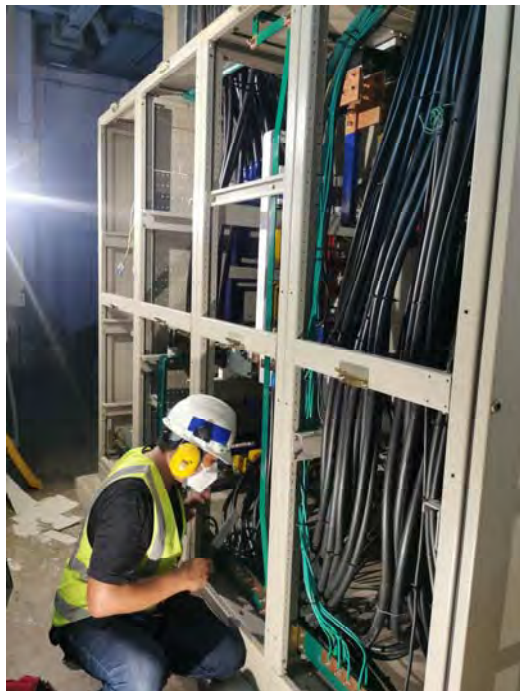
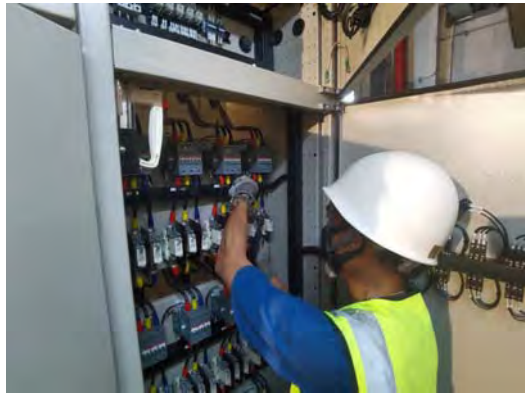
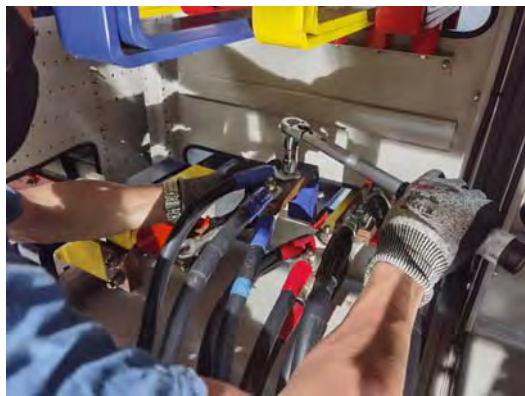
Photo 16-17-18-19-20-21-22-23-24-25-26-27-28-29 : ภาพ  
แสดงการทำ Preventive Maintenance ตู้ LV MDB, Cap.  
Bank, Plug-in unit, DB Panel โดยการ Inspection,  
Cleaning, Tightening torque
