INSPECTION REPORT

**LOADING ARM
BI-1, B-2 AND BI-3**

**ESSO SRIRACHA REFINERY PLANT,
CHONBURI**

18-21 And 24 April 2023
Report No: 2304019_Rev.00

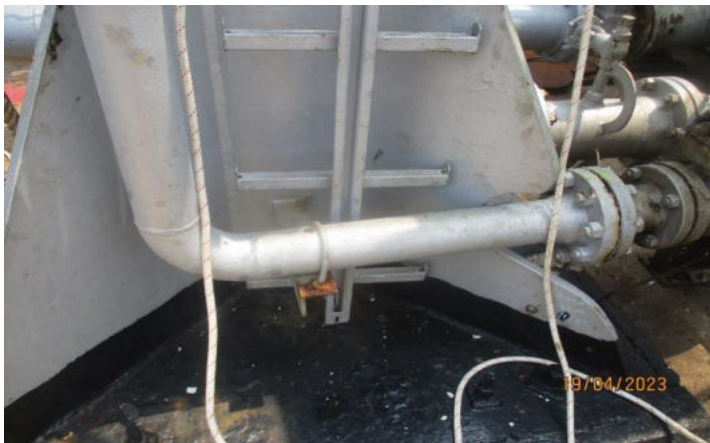
<p>Name of part:</p> <p>3" L-1105 A Loading arm</p> <p>Findings:</p> <p>Normal condition</p>

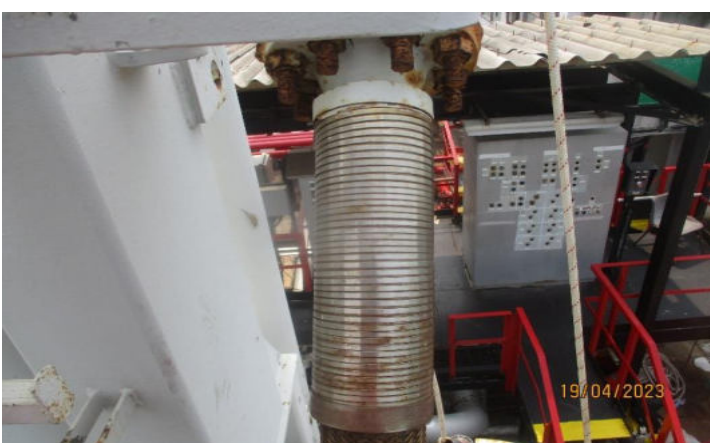
<p>Name of part:</p> <p>3" L-1105 A Loading arm</p> <p>Findings:</p> <p>Normal condition flexible hose</p>

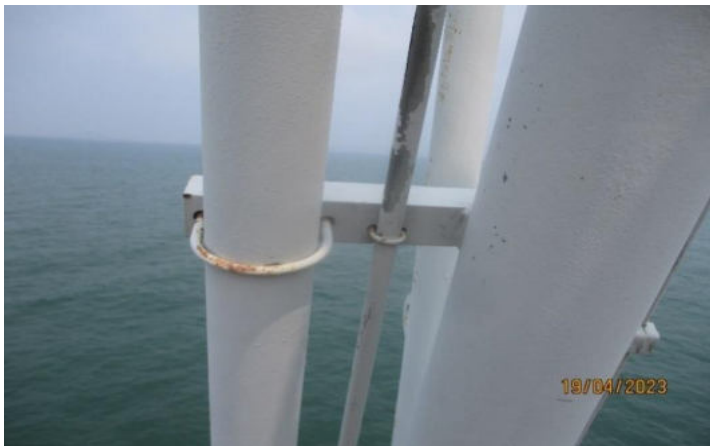
<p>Name of part:</p> <p>3" L-1105 A Loading arm</p> <p>Findings:</p> <p>Normal condition</p>

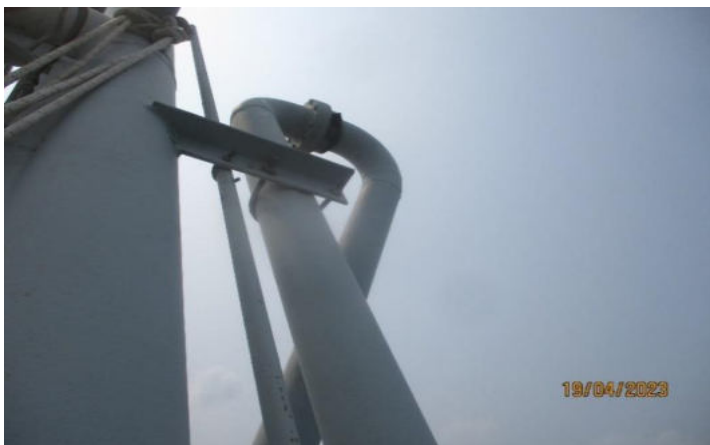
<p>Name of part:</p> <p>3" L-1105 A Loading arm</p> <p>Findings:</p> <p>Normal condition</p>

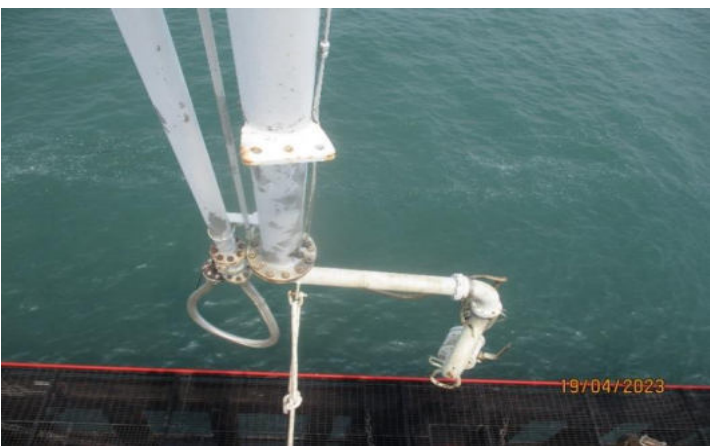
<p>Name of part:</p> <p>3" L-1105 A Loading arm</p> <p>Findings:</p> <p>Normal condition</p>

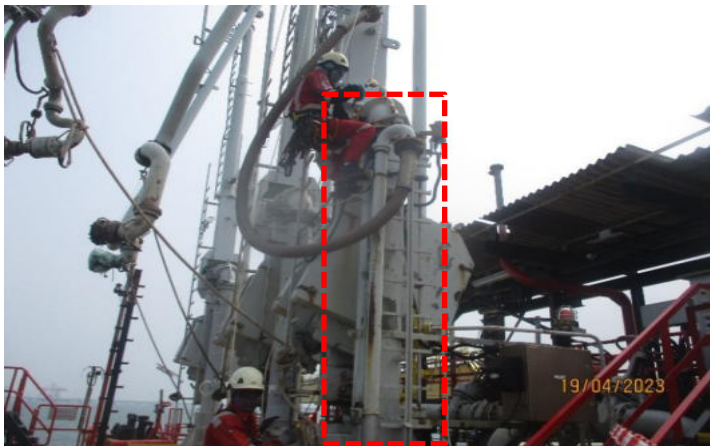
<p>Name of part:</p> <p>3" L-1105 A Loading arm</p> <p>Findings:</p> <p>Corrosion on flange stud bolt & nuts area</p>

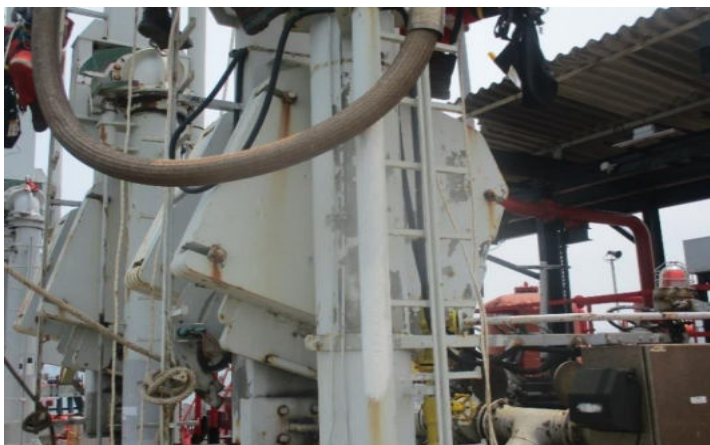
<p>Name of part:</p> <p>3" L-1105 A Loading arm</p> <p>Findings:</p> <p>After paint repair</p>

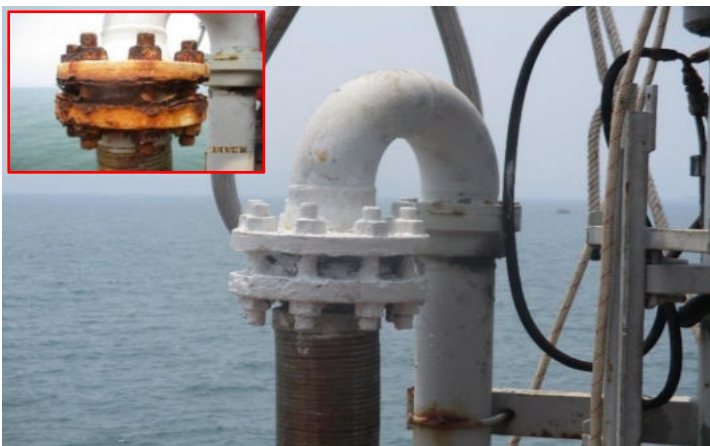
<p>Name of part:</p> <p>3" L-1105 A Loading arm</p> <p>Findings:</p> <p>After paint repair</p>

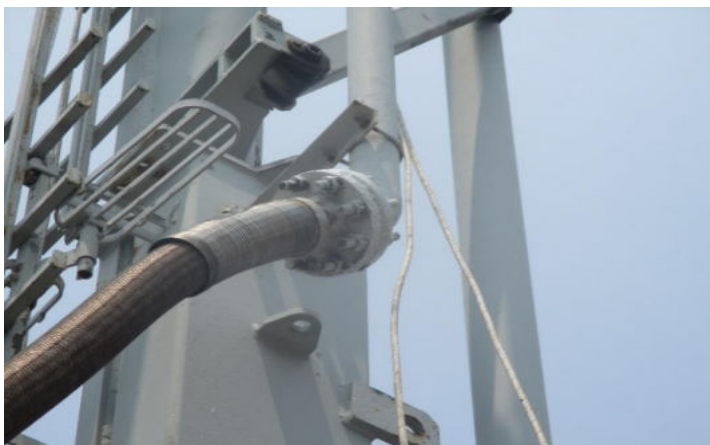
<p>Name of part:</p> <p>3" L-1105 A Loading arm</p> <p>Findings:</p> <p>After paint repair</p>

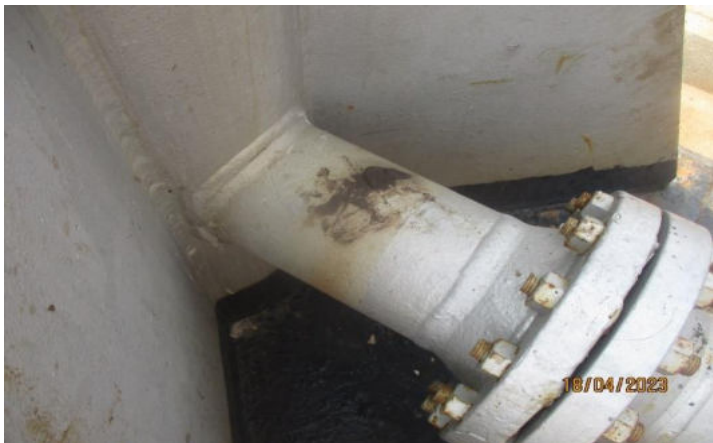
<p>Name of part:</p> <p>8" L-1105 A Loading arm</p> <p>Findings:</p> <p>Normal condition</p>

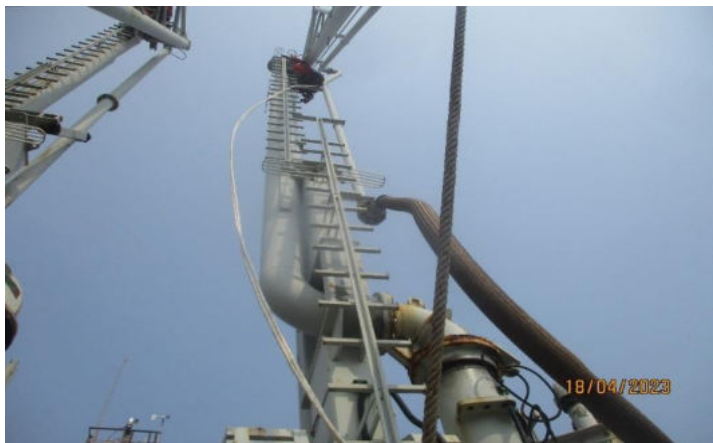
<p>Name of part:</p> <p>8" L-1105 A Loading arm</p> <p>Findings:</p> <p>Normal condition</p>

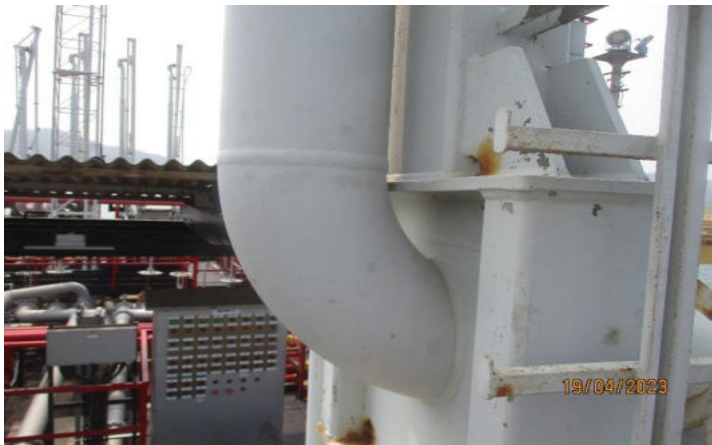
<p>Name of part:</p> <p>8" L-1105 A Loading arm</p> <p>Findings:</p> <p>Normal condition</p>

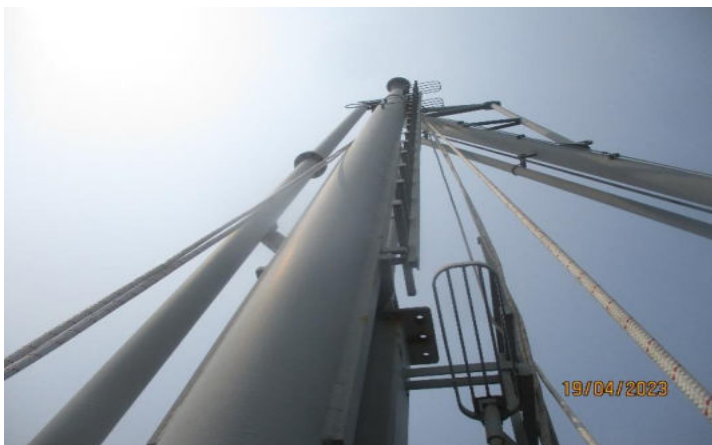
<p>Name of part:</p> <p>8" L-1105 A Loading arm</p> <p>Findings:</p> <p>Normal condition</p>

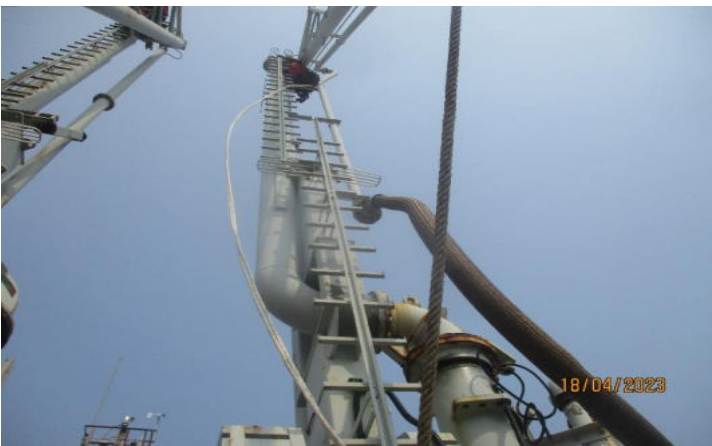
<p>Name of part:</p> <p>8" L-1105 A Loading arm</p> <p>Findings:</p> <p>Normal condition</p>

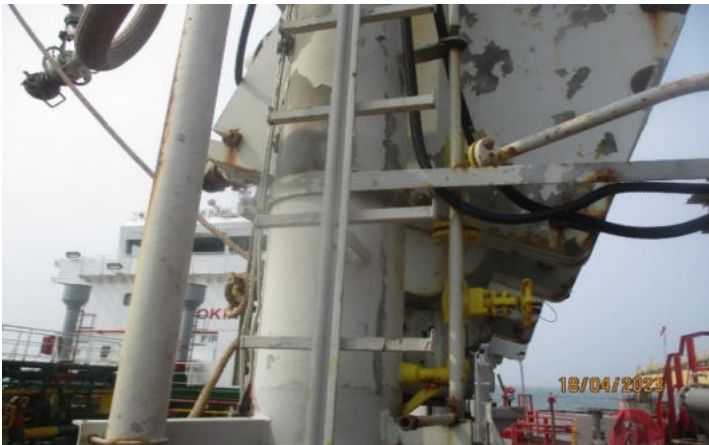
<p>Name of part:</p> <p>8" L-1105 A Loading arm</p> <p>Findings:</p> <p>Normal condition</p>

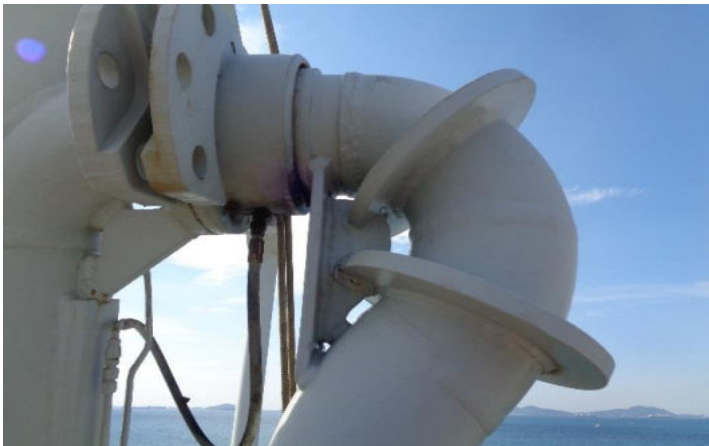
<p>Name of part:</p> <p>8" L-1105 A Loading arm</p> <p>Findings:</p> <p>Normal condition</p>

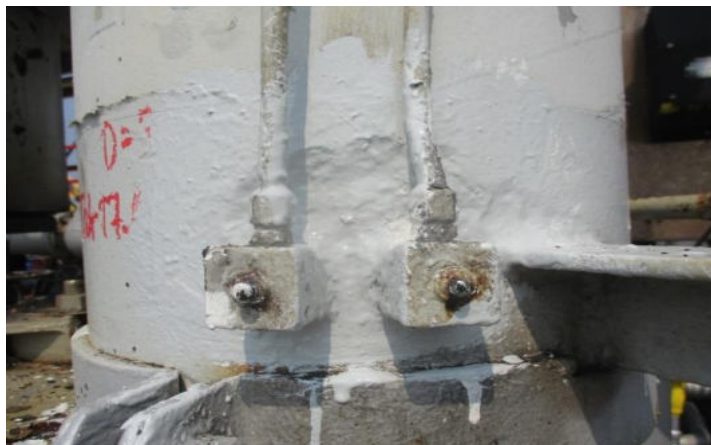
<p>Name of part:</p> <p>8" L-1105 A Loading arm</p> <p>Findings:</p> <p>After paint repair</p>

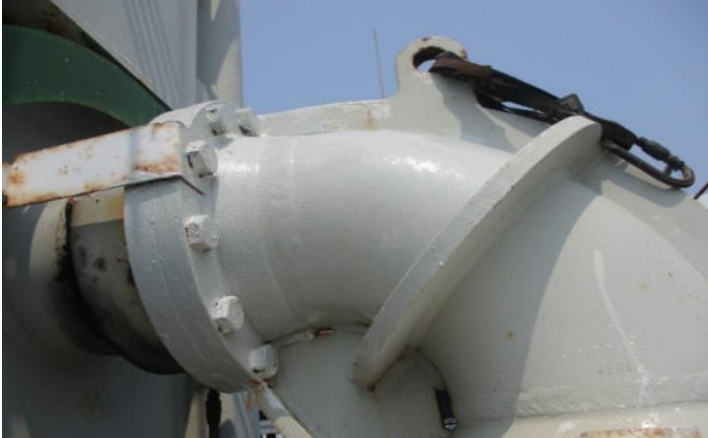
<p>Name of part:</p> <p>8" L-1105 A Loading arm</p> <p>Findings:</p> <p>After paint repair</p>

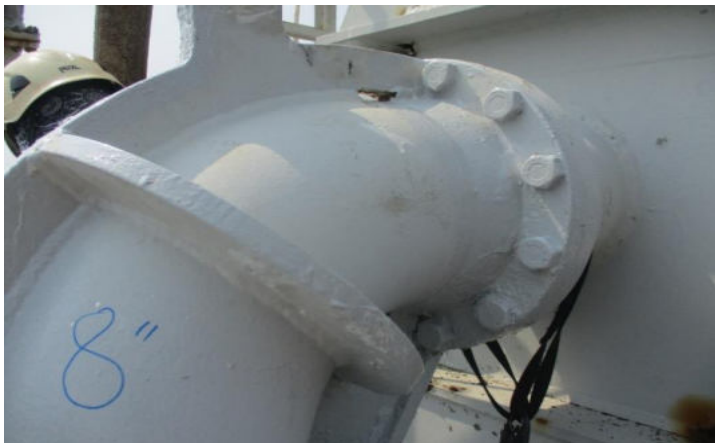
<p>Name of part:</p> <p>8" L-1105 A Loading arm</p> <p>Findings:</p> <p>After paint repair</p>

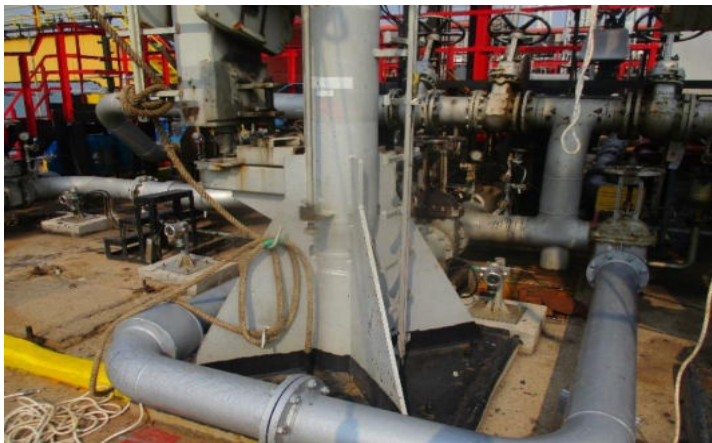
<p>Name of part:</p> <p>8" L-1106 A Loading arm</p> <p>Findings:</p> <p>Normal condition</p>

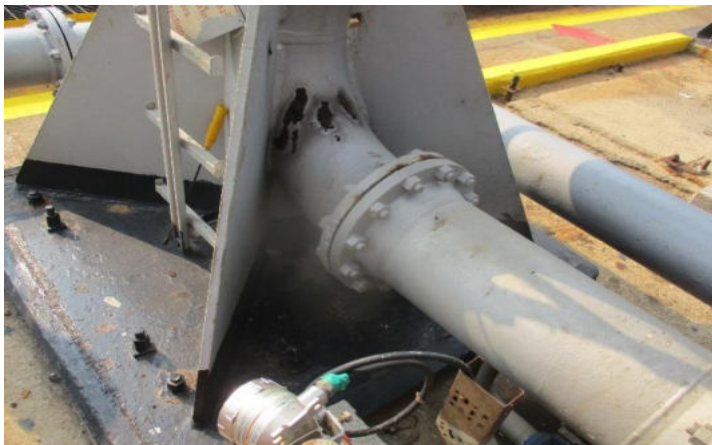
<p>Name of part:</p> <p>8" L-1106 A Loading arm</p> <p>Findings:</p> <p>Normal condition</p>

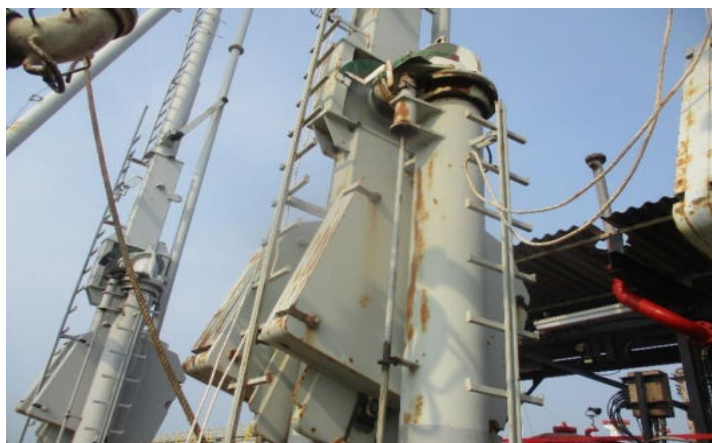
<p>Name of part:</p> <p>8" L-1106 A Loading arm</p> <p>Findings:</p> <p>Corrosion on Counterweight and stud bolt nuts.</p>

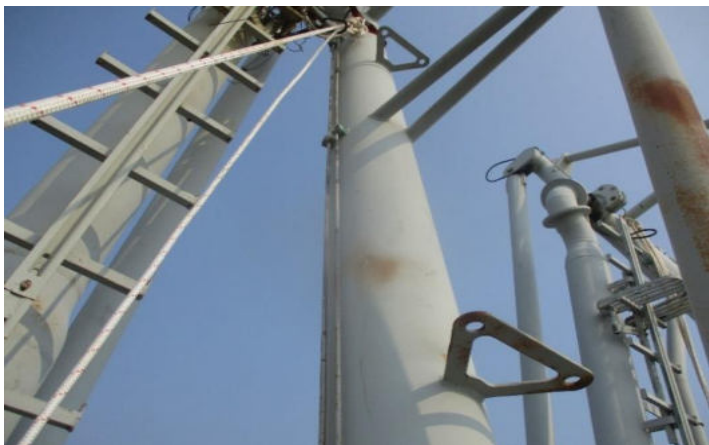
<p>Name of part:</p> <p>8" L-1106 A Loading arm</p> <p>Findings:</p> <p>Normal condition</p>

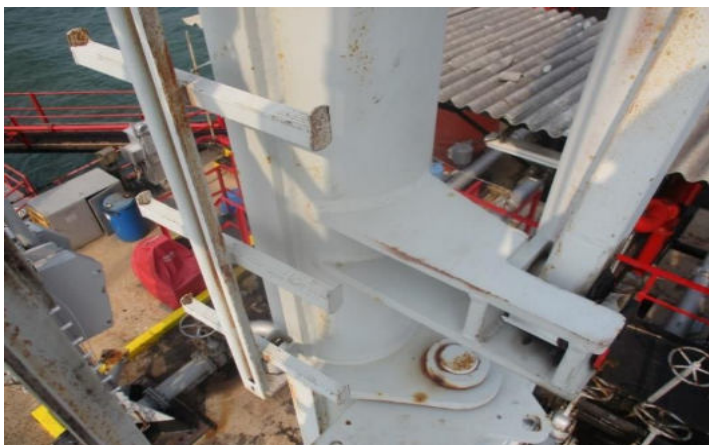
<p>Name of part:</p> <p>8" L-1106 A Loading arm</p> <p>Findings:</p> <p>Normal condition</p>

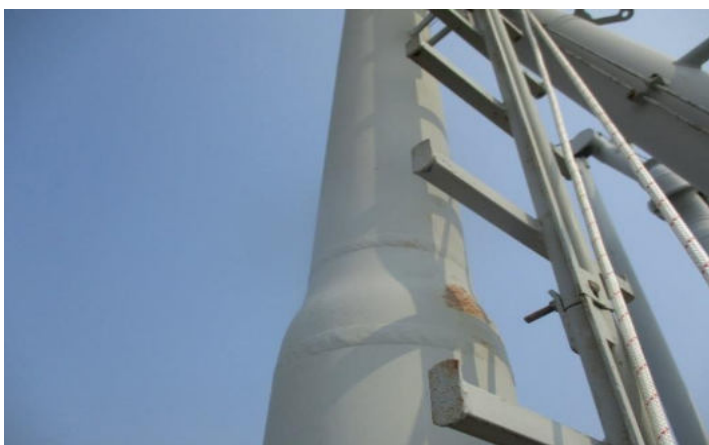
<p>Name of part:</p> <p>8" L-1106 A Loading arm</p> <p>Findings:</p> <p>Normal condition</p>

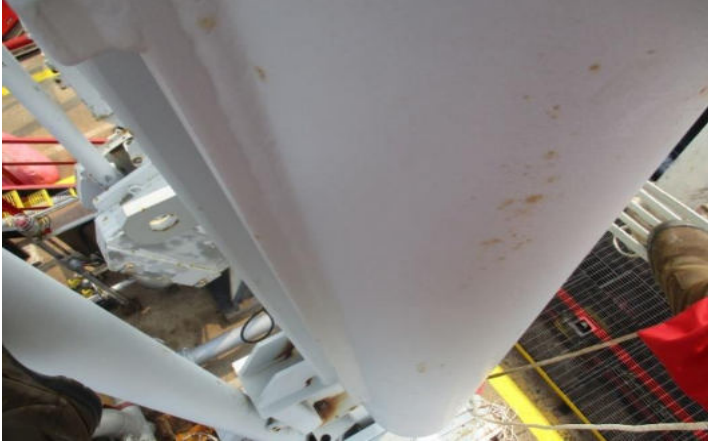
<p>Name of part:</p> <p>8" L-1106 A Loading arm</p> <p>Findings:</p> <p>Normal condition</p>

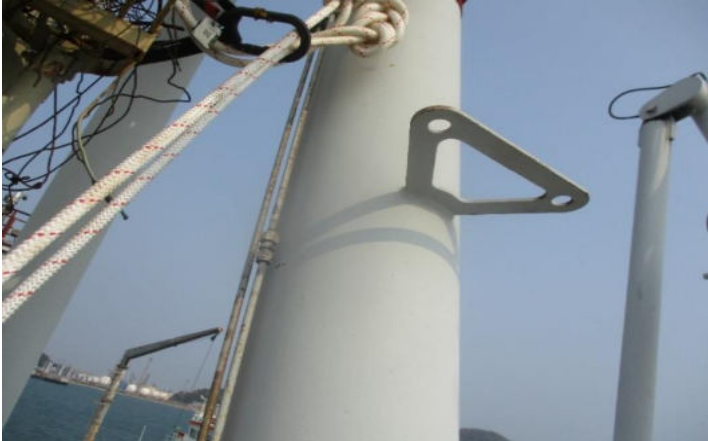
<p>Name of part:</p> <p>8" L-1106 A Loading arm</p> <p>Findings:</p> <p>Normal condition</p>

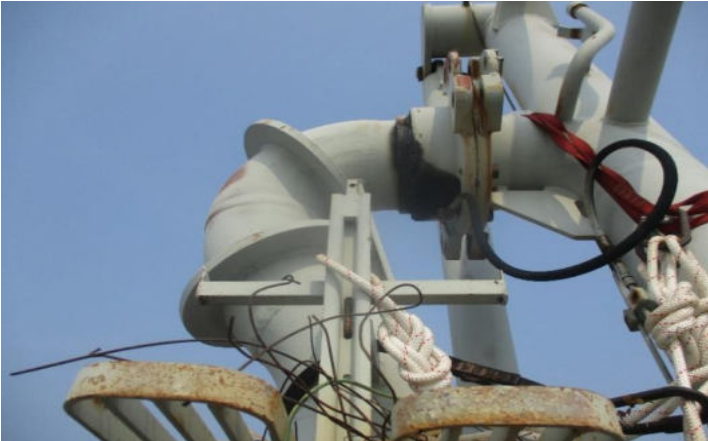
<p>Name of part:</p> <p>8" L-1106 A Loading arm</p> <p>Findings:</p> <p>Normal condition</p>

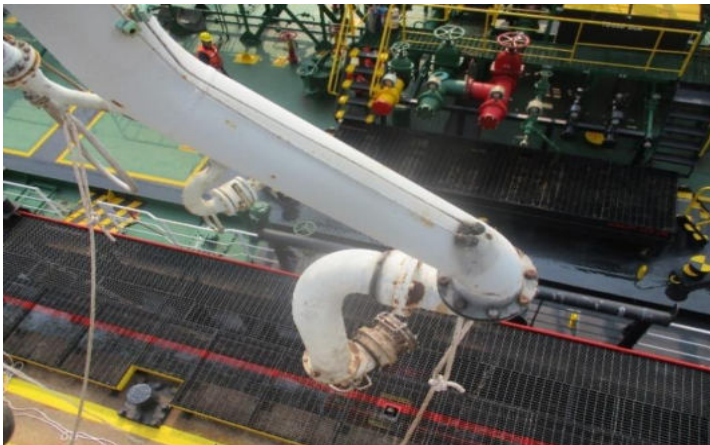
<p>Name of part:</p> <p>8" L-1106 A Loading arm</p> <p>Findings:</p> <p>Normal condition</p>

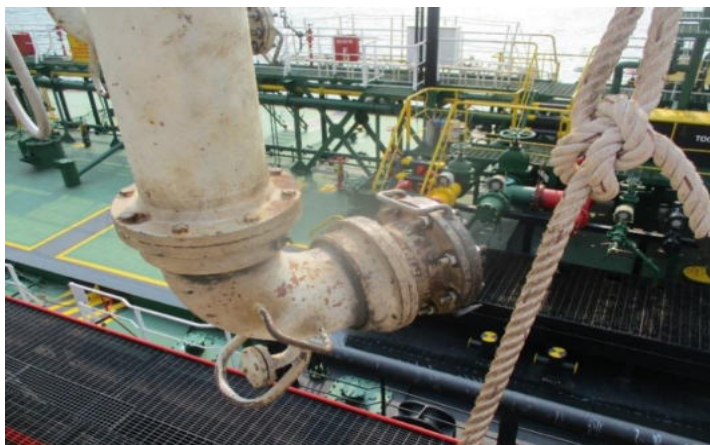
<p>Name of part:</p> <p>8" L-1106 A Loading arm</p> <p>Findings:</p> <p>Was found corrosion on Pipe.</p>

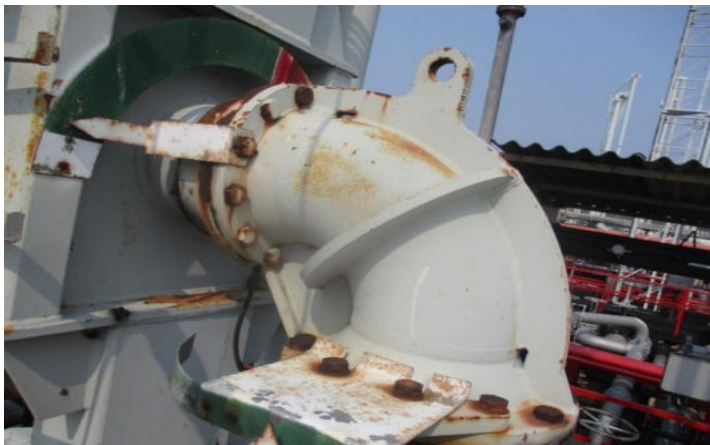
<p>Name of part:</p> <p>8" L-1106 A Loading arm</p> <p>Findings:</p> <p>Corrosion on flange stud bolt & nuts area.</p>

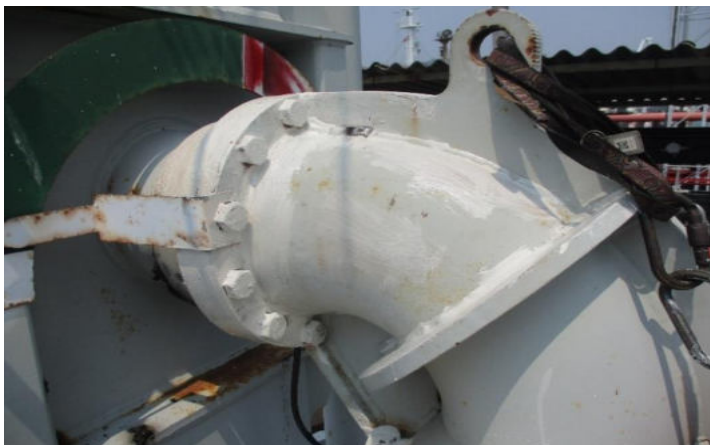
<p>Name of part:</p> <p>8" L-1106 A Loading arm</p> <p>Findings:</p> <p>After paint repair</p>

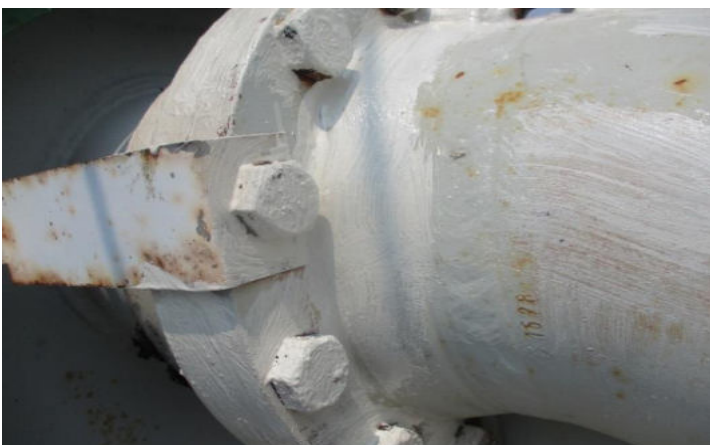
<p>Name of part:</p> <p>8" L-1106 A Loading arm</p> <p>Findings:</p> <p>After paint repair</p>

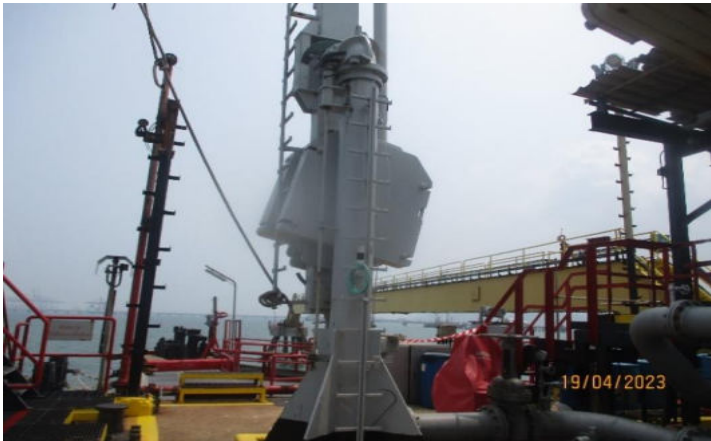
<p>Name of part:</p> <p>8" L-1108 A Loading arm</p> <p>Findings:</p> <p>Normal condition</p>

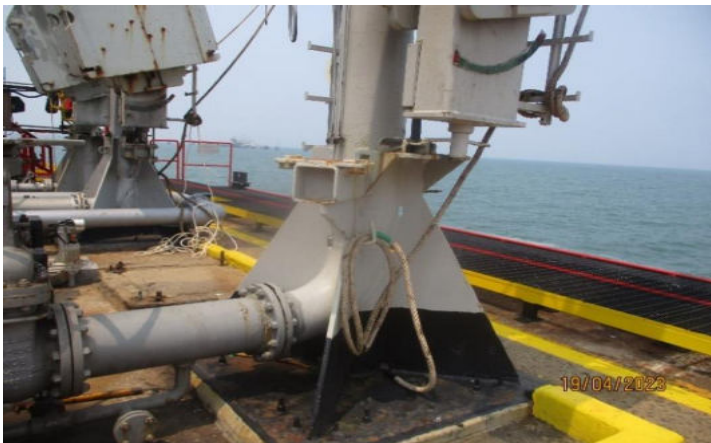
<p>Name of part:</p> <p>8" L-1108 A Loading arm</p> <p>Findings:</p> <p>Normal condition</p>

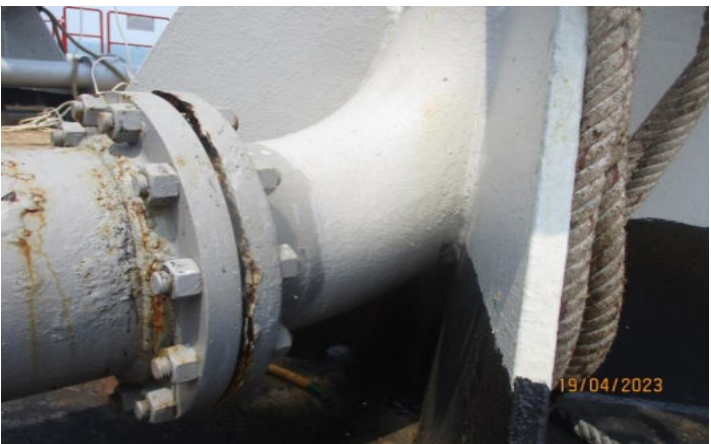
<p>Name of part:</p> <p>8" L-1108 A Loading arm</p> <p>Findings:</p> <p>Normal condition</p>

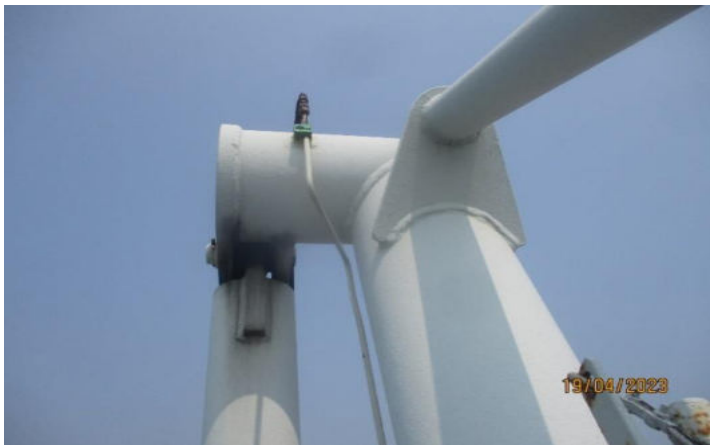
<p>Name of part:</p> <p>8" L-1108 A Loading arm</p> <p>Findings:</p> <p>Normal condition</p>

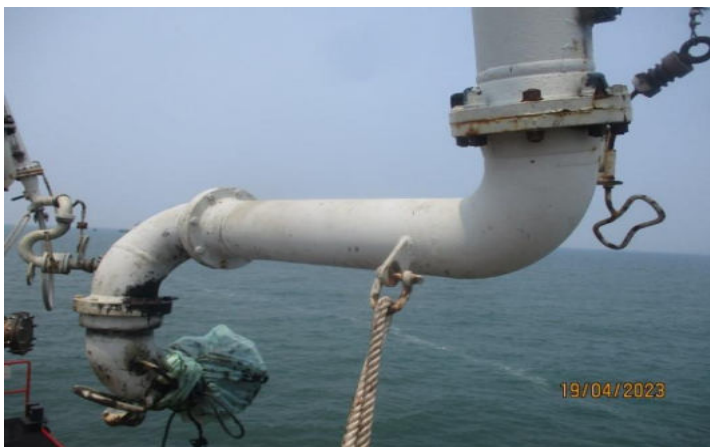
<p>Name of part:</p> <p>8" L-1108 A Loading arm</p> <p>Findings:</p> <p>Normal condition</p>

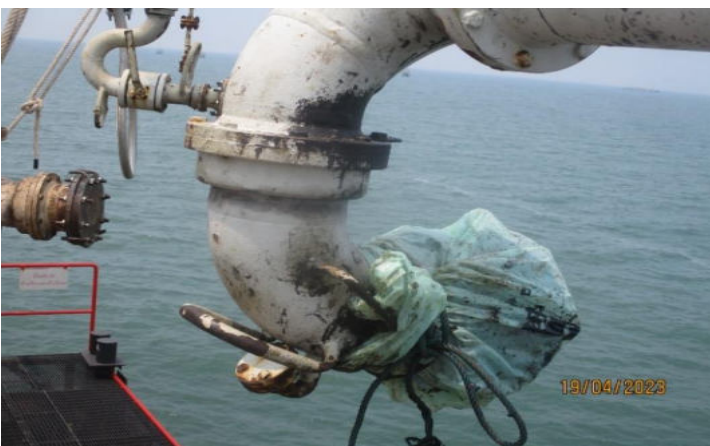
<p>Name of part:</p> <p>8" L-1108 A Loading arm</p> <p>Findings:</p> <p>Normal condition</p>

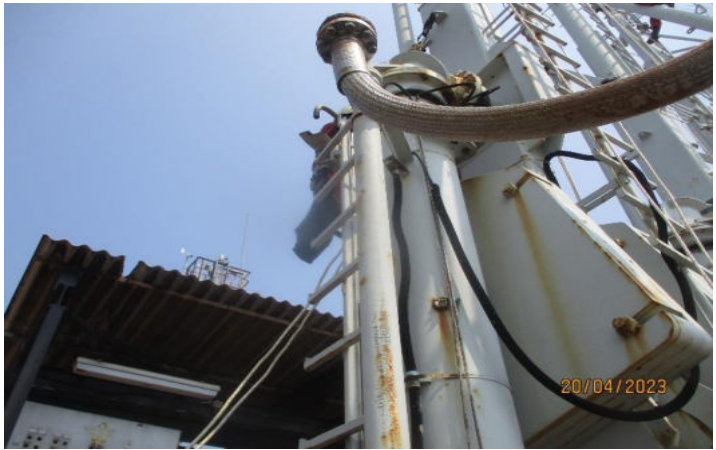
<p>Name of part:</p> <p>3" 1104 B Loading arm</p> <p>Findings:</p> <p>Normal condition</p>

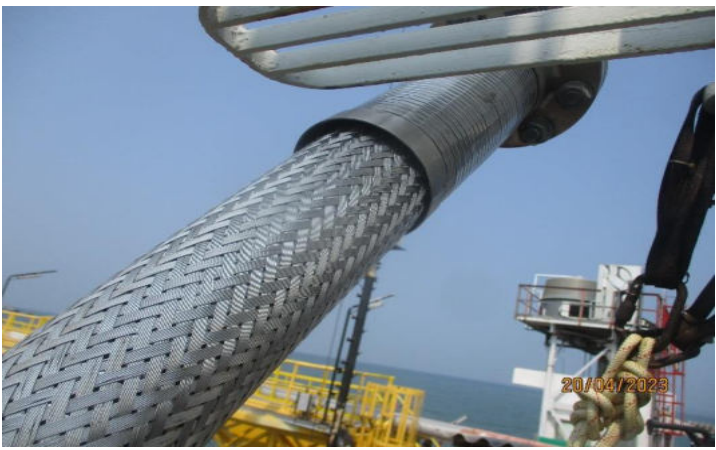
<p>Name of part:</p> <p>3" 1104 B Loading arm</p> <p>Findings:</p> <p>Normal condition flexible hose.</p>

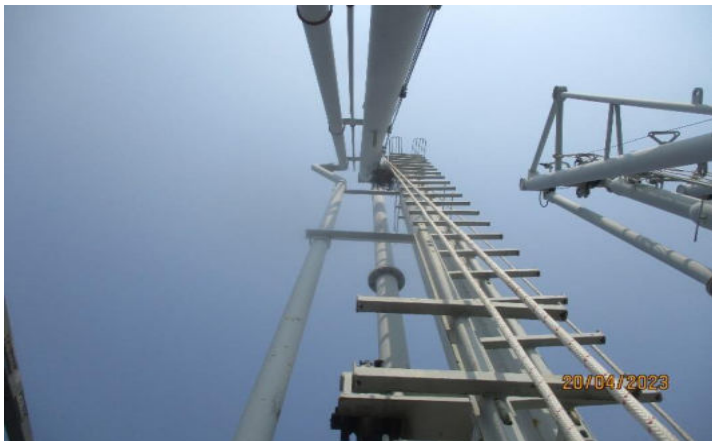
<p>Name of part:</p> <p>3" 1104 B Loading arm</p> <p>Findings:</p> <p>Normal condition</p>

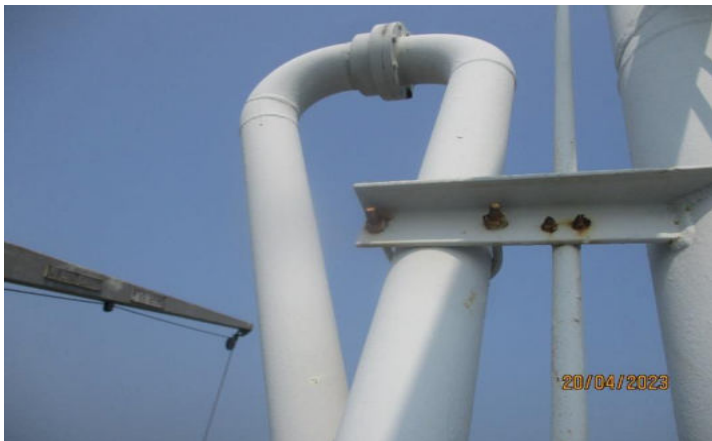
<p>Name of part:</p> <p>3" 1104 B Loading arm</p> <p>Findings:</p> <p>Normal condition</p>

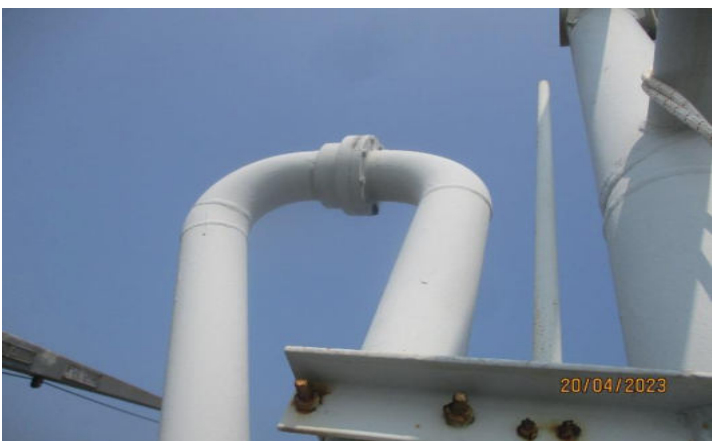
<p>Name of part:</p> <p>3" 1104 B Loading arm</p> <p>Findings:</p> <p>Normal condition</p>

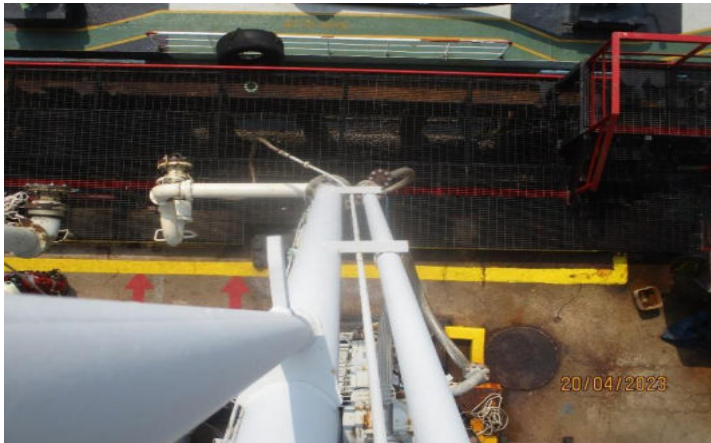
<p>Name of part:</p> <p>3" 1104 B Loading arm</p> <p>Findings:</p> <p>Normal condition</p>

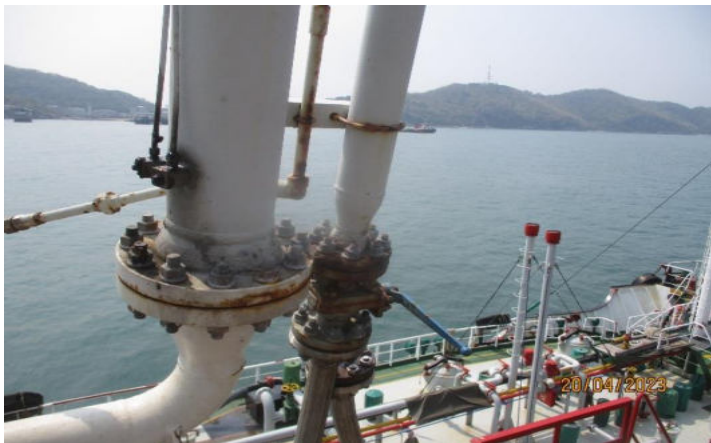
<p>Name of part:</p> <p>3" 1104 B Loading arm</p> <p>Findings:</p> <p>Normal condition</p>

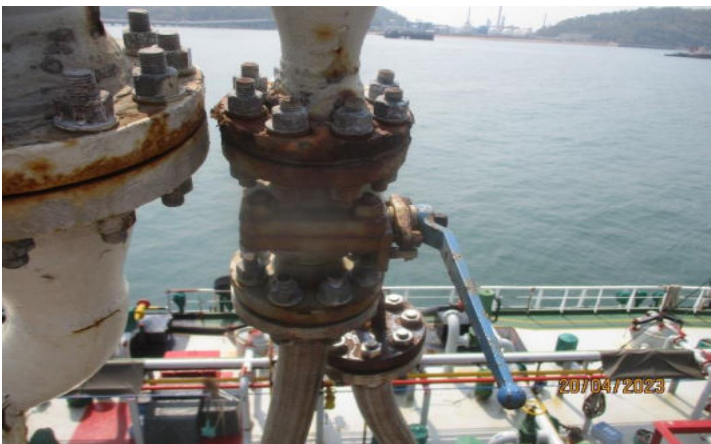
<p>Name of part:</p> <p>3" 1104 B Loading arm</p> <p>Findings:</p> <p>Corrosion on flange stud bolt & nuts area.</p>

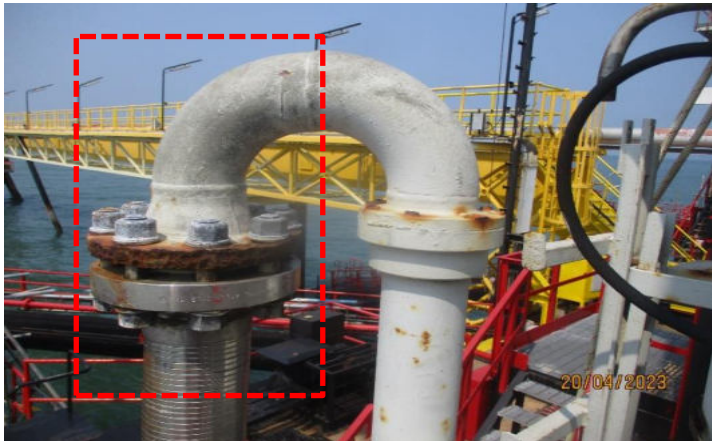
<p>Name of part:</p> <p>3" 1104 B Loading arm</p> <p>Findings:</p> <p>Corrosion on flange stud bolt & nuts area.</p>

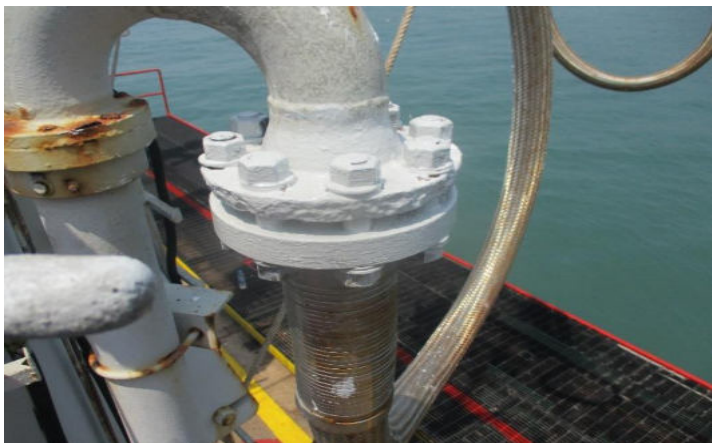
<p>Name of part:</p> <p>3" 1104 B Loading arm</p> <p>Findings:</p> <p>After paint repair</p>

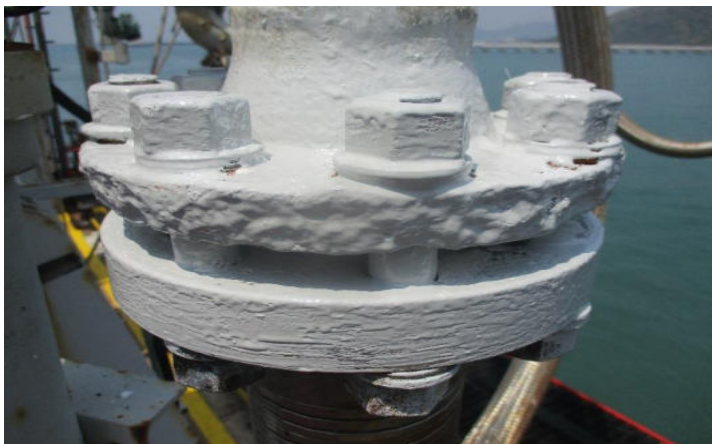
<p>Name of part:</p> <p>3" 1104 B Loading arm</p> <p>Findings:</p> <p>After paint repair</p>

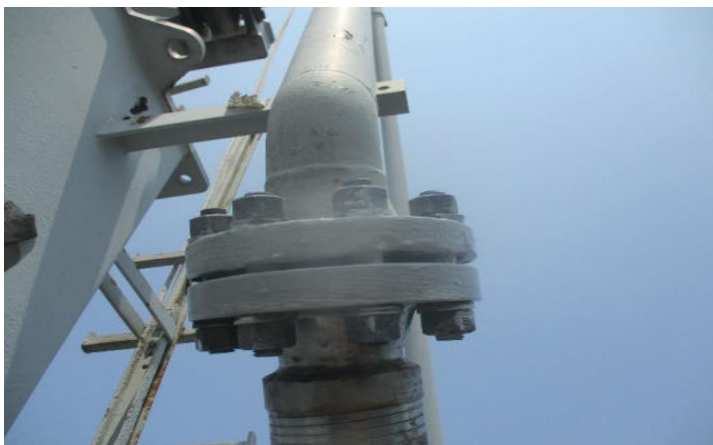
<p>Name of part:</p> <p>3" 1104 B Loading arm</p> <p>Findings:</p> <p>After paint repair</p>

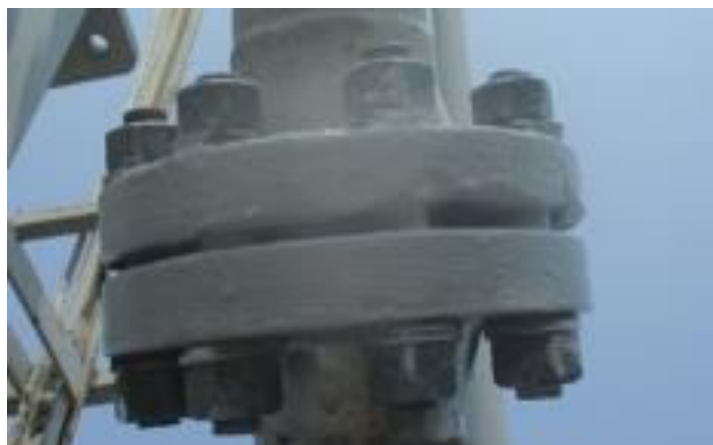
<p>Name of part:</p> <p>3" 1104 B Loading arm</p> <p>Findings:</p> <p>After paint repair</p>

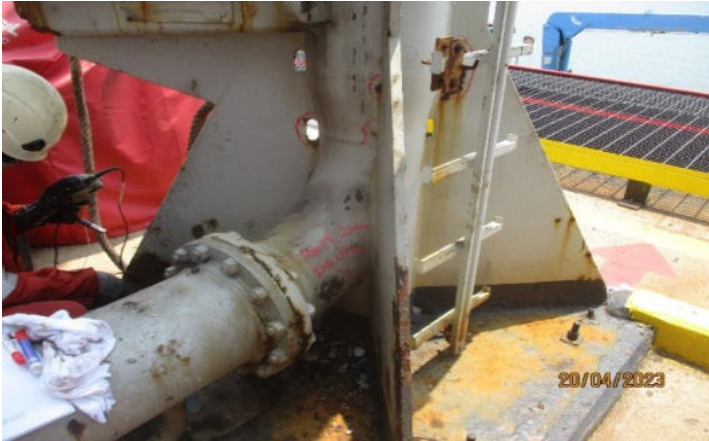
<p>Name of part:</p> <p>8" L-1101 B Loading arm</p> <p>Findings:</p> <p>Corrosion on Elbow.</p>

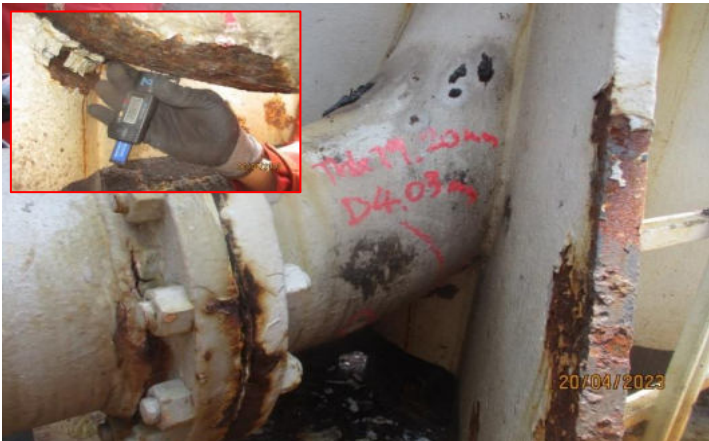
<p>Name of part:</p> <p>8" L-1101 B Loading arm</p> <p>Findings:</p> <p>Corrosion on Elbow. Good area 19.20 mm. Depth = 4.03 mm.</p>

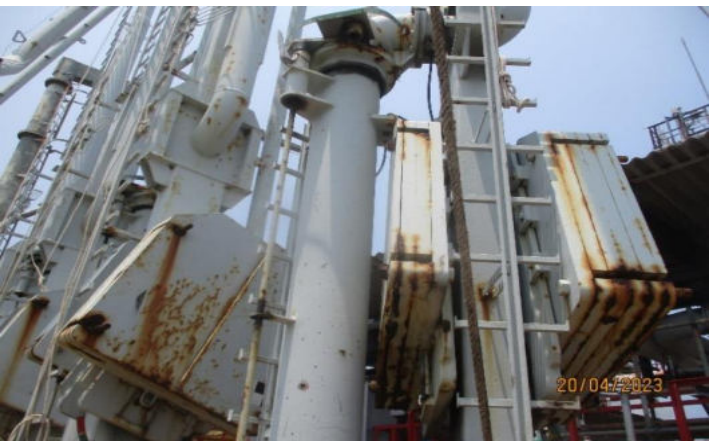
<p>Name of part:</p> <p>8" L-1101 B Loading arm</p> <p>Findings:</p> <p>Corrosion on Counterweight and stud bolt nuts.</p>

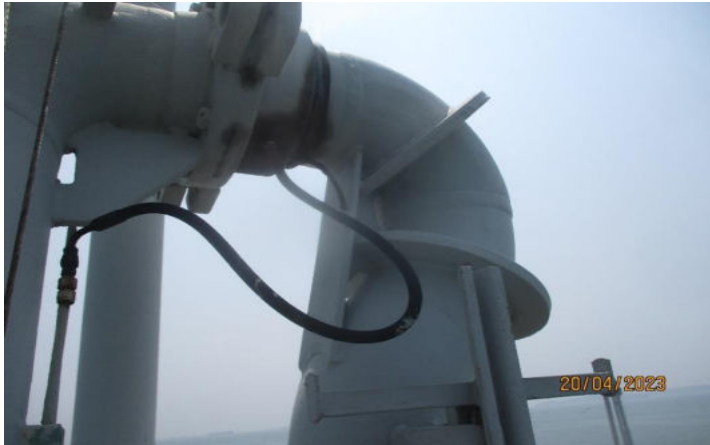
<p>Name of part:</p> <p>8" L-1101 B Loading arm</p> <p>Findings:</p> <p>Normal condition</p>

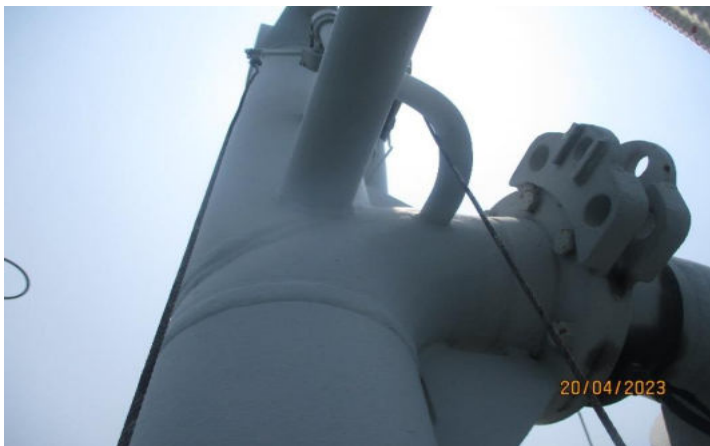
<p>Name of part:</p> <p>8" L-1101 B Loading arm</p> <p>Findings:</p> <p>Normal condition</p>

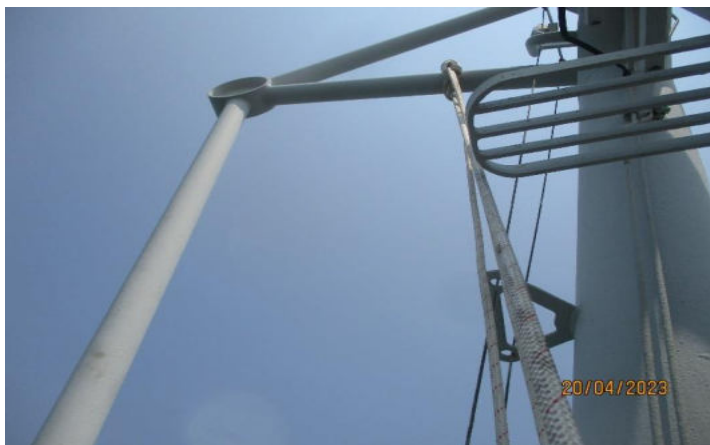
<p>Name of part:</p> <p>8" L-1101 B Loading arm</p> <p>Findings:</p> <p>Normal condition</p>

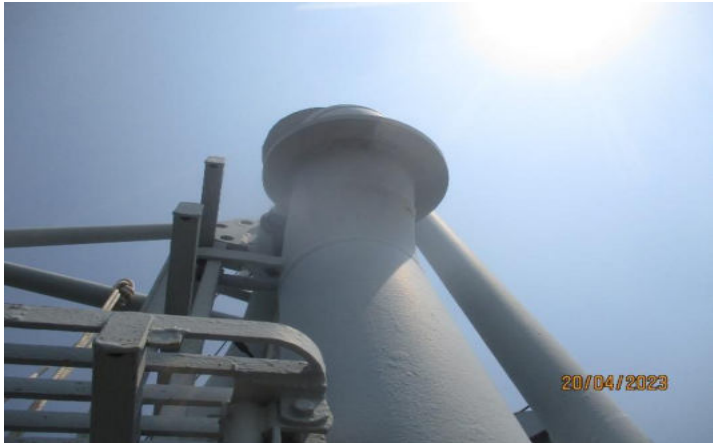
<p>Name of part:</p> <p>8" L-1101 B Loading arm</p> <p>Findings:</p> <p>Normal condition</p>

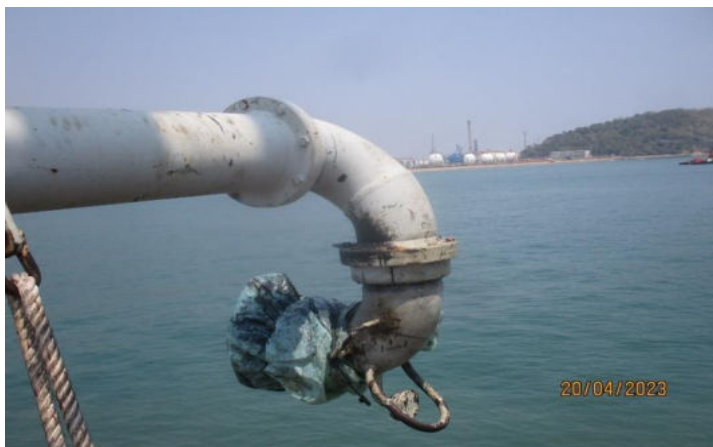
<p>Name of part:</p> <p>8" L-1101 B Loading arm</p> <p>Findings:</p> <p>Normal condition</p>

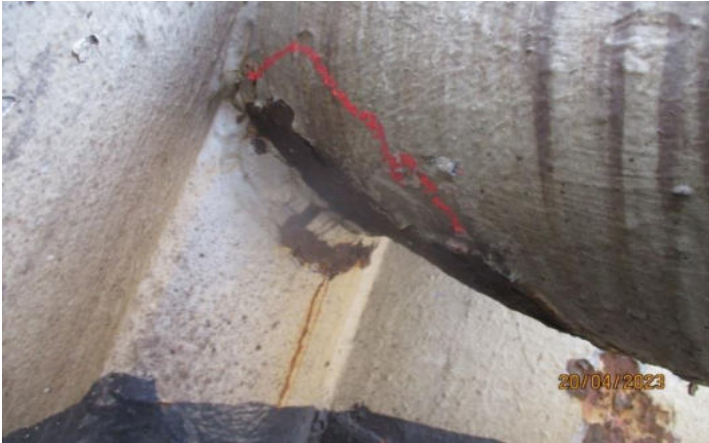
<p>Name of part:</p> <p>8" L-1101 B Loading arm</p> <p>Findings:</p> <p>Corrosion on Elbow.</p>

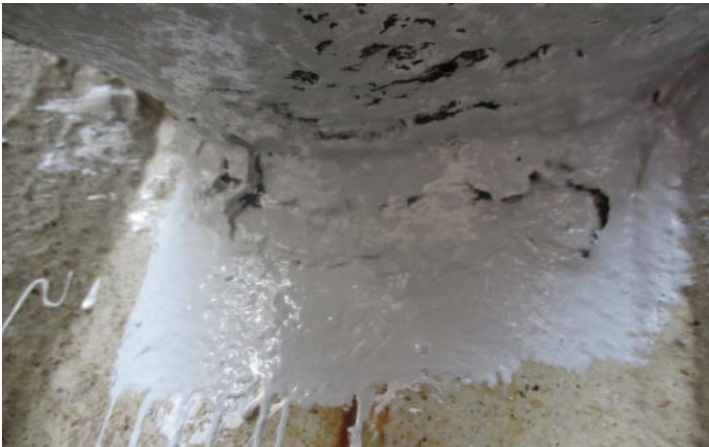
<p>Name of part:</p> <p>8" L-1101 B Loading arm</p> <p>Findings:</p> <p>After paint repair</p>

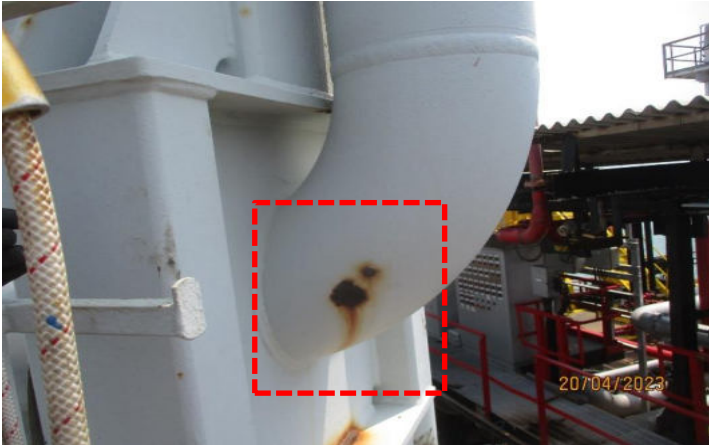
<p>Name of part:</p> <p>8" L-1101 B Loading arm</p> <p>Findings:</p> <p>Corrosion on Elbow.</p>

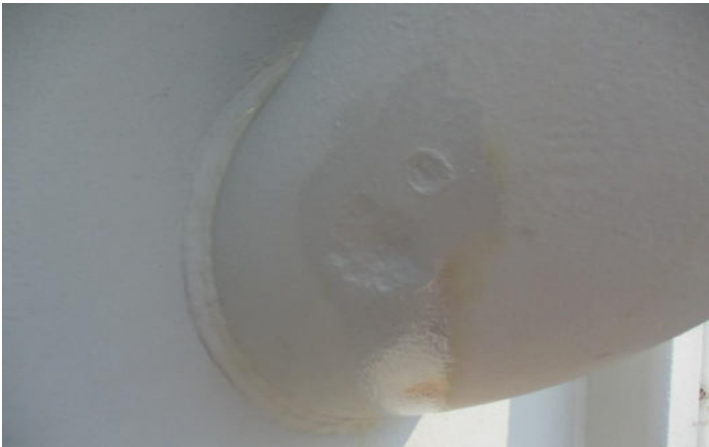
<p>Name of part:</p> <p>8" L-1101 B Loading arm</p> <p>Findings:</p> <p>After paint repair</p>

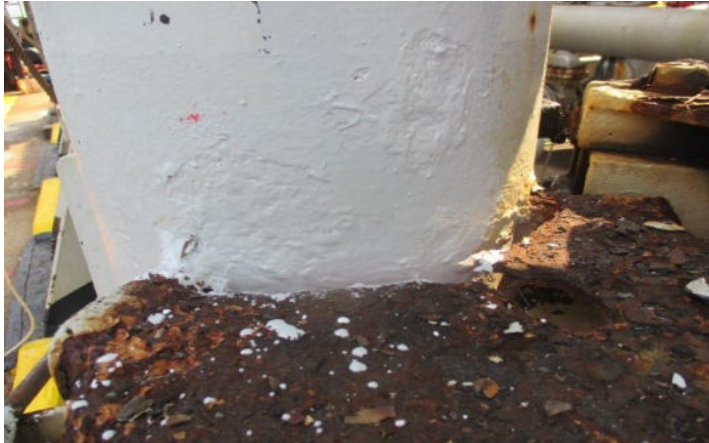
<p>Name of part:</p> <p>8" L-1101 B Loading arm</p> <p>Findings:</p> <p>After paint repair</p>

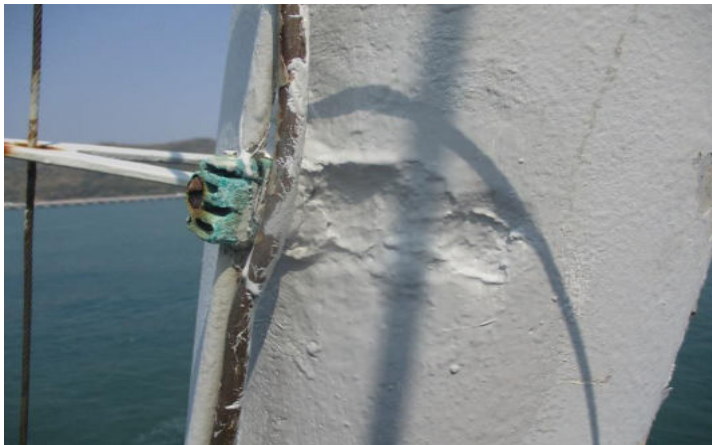
<p>Name of part:</p> <p>8" L-1101 B Loading arm</p> <p>Findings:</p> <p>After paint repair</p>

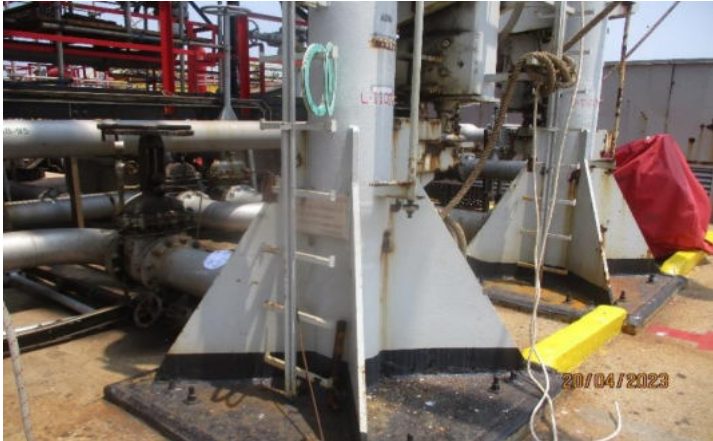
<p>Name of part:</p> <p>8" L-1102 B Loading arm</p> <p>Findings:</p> <p>Normal condition</p>
