INSPECTION REPORT

**LOADING ARM
BI-1, B-2 AND BI-3**

**ESSO SRIRACHA REFINERY PLANT,
CHONBURI**

18-21 And 24 April 2023
Report No: 2304019_Rev.00

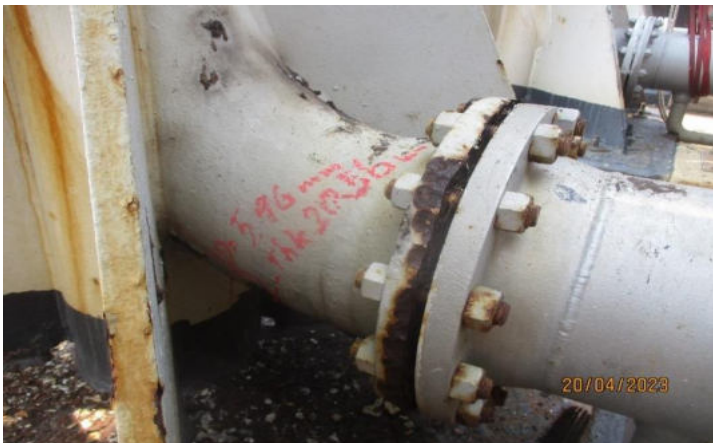
<p>Name of part:</p> <p>8" L-1102 B Loading arm</p> <p>Findings:</p> <p>Corrosion on Elbow. Good area 20.56 mm. Depth = 5.96 mm.</p>

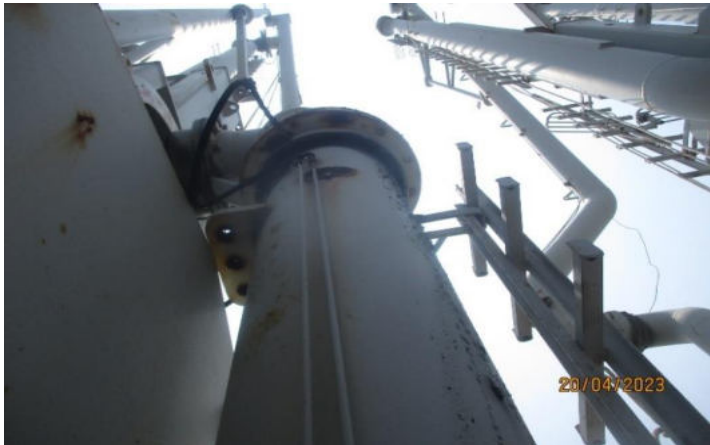
<p>Name of part:</p> <p>8" L-1102 B Loading arm</p> <p>Findings:</p> <p>Corrosion on Pipe.</p>

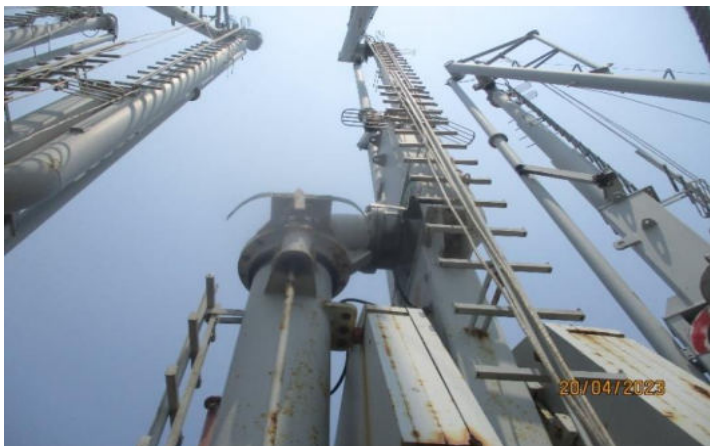
<p>Name of part:</p> <p>8" L-1102 B Loading arm</p> <p>Findings:</p> <p>Normal condition</p>

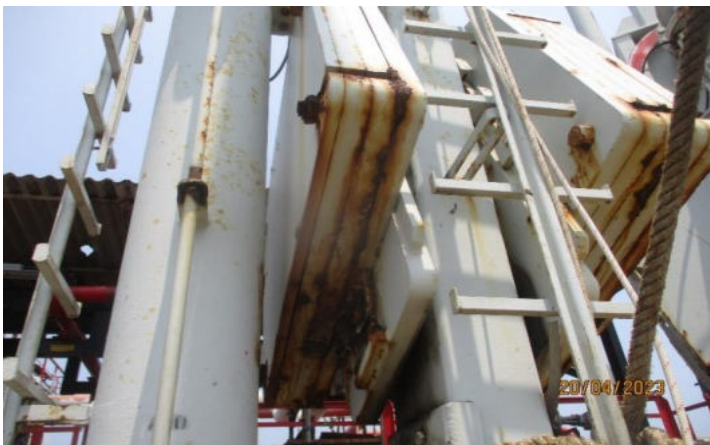
<p>Name of part:</p> <p>8" L-1102 B Loading arm</p> <p>Findings:</p> <p>Corrosion on Counterweight and stud bolt nuts.</p>

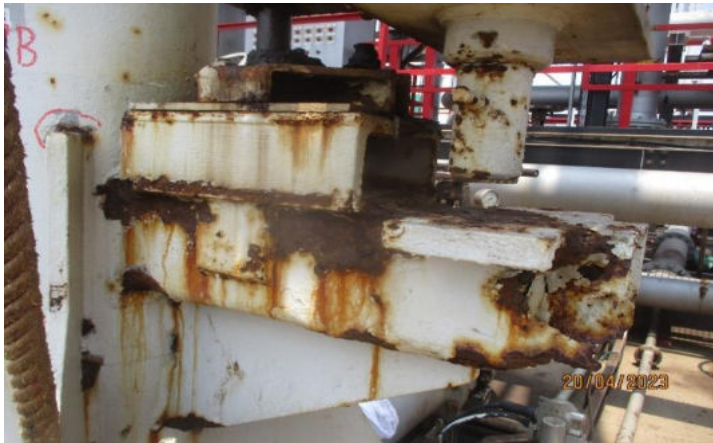
<p>Name of part:</p> <p>8" L-1102 B Loading arm</p> <p>Findings:</p> <p>Corrosion on Support Counterweight.</p>

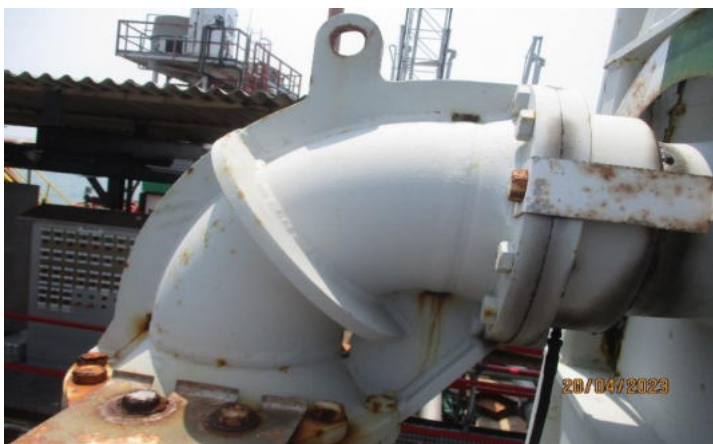
<p>Name of part:</p> <p>8" L-1102 B Loading arm</p> <p>Findings:</p> <p>Normal condition</p>

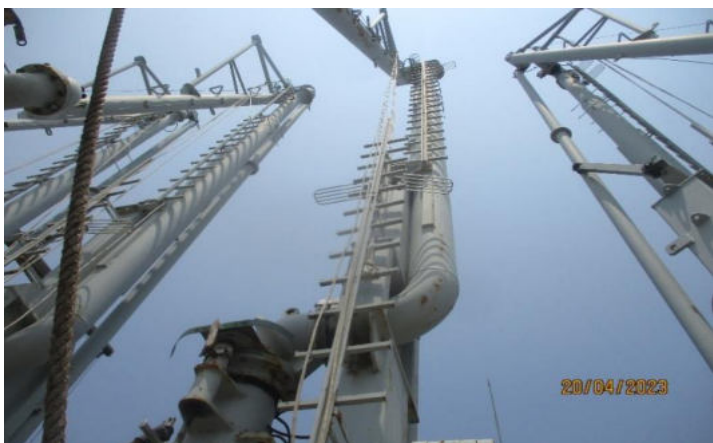
<p>Name of part:</p> <p>8" L-1102 B Loading arm</p> <p>Findings:</p> <p>Corrosion on Counterweight and stud bolt nuts.</p>

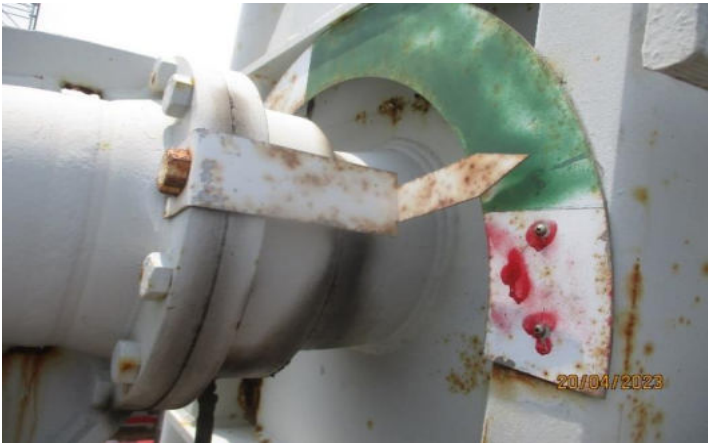
<p>Name of part:</p> <p>8" L-1102 B Loading arm</p> <p>Findings:</p> <p>Normal condition</p>

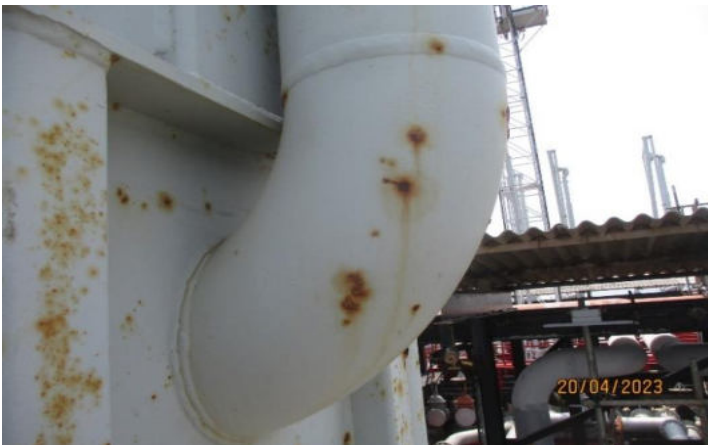
<p>Name of part:</p> <p>8" L-1102 B Loading arm</p> <p>Findings:</p> <p>Corrosion on Elbow.</p>

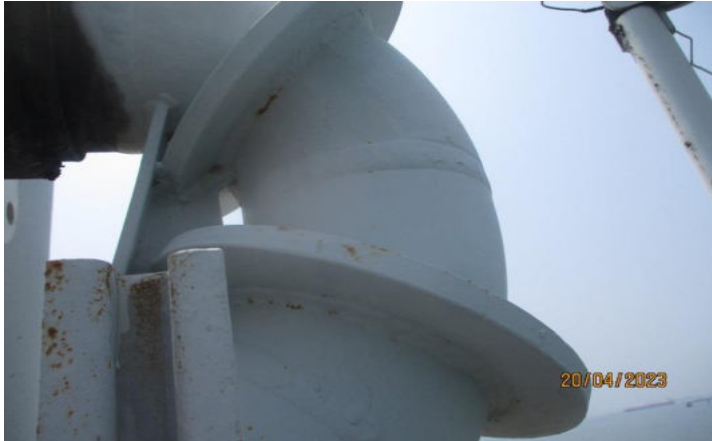
<p>Name of part:</p> <p>8" L-1102 B Loading arm</p> <p>Findings:</p> <p>Normal condition</p>

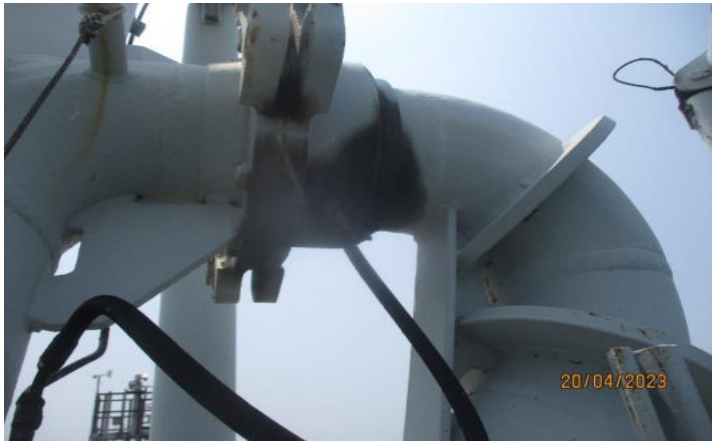
<p>Name of part:</p> <p>8" L-1102 B Loading arm</p> <p>Findings:</p> <p>Normal condition</p>

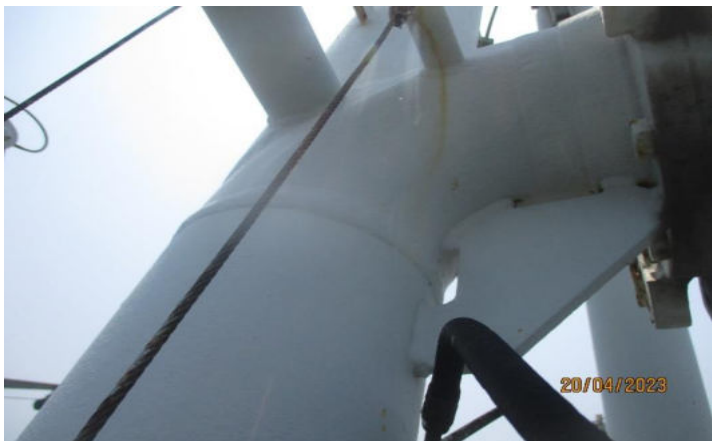
<p>Name of part:</p> <p>8" L-1102 B Loading arm</p> <p>Findings:</p> <p>Normal condition</p>

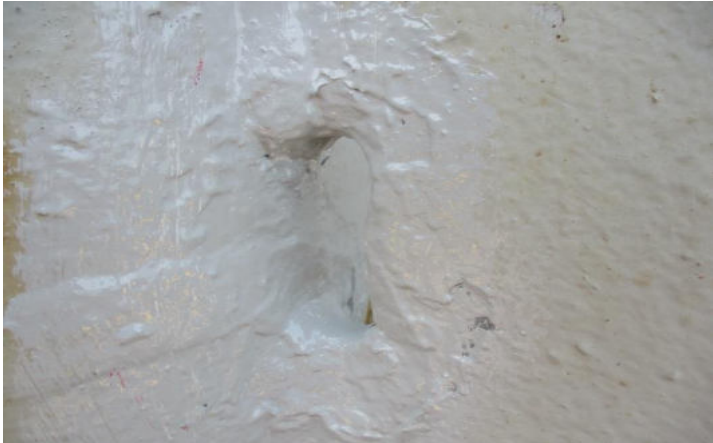
<p>Name of part:</p> <p>8" L-1102 B Loading arm</p> <p>Findings:</p> <p>After paint repair</p>

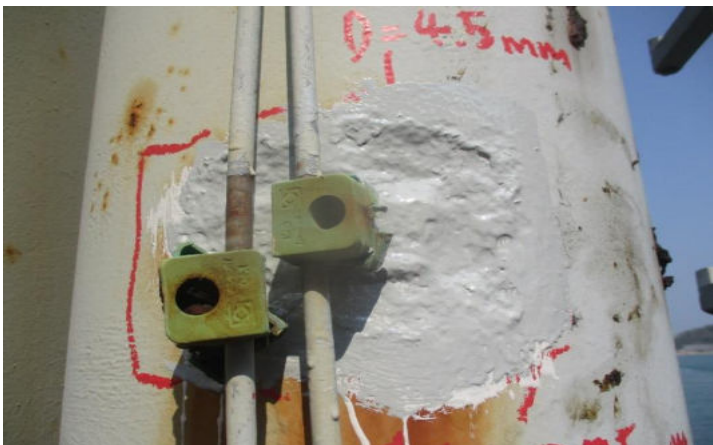
<p>Name of part:</p> <p>8" L-1102 B Loading arm</p> <p>Findings:</p> <p>Corrosion on Structure support</p>

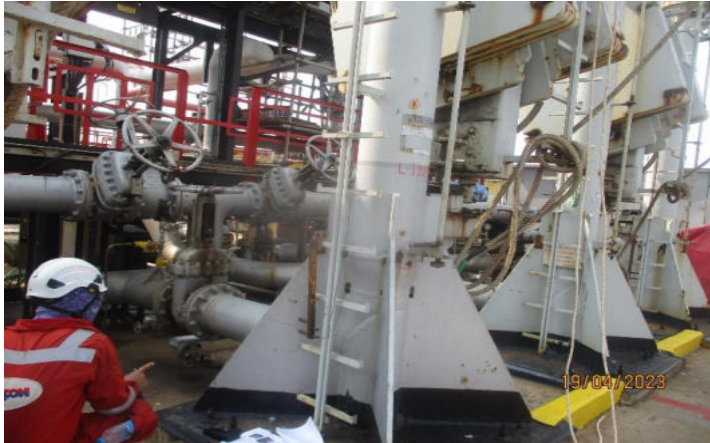
<p>Name of part:</p> <p>8" L-1103 B Loading arm</p> <p>Findings:</p> <p>Normal condition</p>

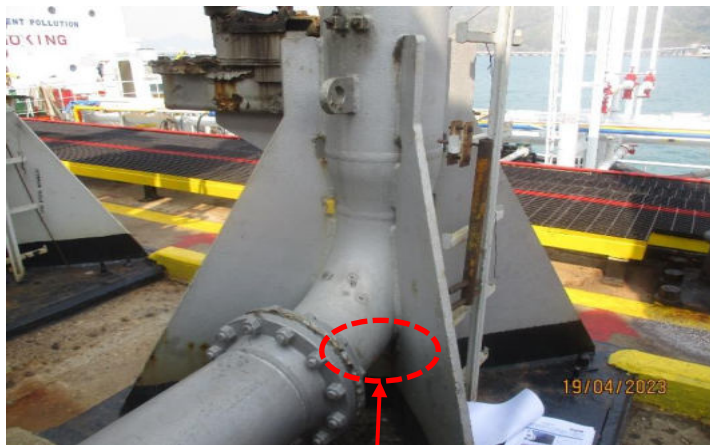
<p>Name of part:</p> <p>8" L-1103 B Loading arm</p> <p>Findings:</p> <p>Was found corrosion on Elbow.</p>

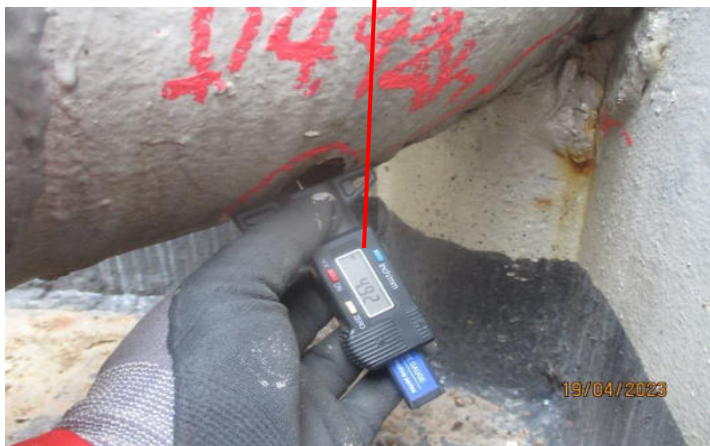
<p>Name of part:</p> <p>8" L-1103 B Loading arm</p> <p>Findings:</p> <p>Was found corrosion on Elbow. Good area 19.80 mm. Depth = 4.92 mm.</p>

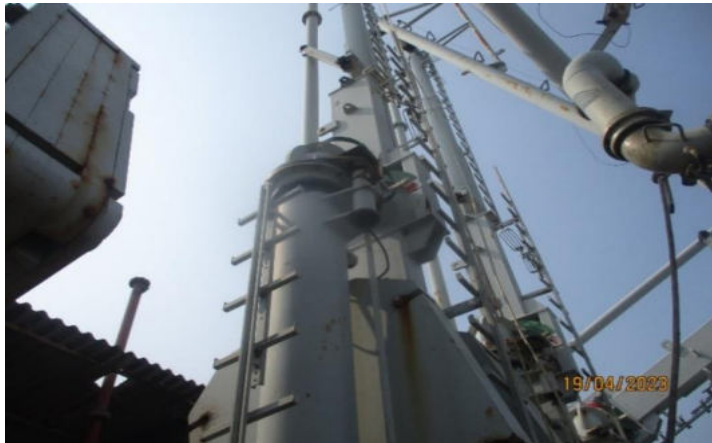
<p>Name of part:</p> <p>8" L-1103 B Loading arm</p> <p>Findings:</p> <p>Normal condition</p>

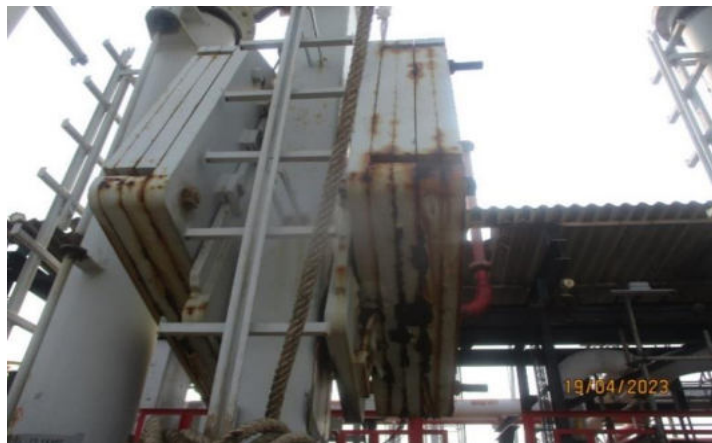
<p>Name of part:</p> <p>8" L-1103 B Loading arm</p> <p>Findings:</p> <p>Corrosion on Counter eight and stud bolt nuts.</p>

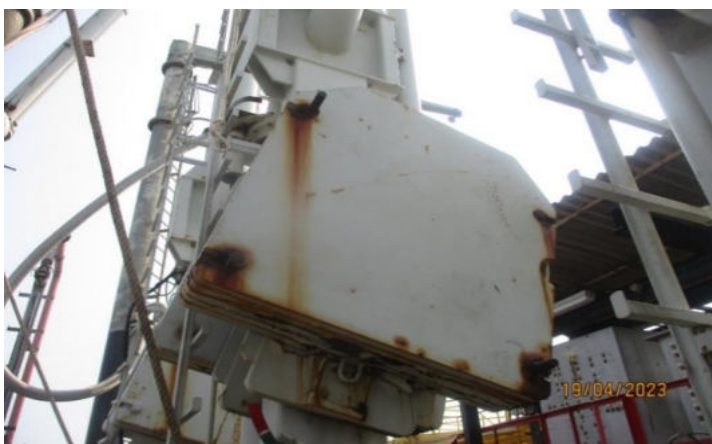
<p>Name of part:</p> <p>8" L-1103 B Loading arm</p> <p>Findings:</p> <p>Corrosion on Counter eight and stud bolt nuts.</p>

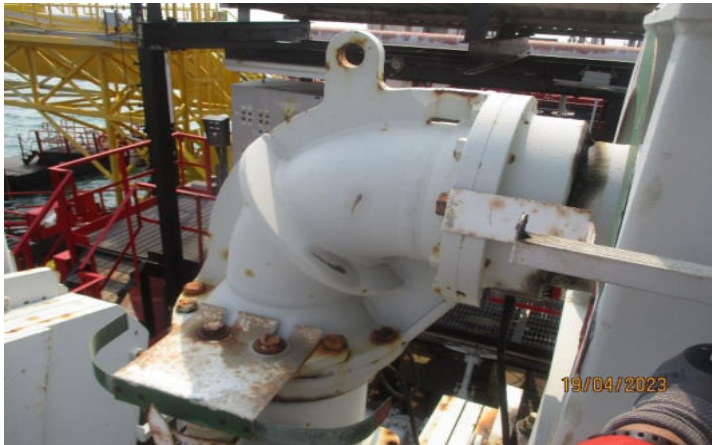
<p>Name of part:</p> <p>8" L-1103 B Loading arm</p> <p>Findings:</p> <p>Normal condition</p>

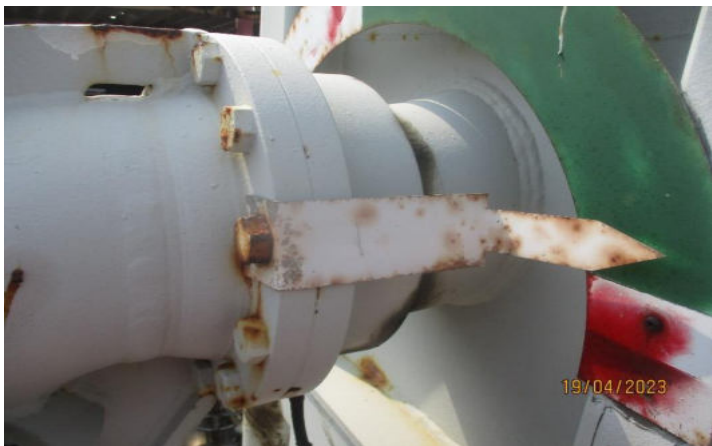
<p>Name of part:</p> <p>8" L-1103 B Loading arm</p> <p>Findings:</p> <p>Normal condition</p>

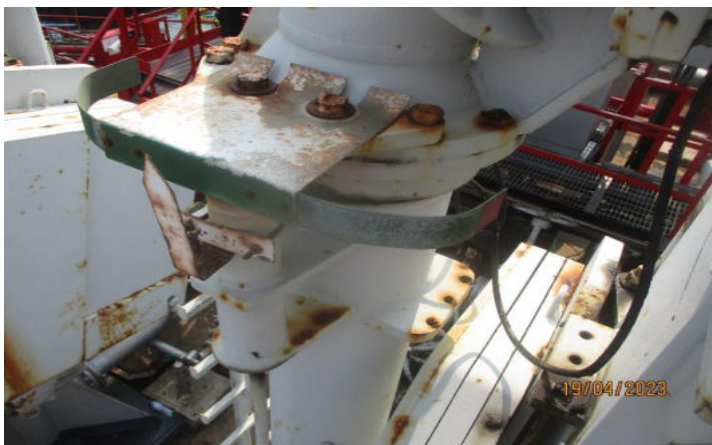
<p>Name of part:</p> <p>8" L-1103 B Loading arm</p> <p>Findings:</p> <p>Normal condition</p>

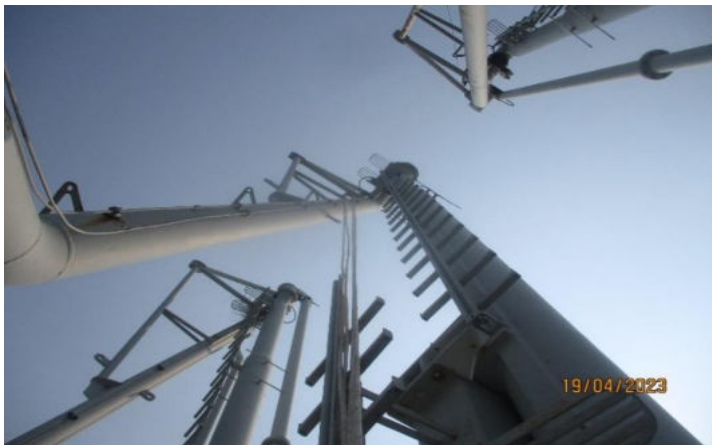
<p>Name of part:</p> <p>8" L-1103 B Loading arm</p> <p>Findings:</p> <p>Normal condition</p>

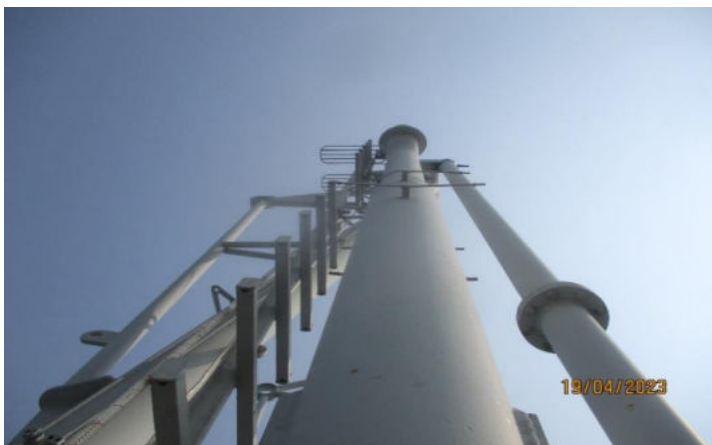
<p>Name of part:</p> <p>8" L-1103 B Loading arm</p> <p>Findings:</p> <p>Normal condition</p>

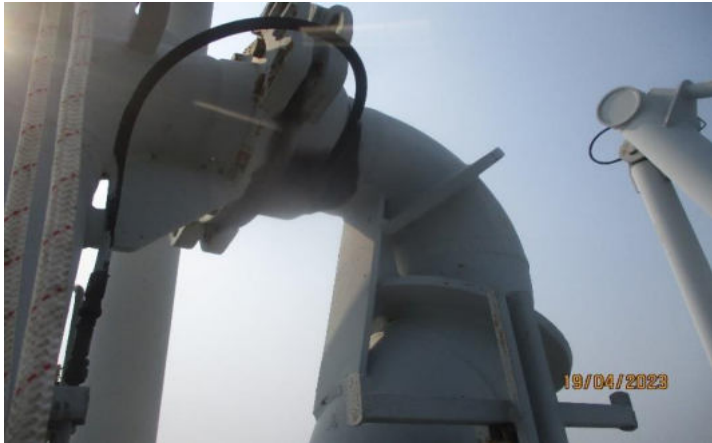
<p>Name of part:</p> <p>8" L-1103 B Loading arm</p> <p>Findings:</p> <p>Normal condition</p>

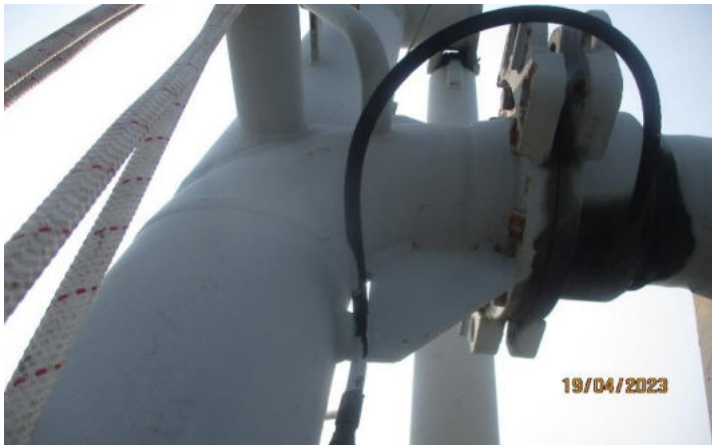
<p>Name of part:</p> <p>8" L-1103 B Loading arm</p> <p>Findings:</p> <p>Normal condition</p>

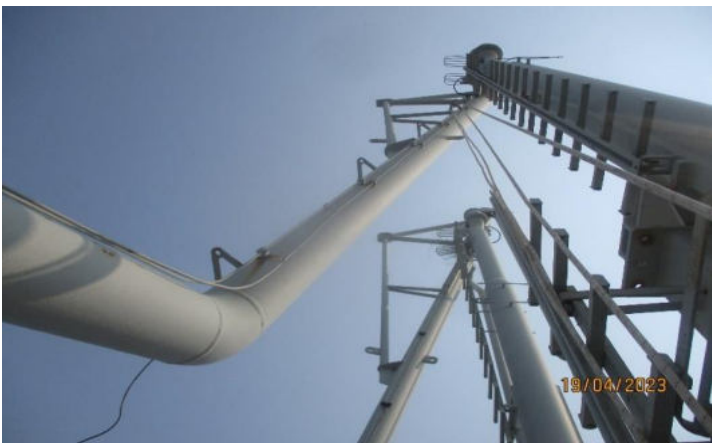
<p>Name of part:</p> <p>8" L-1103 B Loading arm</p> <p>Findings:</p> <p>Normal condition</p>

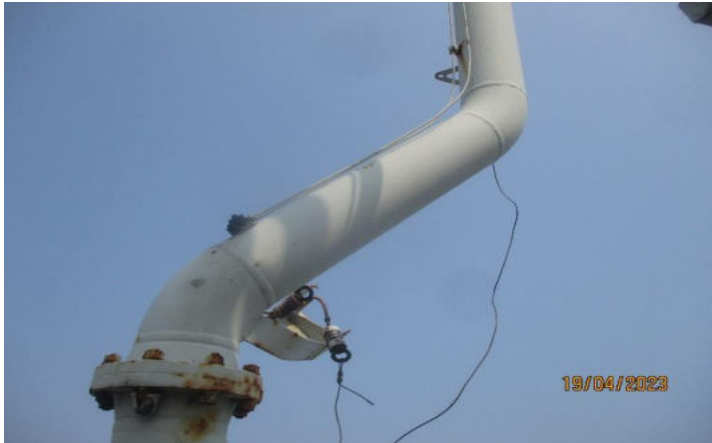
<p>Name of part:</p> <p>8" L-1103 B Loading arm</p> <p>Findings:</p> <p>Corrosion on Flange stud bolt & nuts area.</p>

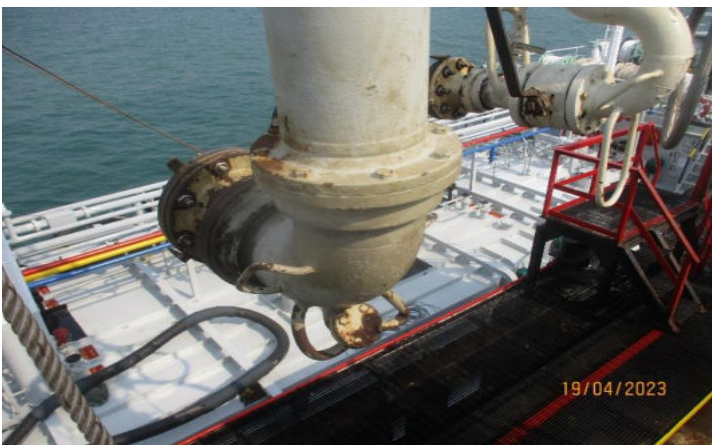
<p>Name of part:</p> <p>8" L-1103 B Loading arm</p> <p>Findings:</p> <p>Corrosion on Flange stud bolt & nuts area.</p>

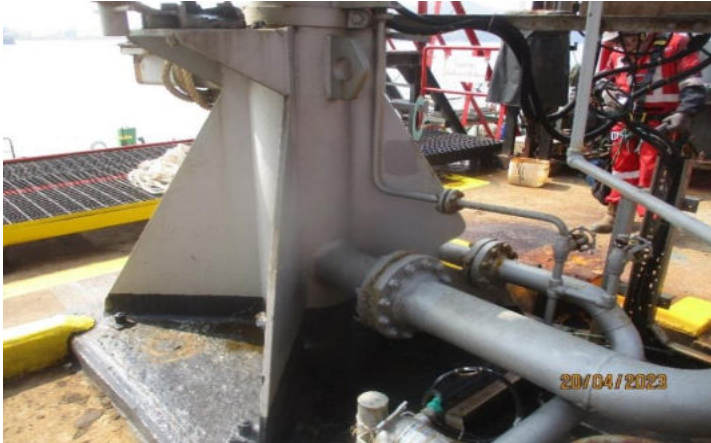
<p>Name of part:</p> <p>8" L-1104 B Loading arm</p> <p>Findings:</p> <p>Normal condition</p>

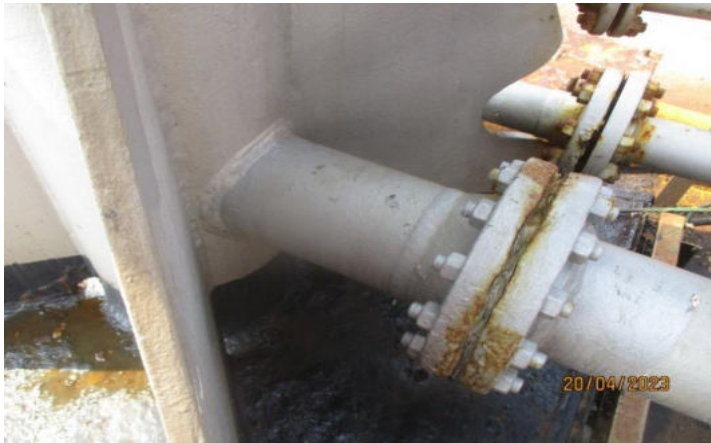
<p>Name of part:</p> <p>8" L-1104 B Loading arm</p> <p>Findings:</p> <p>Normal condition</p>

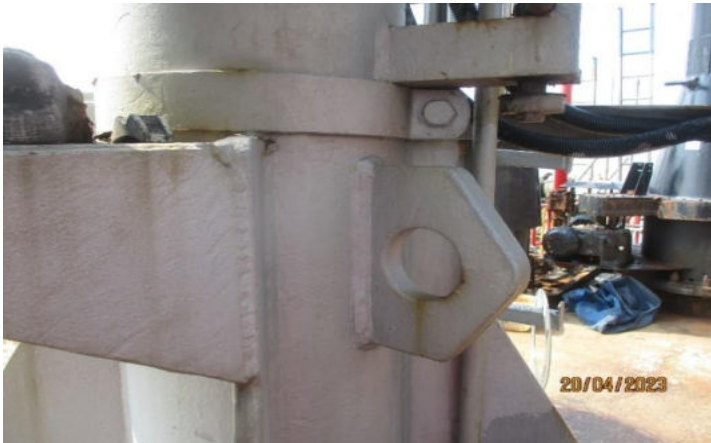
<p>Name of part:</p> <p>8" L-1104 B Loading arm</p> <p>Findings:</p> <p>Normal condition</p>

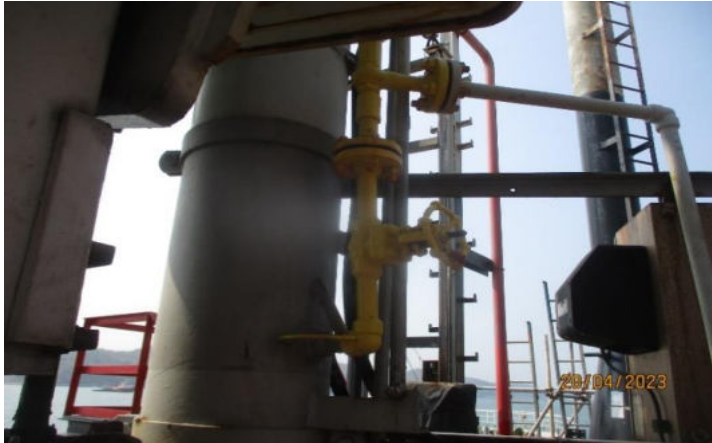
<p>Name of part:</p> <p>8" L-1104 B Loading arm</p> <p>Findings:</p> <p>Normal condition</p>

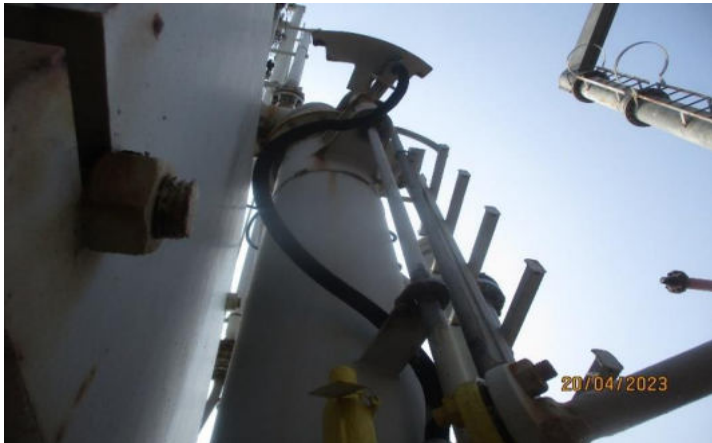
<p>Name of part:</p> <p>8" L-1104 B Loading arm</p> <p>Findings:</p> <p>Normal condition</p>

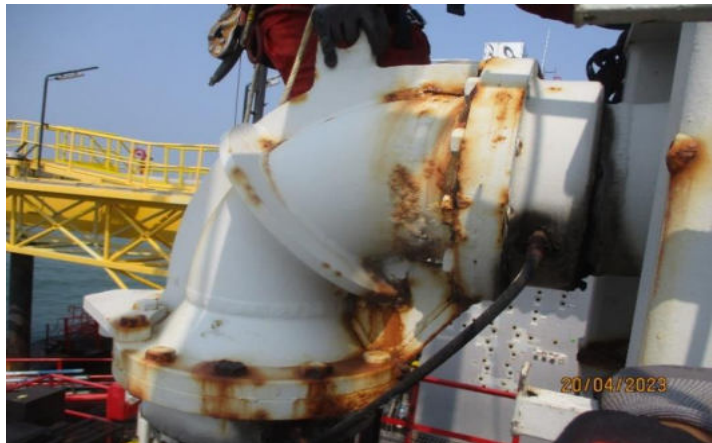
<p>Name of part:</p> <p>8" L-1104 B Loading arm</p> <p>Findings:</p> <p>Corrosion on Flange stud bolt & nuts area.</p>

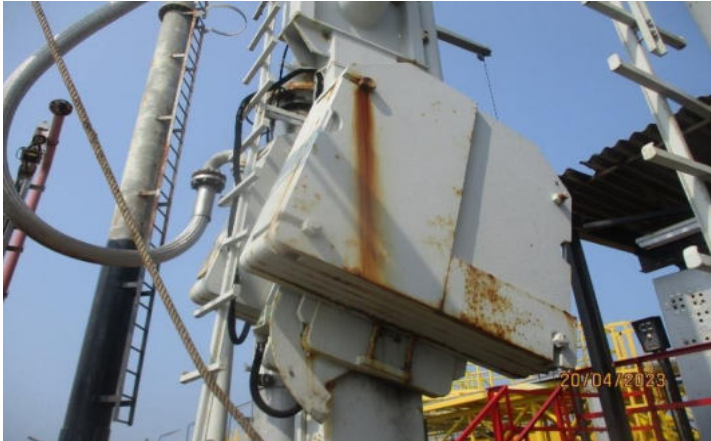
<p>Name of part:</p> <p>8" L-1104 B Loading arm</p> <p>Findings:</p> <p>Corrosion on Counter weight and stud bolt nuts.</p>

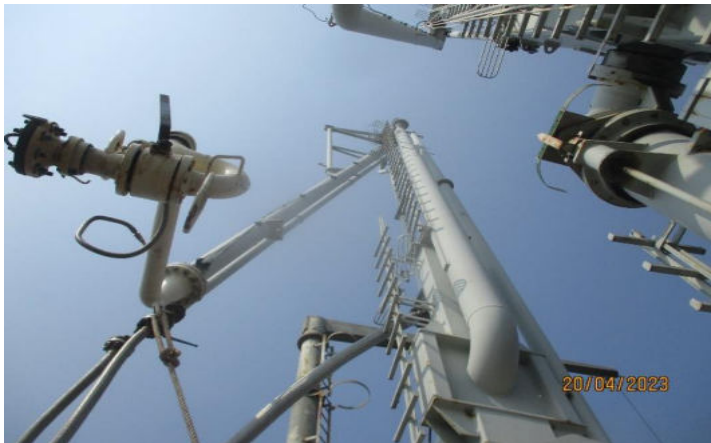
<p>Name of part:</p> <p>8" L-1104 B Loading arm</p> <p>Findings:</p> <p>Normal condition</p>

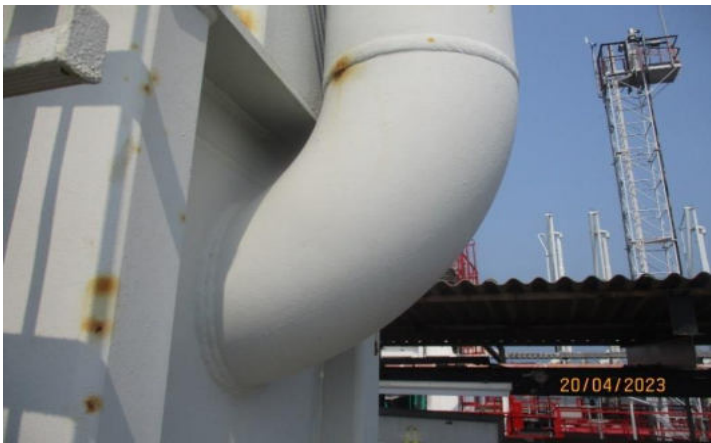
<p>Name of part:</p> <p>8" L-1104 B Loading arm</p> <p>Findings:</p> <p>Normal condition</p>

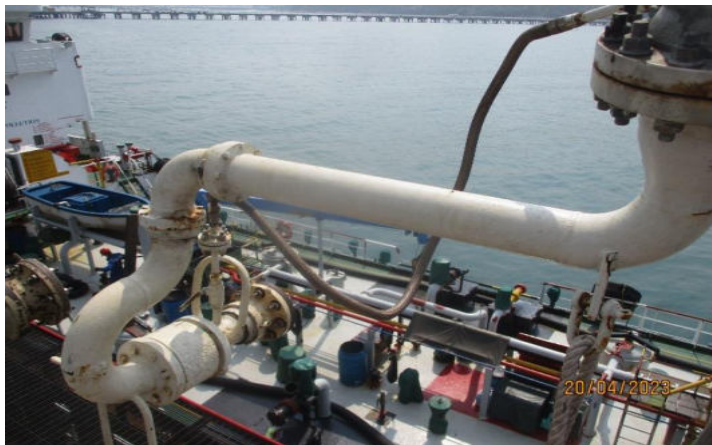
<p>Name of part:</p> <p>8" L-1104 B Loading arm</p> <p>Findings:</p> <p>Normal condition</p>

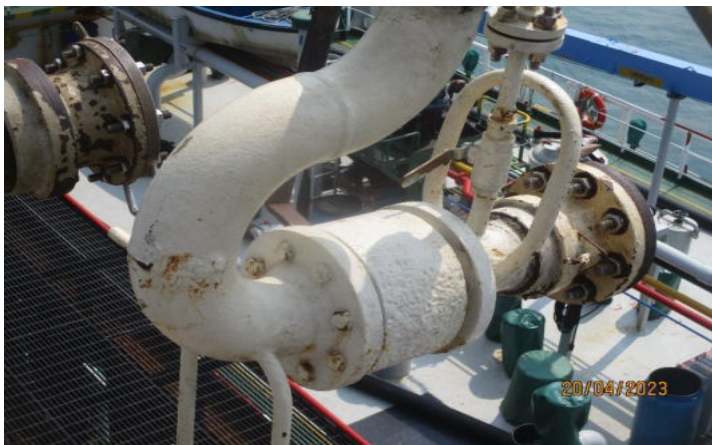
<p>Name of part:</p> <p>8" L-1104 B Loading arm</p> <p>Findings:</p> <p>Corrosion on Pipe Elbow.</p>

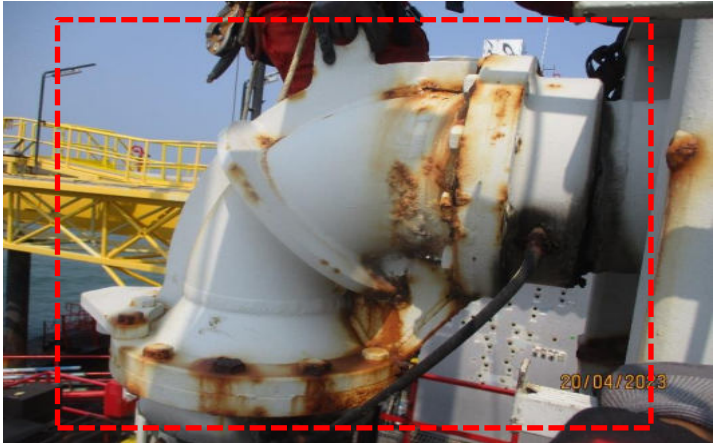
<p>Name of part:</p> <p>8" L-1104 B Loading arm</p> <p>Findings:</p> <p>Corrosion on Flange stud bolt & nuts area.</p>

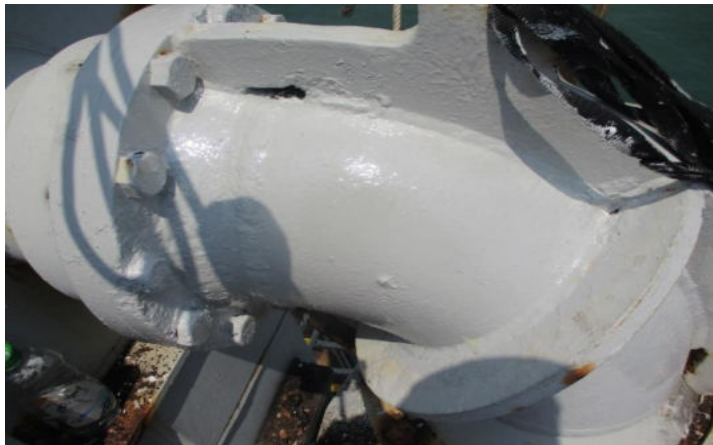
<p>Name of part:</p> <p>8" L-1104 B Loading arm</p> <p>Findings:</p> <p>After paint repair</p>

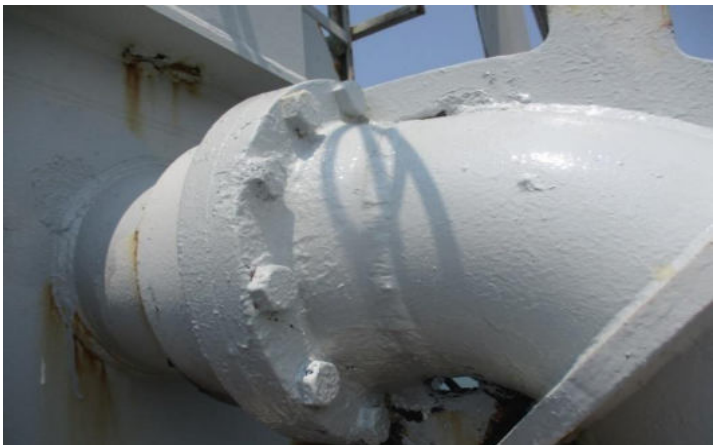
<p>Name of part:</p> <p>8" L-1104 B Loading arm</p> <p>Findings:</p> <p>After paint repair</p>

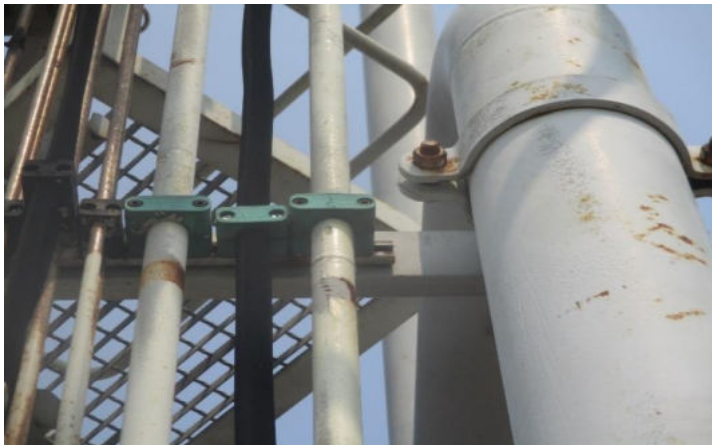
<p>Name of part:</p> <p>1"-LA-B N2</p> <p>Findings:</p> <p>Normal condition</p>

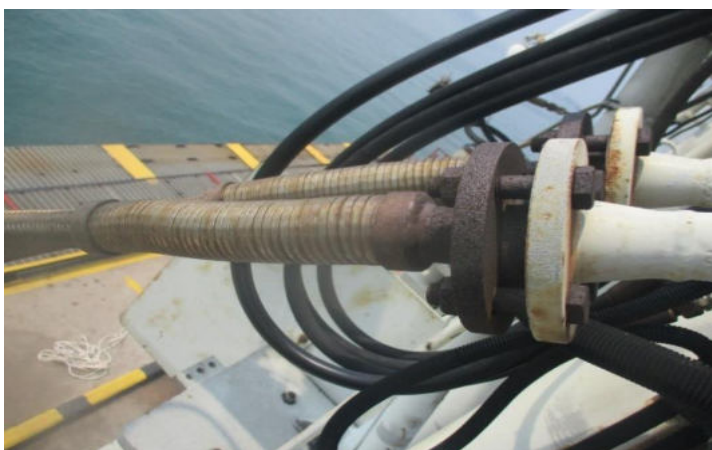
<p>Name of part:</p> <p>1"-LA-B N2</p> <p>Findings:</p> <p>Normal condition</p>

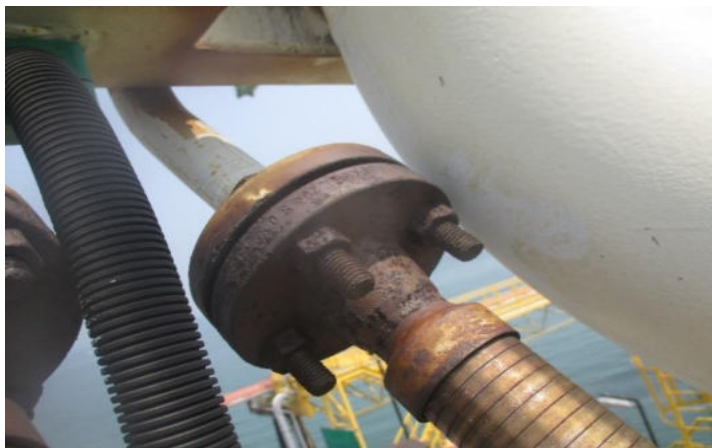
<p>Name of part:</p> <p>1"-LA-B N2</p> <p>Findings:</p> <p>Normal condition</p>

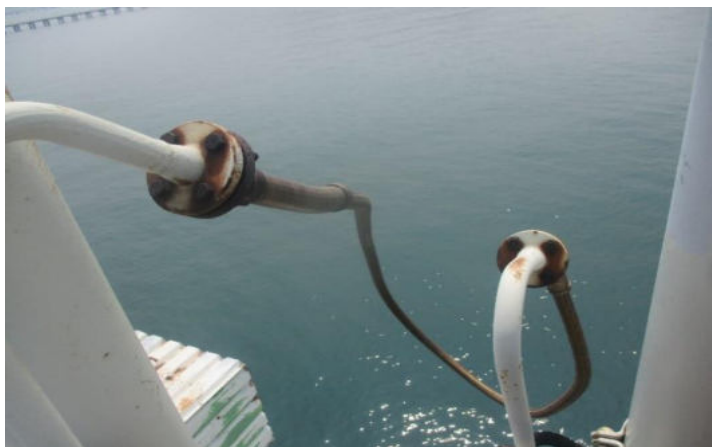
<p>Name of part:</p> <p>1"-LA-B N2</p> <p>Findings:</p> <p>Normal condition</p>

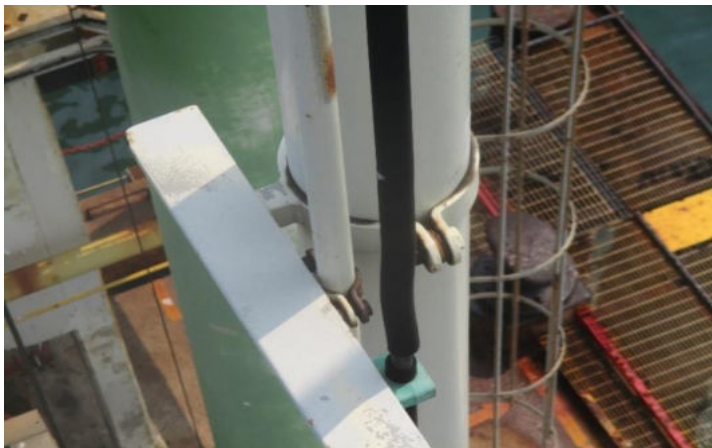
<p>Name of part:</p> <p>1"-LA-B N2</p> <p>Findings:</p> <p>Normal condition</p>
 	<p>Name of part:</p> <p>1"-LA-B N2</p> <p>Findings:</p> <p>Normal condition</p>

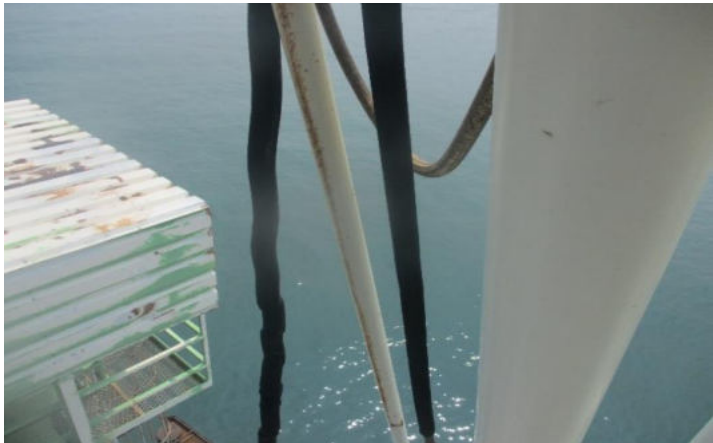
<p>Name of part:</p> <p>1"-LA-B N2</p>
	<p>Findings:</p> <p>Normal condition</p>

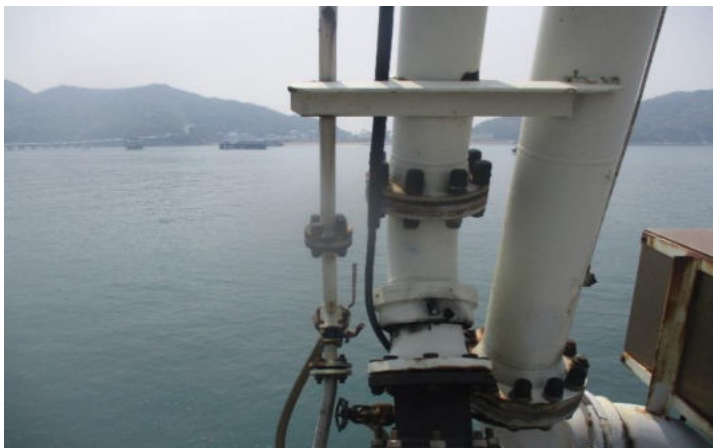
<p>Name of part:</p> <p>1"-LA-B N2</p>
	<p>Findings:</p> <p>Normal condition</p>

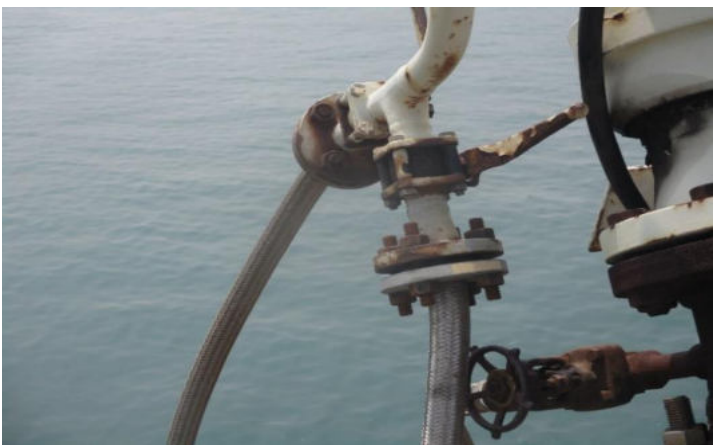
<p>Name of part:</p> <p>1"-LA-B N2</p>
	<p>Findings:</p> <p>Normal condition</p>

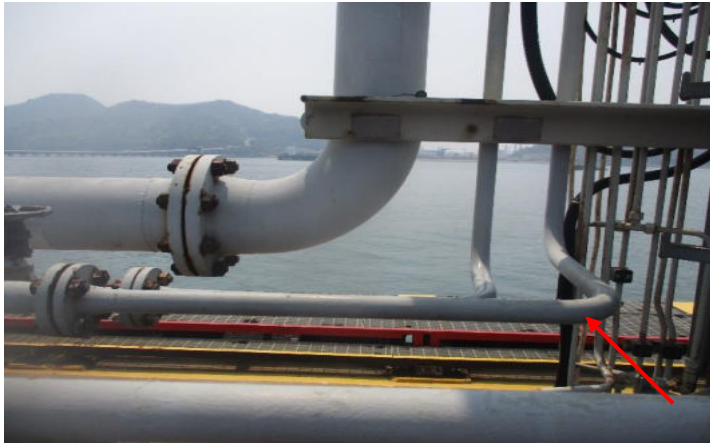
<p>Name of part:</p> <p>1"-LA-B vapor return</p> <p>Findings:</p> <p>Normal condition</p>

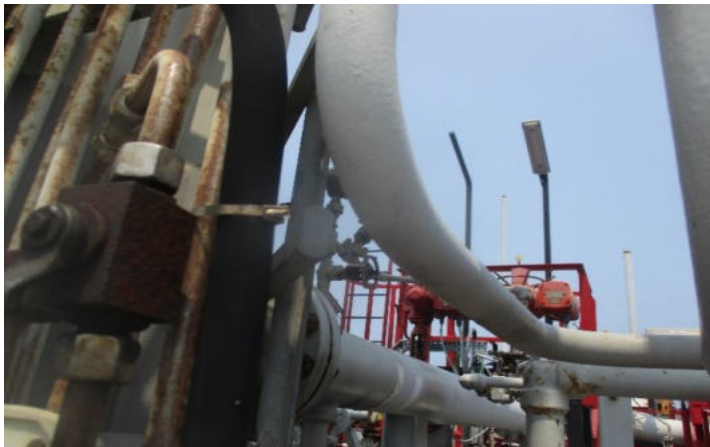
<p>Name of part:</p> <p>1"-LA-B vapor return</p> <p>Findings:</p> <p>Normal condition</p>

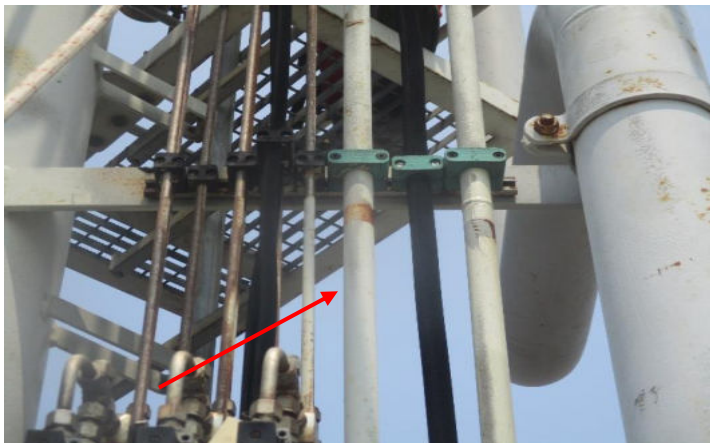
<p>Name of part:</p> <p>1"-LA-B vapor return</p> <p>Findings:</p> <p>Normal condition</p>

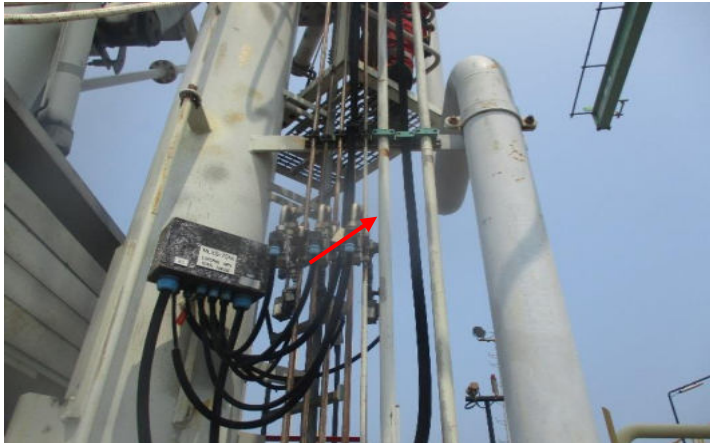
<p>Name of part:</p> <p>1"-LA-B vapor return</p> <p>Findings:</p> <p>Normal condition</p>

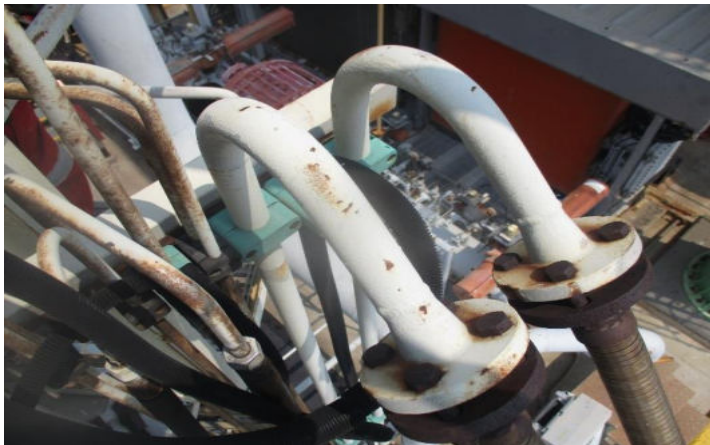
<p>Name of part:</p> <p>1"-LA-B vapor return</p> <p>Findings:</p> <p>Normal condition</p>

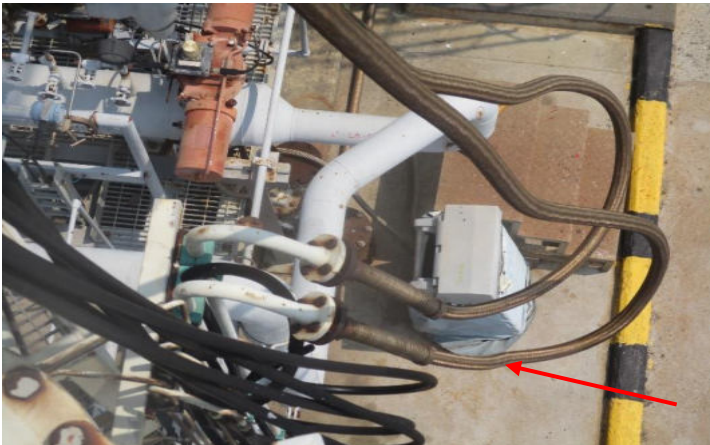
<p>Name of part:</p> <p>1"-LA-B vapor return</p> <p>Findings:</p> <p>Normal condition</p>

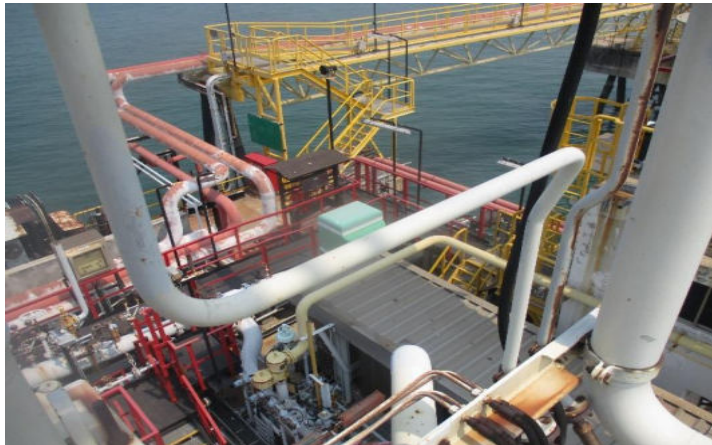
<p>Name of part:</p> <p>1"-LA-B vapor return</p> <p>Findings:</p> <p>Normal condition</p>

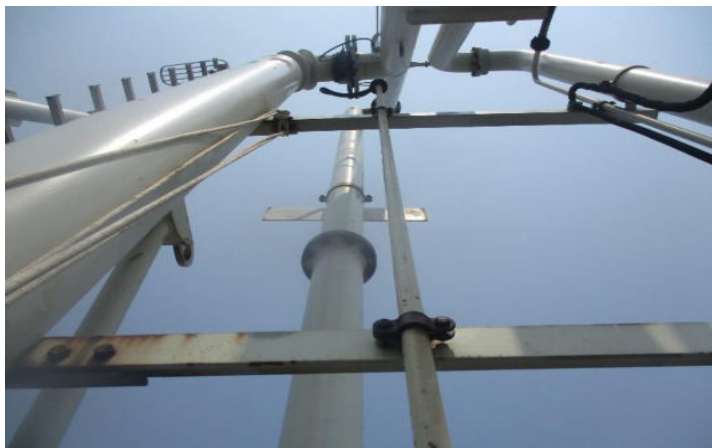
<p>Name of part:</p> <p>1"-LA-B vapor return</p> <p>Findings:</p> <p>Normal condition</p>

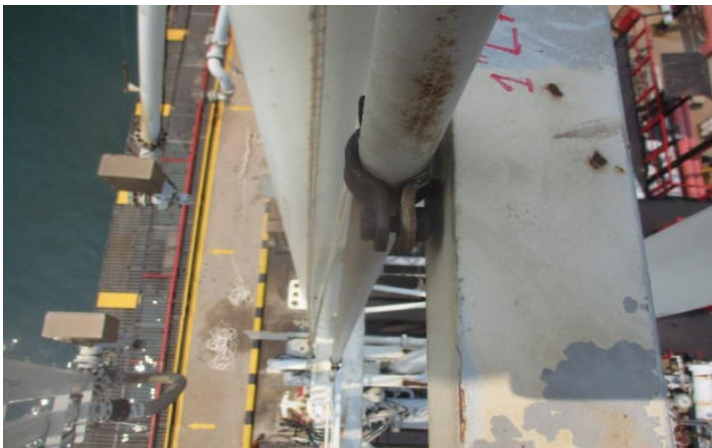
<p>Name of part:</p> <p>1"-LA-B vapor return</p> <p>Findings:</p> <p>Normal condition</p>

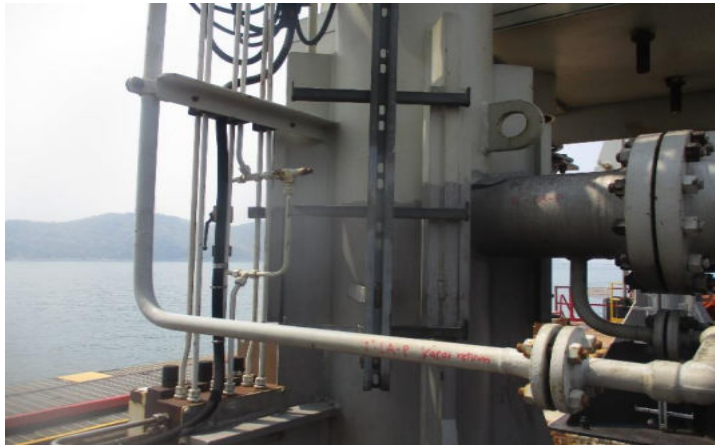
<p>Name of part:</p> <p>1"-LA-P vapor return</p> <p>Findings:</p> <p>Normal condition</p>

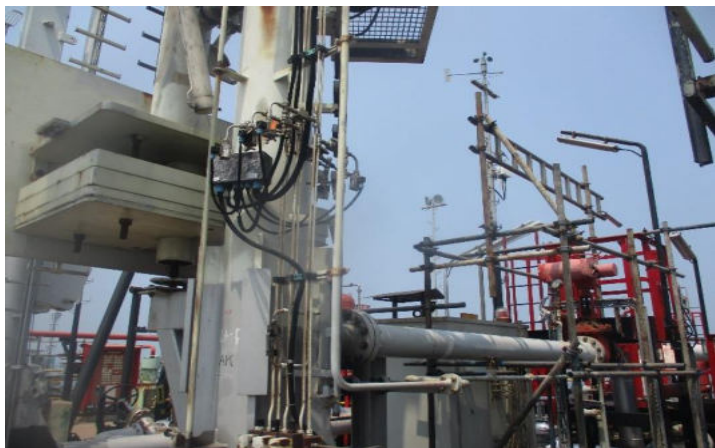
<p>Name of part:</p> <p>1"-LA-P vapor return</p> <p>Findings:</p> <p>Normal condition</p>

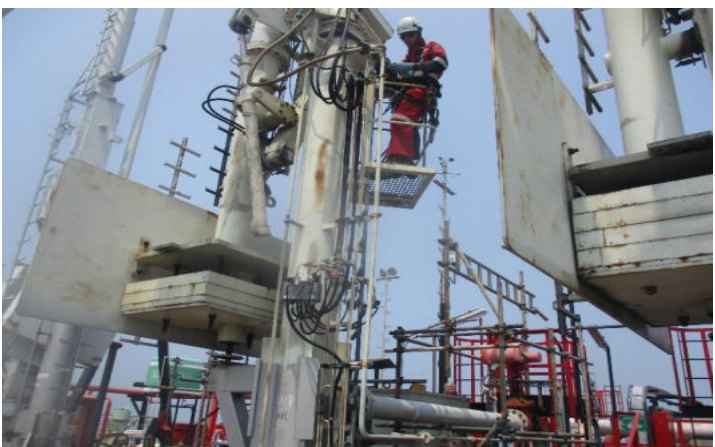
<p>Name of part:</p> <p>1"-LA-P vapor return</p> <p>Findings:</p> <p>Normal condition</p>

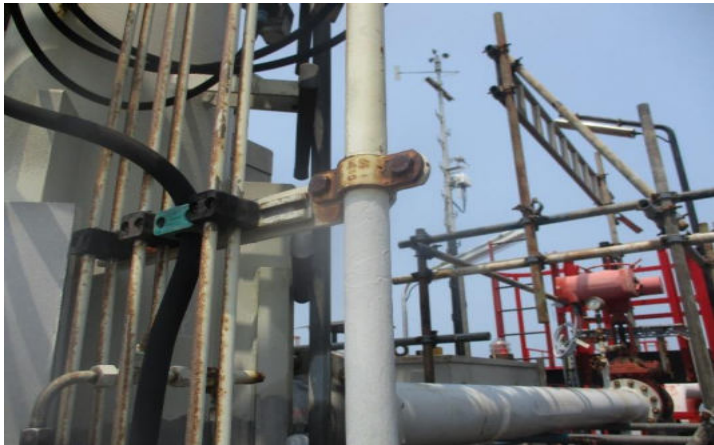
<p>Name of part:</p> <p>1"-LA-P vapor return</p> <p>Findings:</p> <p>Normal condition</p>

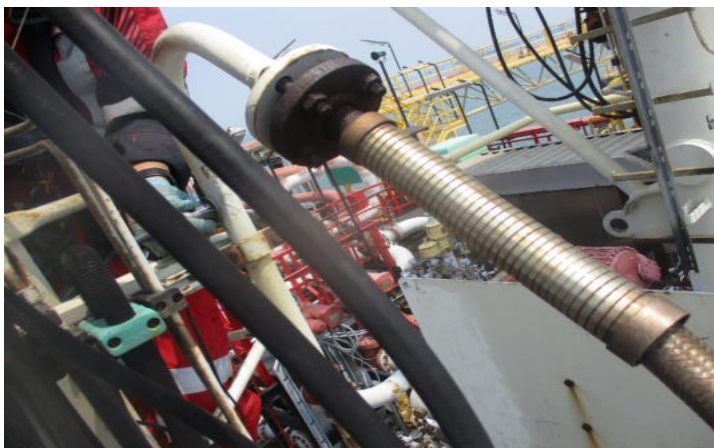
<p>Name of part:</p> <p>1"-LA-P vapor return</p> <p>Findings:</p> <p>Normal condition</p>

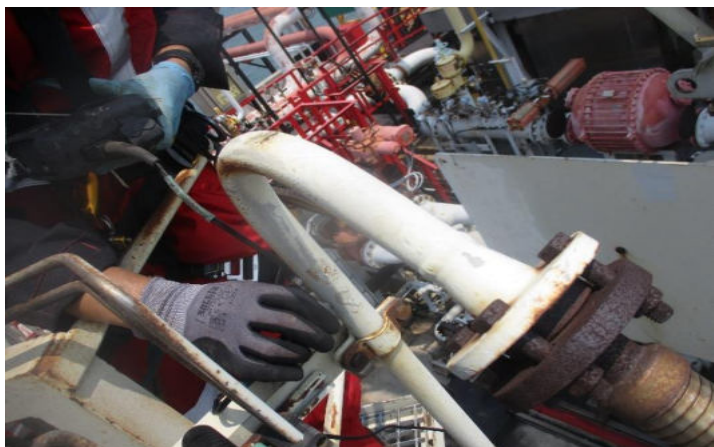
<p>Name of part:</p> <p>1"-LA-P vapor return</p> <p>Findings:</p> <p>Normal condition</p>
