INSPECTION REPORT

**LOADING ARM
BI-1, B-2 AND BI-3**

**ESSO SRIRACHA REFINERY PLANT,
CHONBURI**

18-21 And 24 April 2023
Report No: 2304019_Rev.00

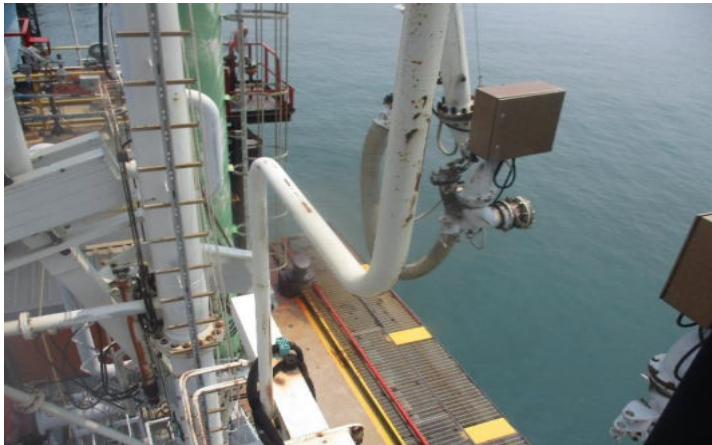
<p>Name of part:</p> <p>1"-LA-P vapor return</p> <p>Findings:</p> <p>Normal condition</p>

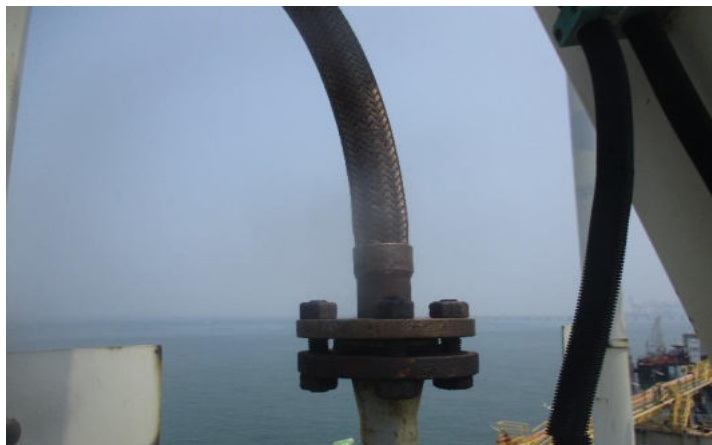
<p>Name of part:</p> <p>1"-LA-P vapor return</p> <p>Findings:</p> <p>Normal condition</p>

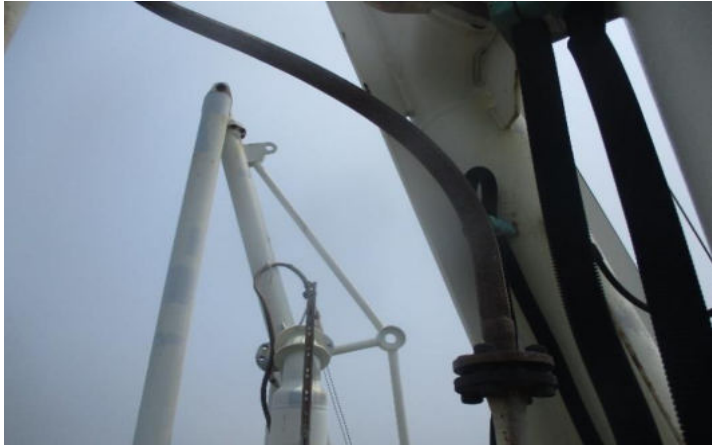
<p>Name of part:</p> <p>1"-LA-P vapor return</p> <p>Findings:</p> <p>Normal condition</p>

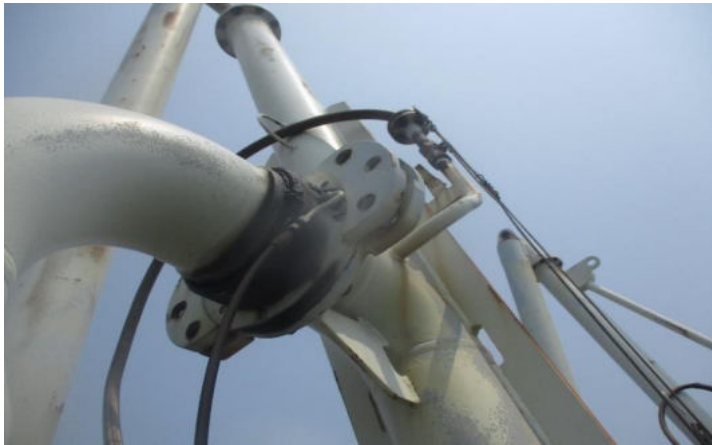
<p>Name of part:</p> <p>1"-LA-P vapor return</p> <p>Findings:</p> <p>Normal condition</p>

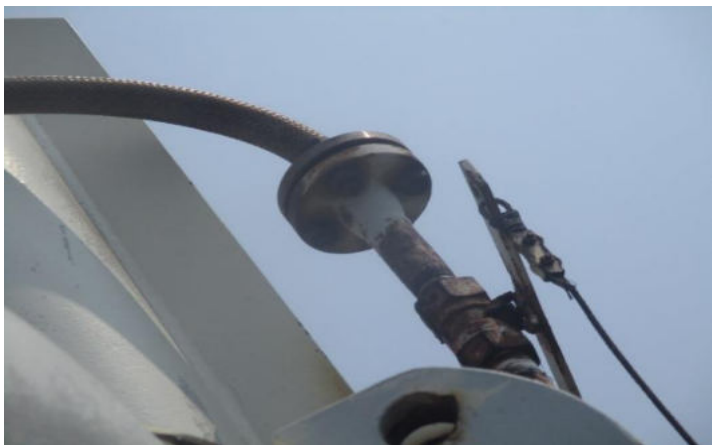
<p>Name of part:</p> <p>1"-LA-P vapor return</p> <p>Findings:</p> <p>Normal condition</p>

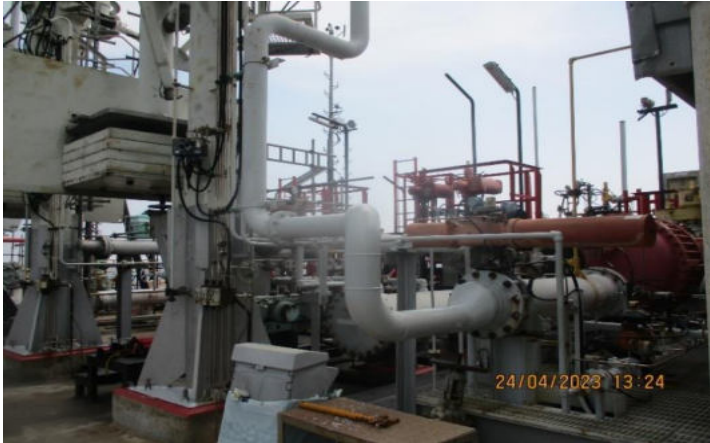
<p>Name of part:</p> <p>6"-LA-B Loading arm</p> <p>Findings:</p> <p>Normal condition</p>

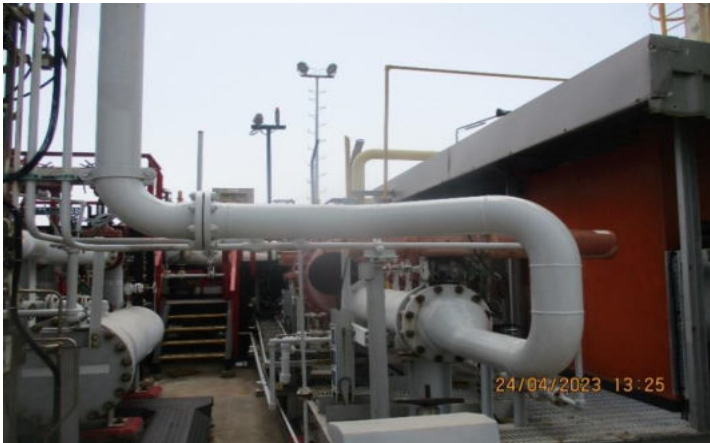
<p>Name of part:</p> <p>6"-LA-B Loading arm</p> <p>Findings:</p> <p>Normal condition</p>

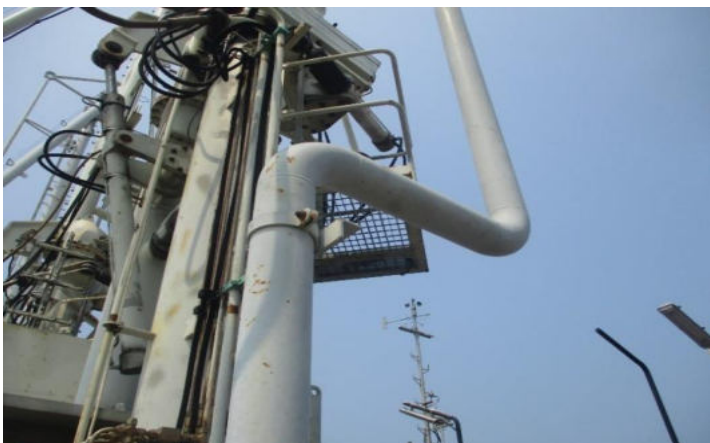
<p>Name of part:</p> <p>6"-LA-B Loading arm</p> <p>Findings:</p> <p>Normal condition</p>

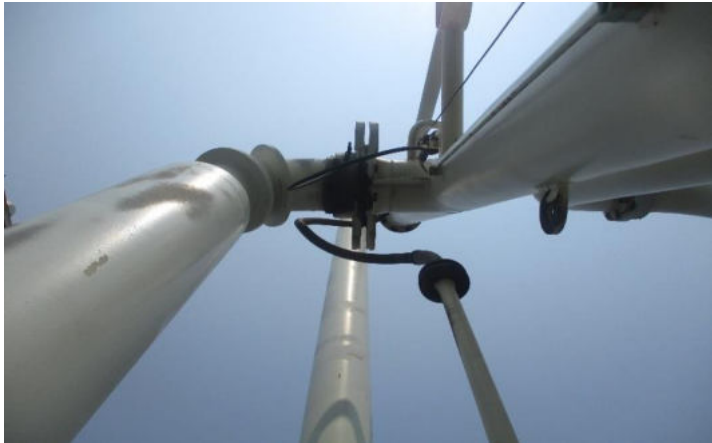
<p>Name of part:</p> <p>6"-LA-B Loading arm</p> <p>Findings:</p> <p>Normal condition</p>

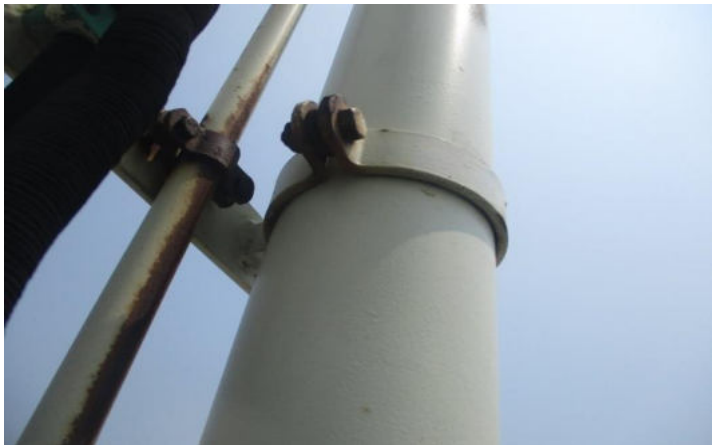
<p>Name of part:</p> <p>6"-LA-B Loading arm</p> <p>Findings:</p> <p>Normal condition</p>

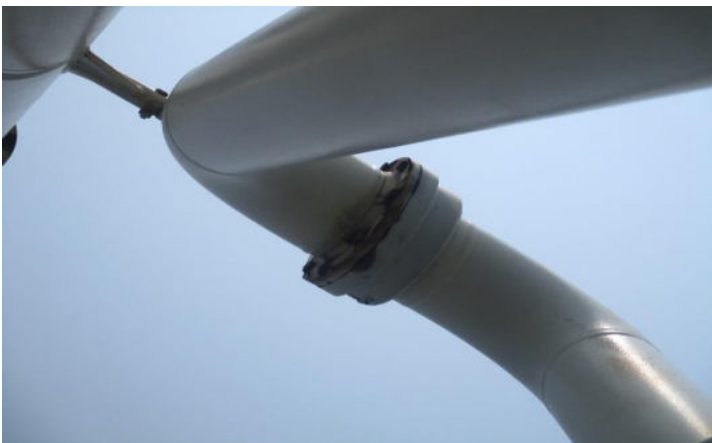
<p>Name of part:</p> <p>6"-LA-B Loading arm</p> <p>Findings:</p> <p>Normal condition</p>

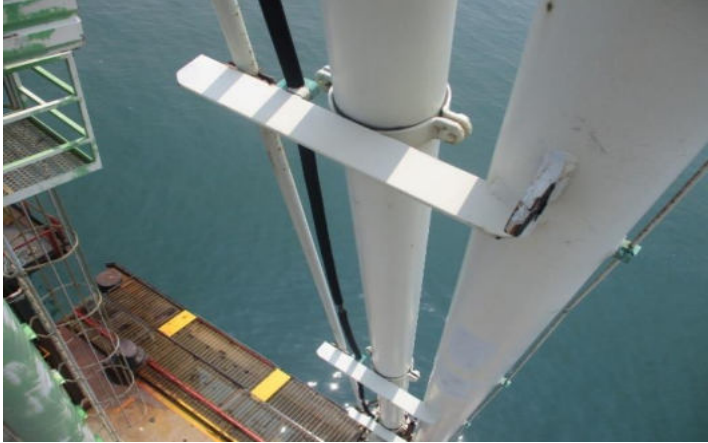
Name of part: 6"-LA-B Loading arm
	Findings: Normal condition

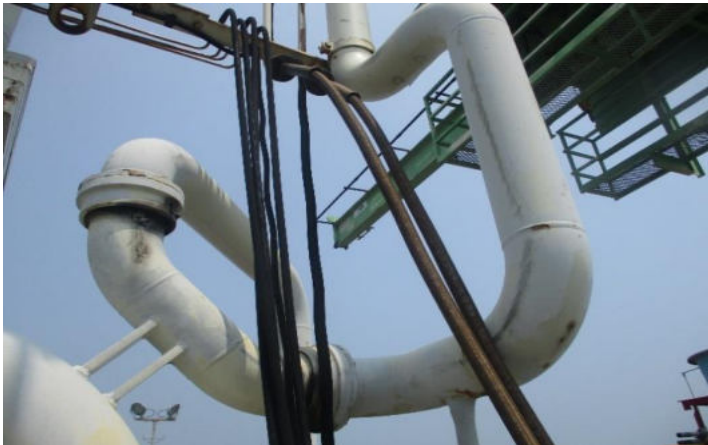
Name of part: 6"-LA-B Loading arm
	Findings: Normal condition

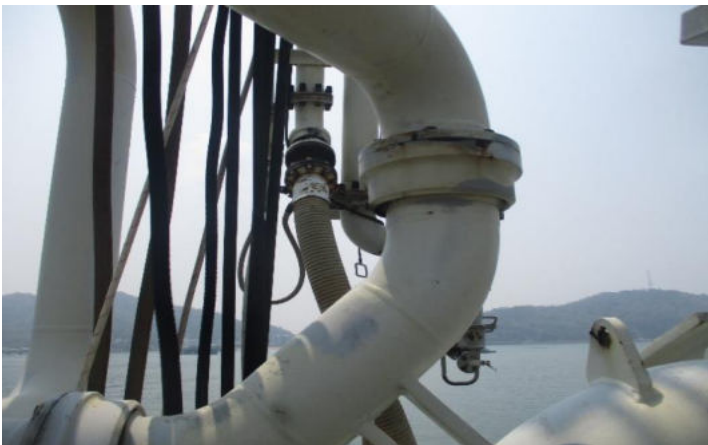
Name of part: 6"-LA-B Loading arm
	Findings: Normal condition

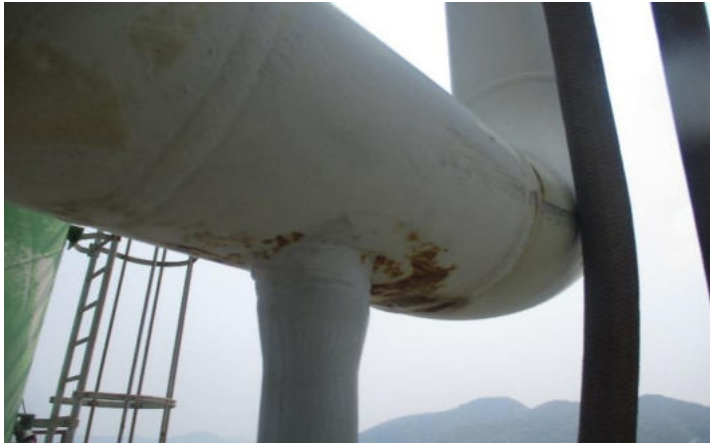
<p>Name of part:</p> <p>6"-LA-B Loading arm</p> <p>Findings:</p> <p>Corrosion on Pipe.</p>

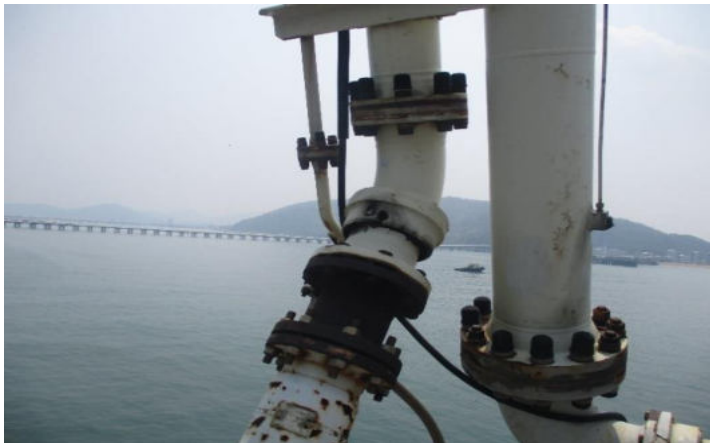
<p>Name of part:</p> <p>6"-LA-B Loading arm</p> <p>Findings:</p> <p>Normal condition</p>

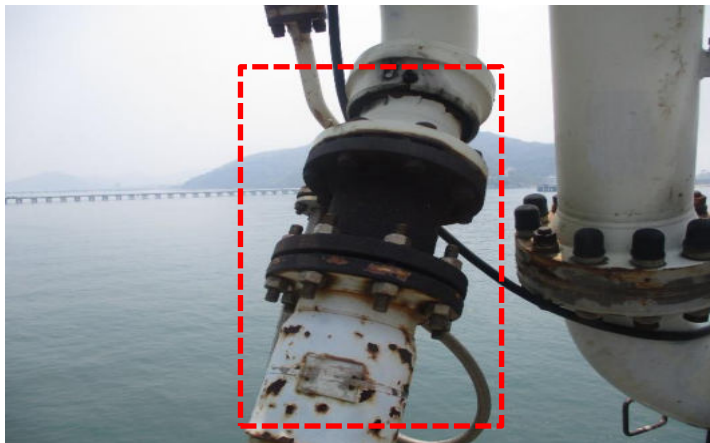
<p>Name of part:</p> <p>6"-LA-B Loading arm</p> <p>Findings:</p> <p>Corrosion on Pipe.</p>

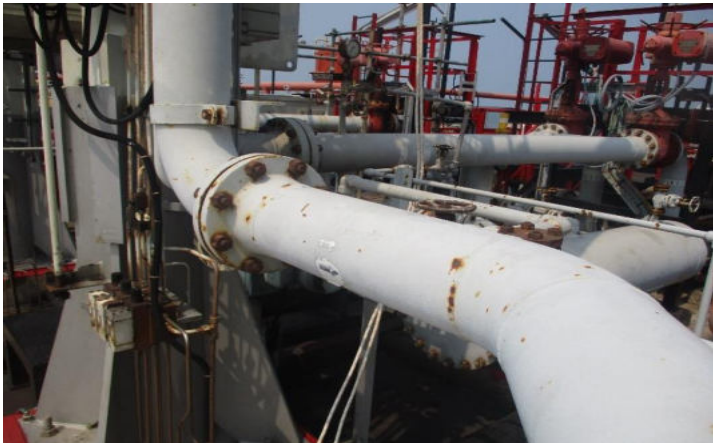
<p>Name of part:</p> <p>6"-LA-B Loading arm</p> <p>Findings:</p> <p>Corrosion on Pipe.</p>

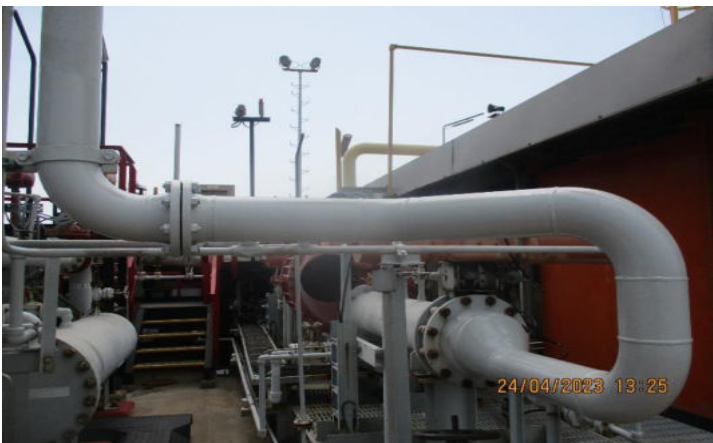
<p>Name of part:</p> <p>6"-LA-B Loading arm</p> <p>Findings:</p> <p>After paint repair</p>

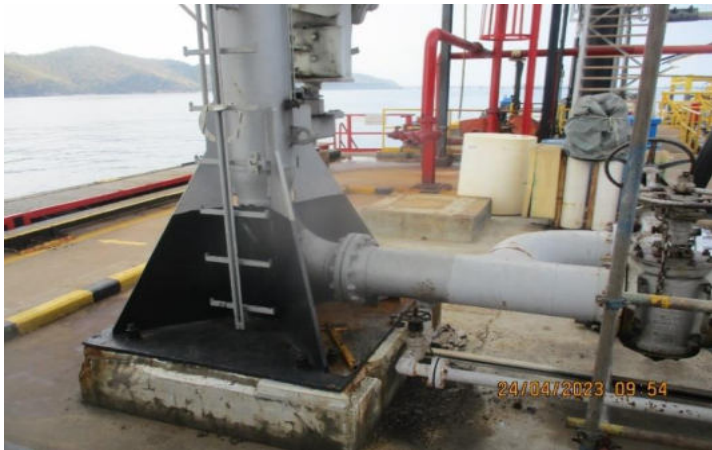
<p>Name of part:</p> <p>8"-LA-1107 A Loading arm</p> <p>Findings:</p> <p>Normal condition</p>

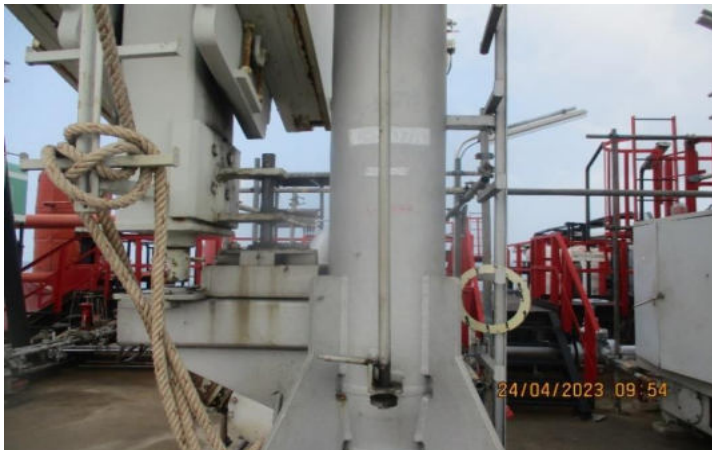
<p>Name of part:</p> <p>8"-LA-1107 A Loading arm</p> <p>Findings:</p> <p>Normal condition</p>

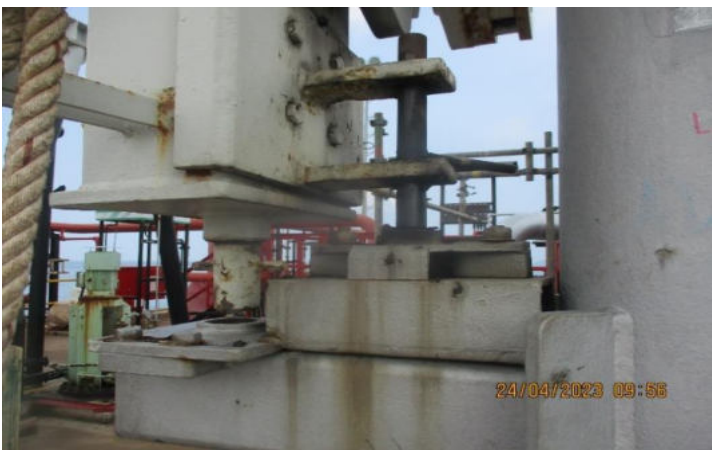
<p>Name of part:</p> <p>8"-LA-1107 A Loading arm</p> <p>Findings:</p> <p>Normal condition</p>

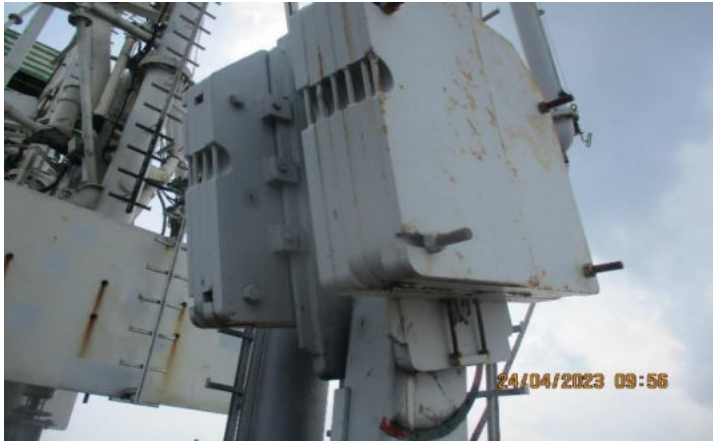
<p>Name of part:</p> <p>8"-LA-1107 A Loading arm</p> <p>Findings:</p> <p>Normal condition</p>

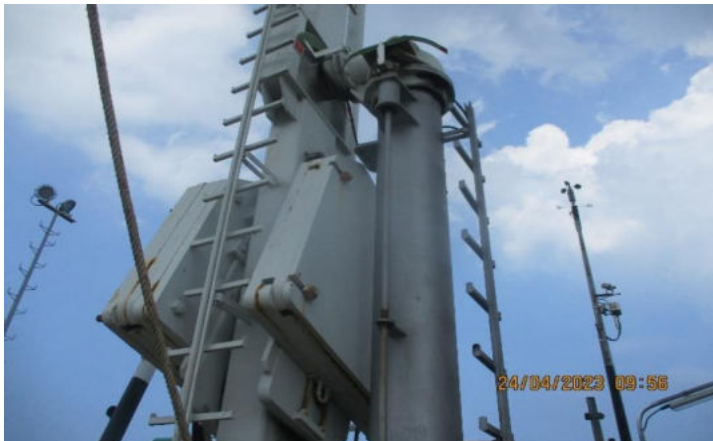
<p>Name of part:</p> <p>8"-LA-1107 A Loading arm</p> <p>Findings:</p> <p>Normal condition</p>

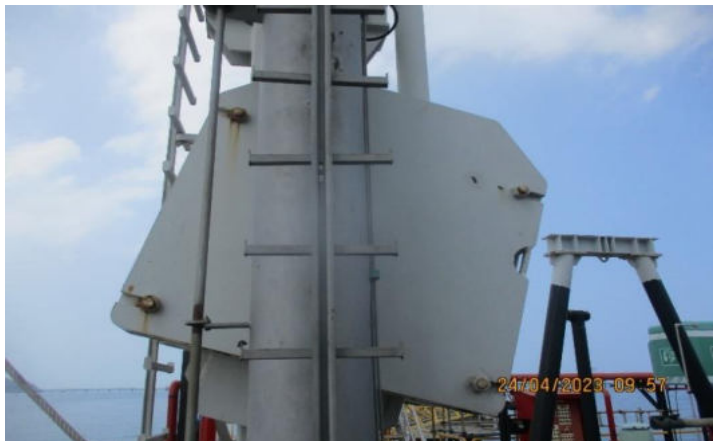
<p>Name of part:</p> <p>8"-LA-1107 A Loading arm</p> <p>Findings:</p> <p>Normal condition</p>

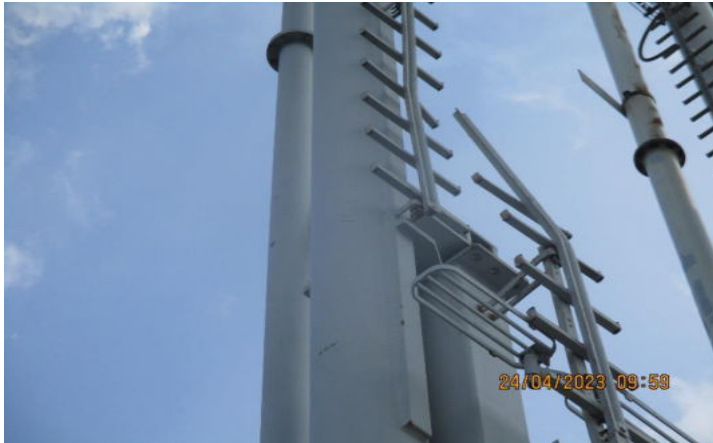
<p>Name of part:</p> <p>8"-LA-1107 A Loading arm</p> <p>Findings:</p> <p>Normal condition</p>

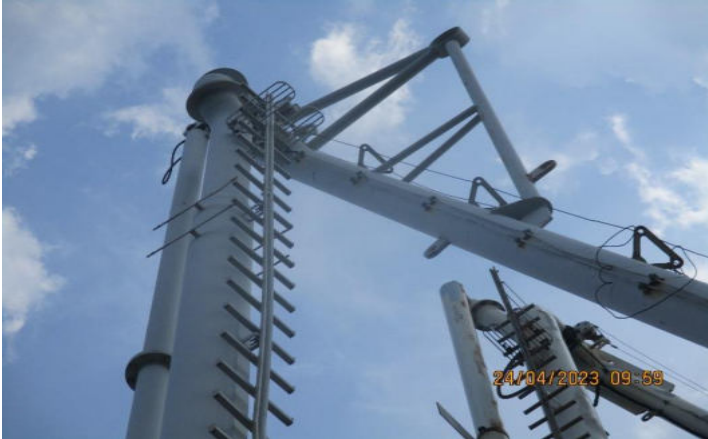
<p>Name of part:</p> <p>8"-LA-1107 A Loading arm</p> <p>Findings:</p> <p>Normal condition</p>

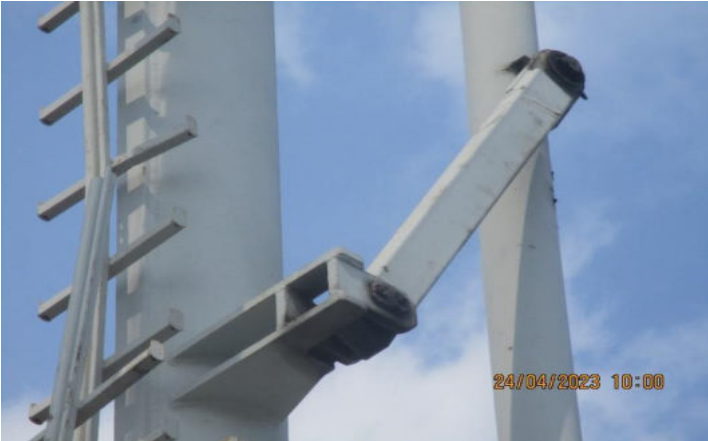
<p>Name of part:</p> <p>8"-LA-1107 A Loading arm</p> <p>Findings:</p> <p>Normal condition</p>

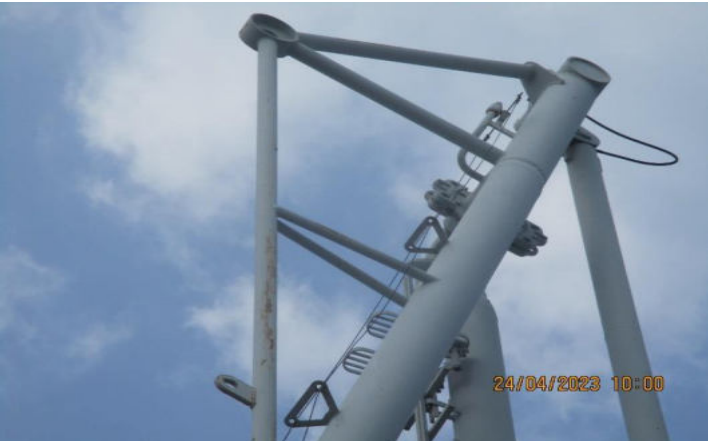
<p>Name of part:</p> <p>8"-LA-1107 A Loading arm</p> <p>Findings:</p> <p>Normal condition</p>

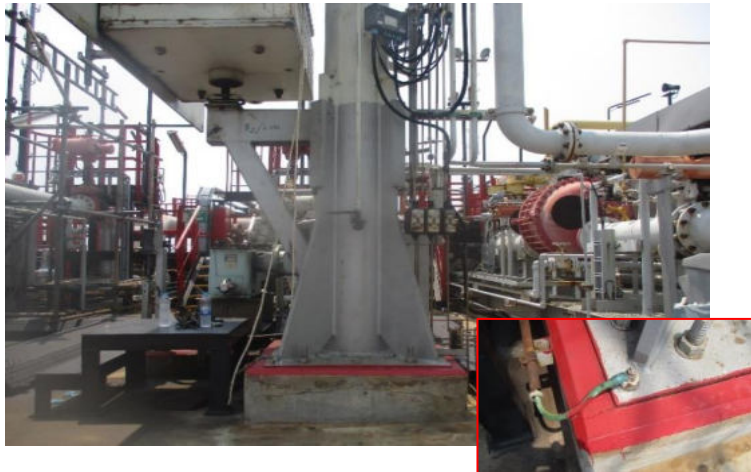
<p>Name of part:</p> <p>8"-LA-B Loading arm</p> <p>Findings:</p> <p>Normal condition</p>

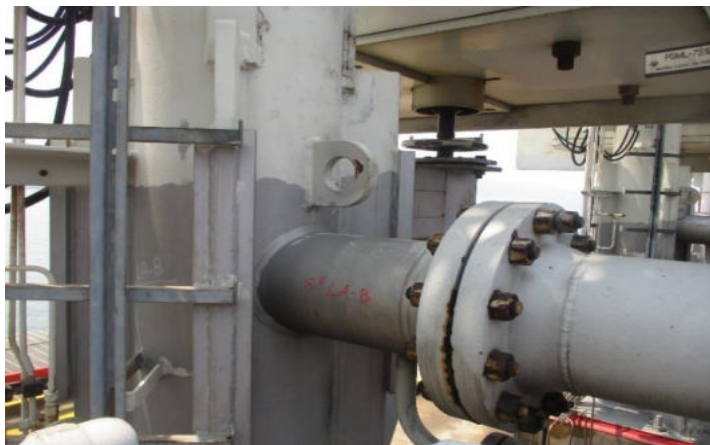
<p>Name of part:</p> <p>8"-LA-B Loading arm</p> <p>Findings:</p> <p>Normal condition</p>

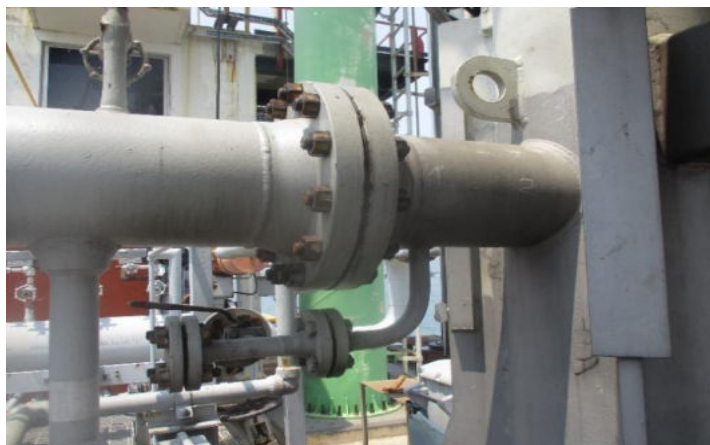
<p>Name of part:</p> <p>8"-LA-B Loading arm</p> <p>Findings:</p> <p>Normal condition</p>

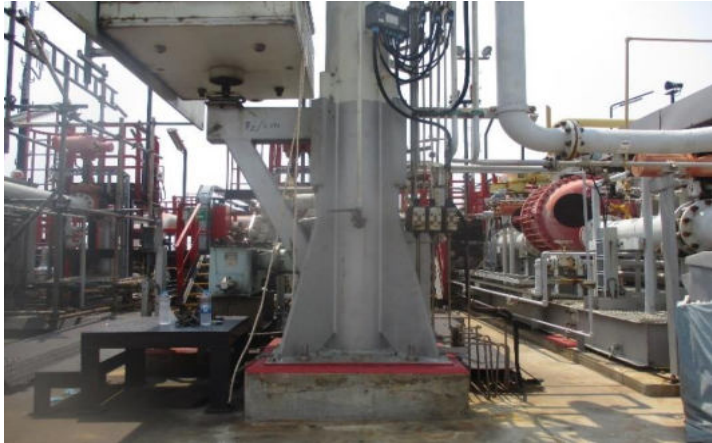
<p>Name of part:</p> <p>8"-LA-B Loading arm</p> <p>Findings:</p> <p>Normal condition</p>

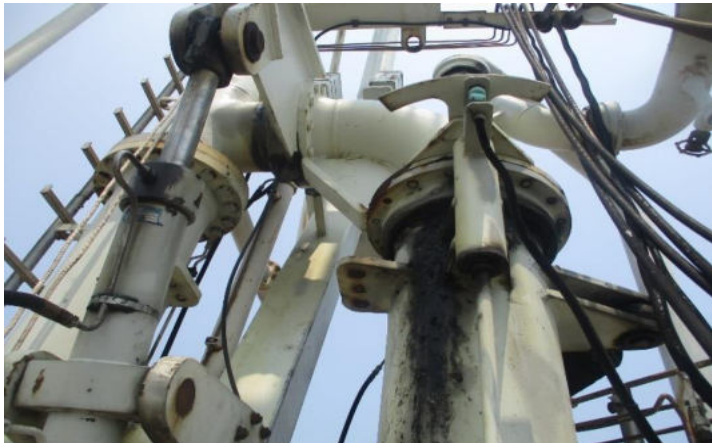
<p>Name of part:</p> <p>8"-LA-B Loading arm</p> <p>Findings:</p> <p>Normal condition</p>

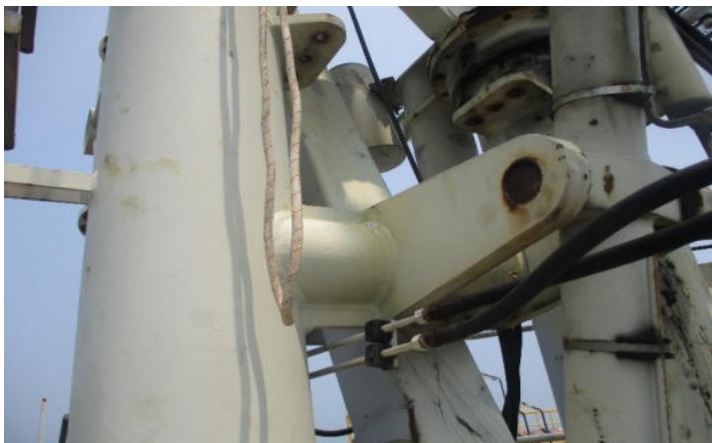
<p>Name of part:</p> <p>8"-LA-B Loading arm</p> <p>Findings:</p> <p>Normal condition</p>

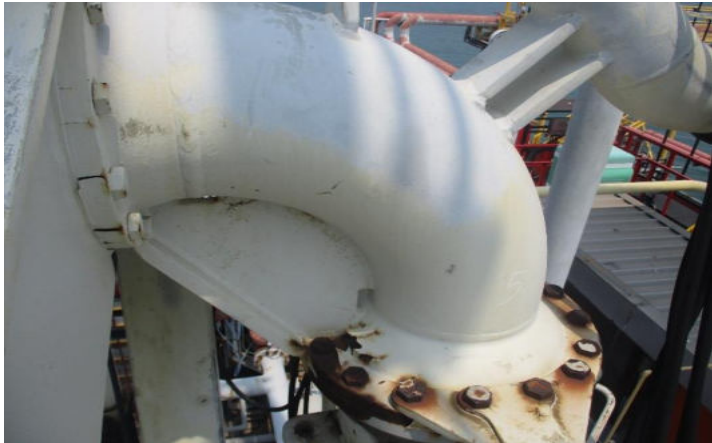
<p>Name of part:</p> <p>8"-LA-B Loading arm</p> <p>Findings:</p> <p>Corrosion on stud bolt & nuts area.</p>

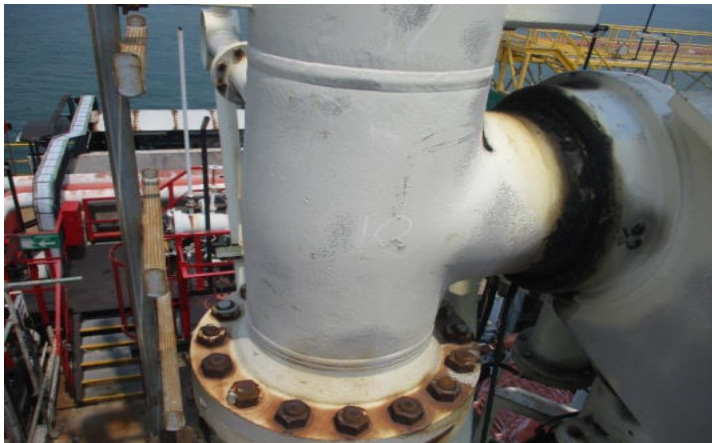
<p>Name of part:</p> <p>8"-LA-B Loading arm</p> <p>Findings:</p> <p>Corrosion on stud bolt & nuts area.</p>

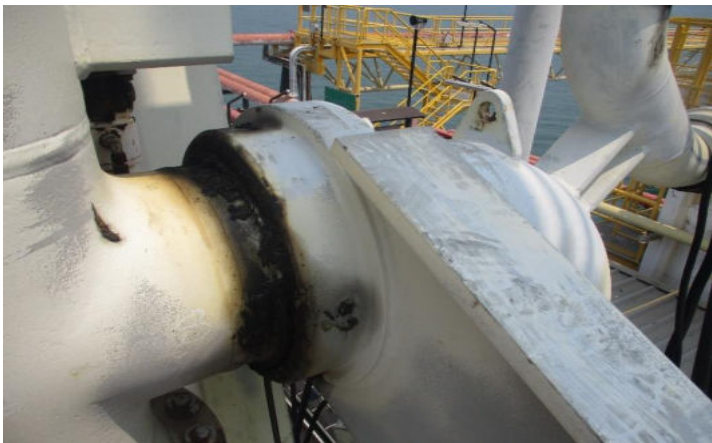
<p>Name of part:</p> <p>8"-LA-B Loading arm</p> <p>Findings:</p> <p>Normal condition</p>

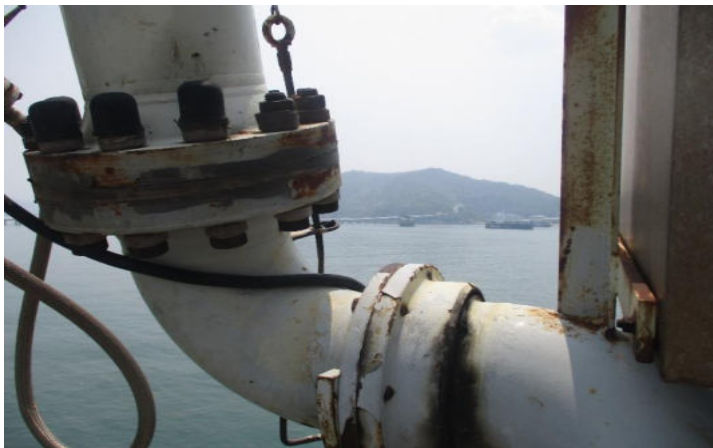
<p>Name of part:</p> <p>8"-LA-B Loading arm</p> <p>Findings:</p> <p>Normal condition</p>

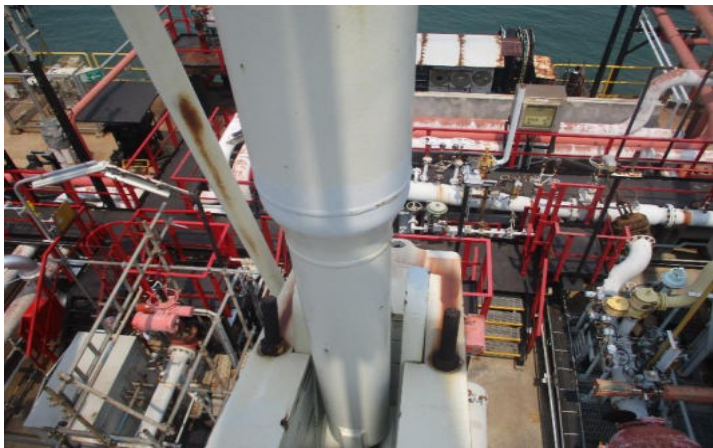
<p>Name of part:</p> <p>8"-LA-B Loading arm</p> <p>Findings:</p> <p>Normal condition</p>

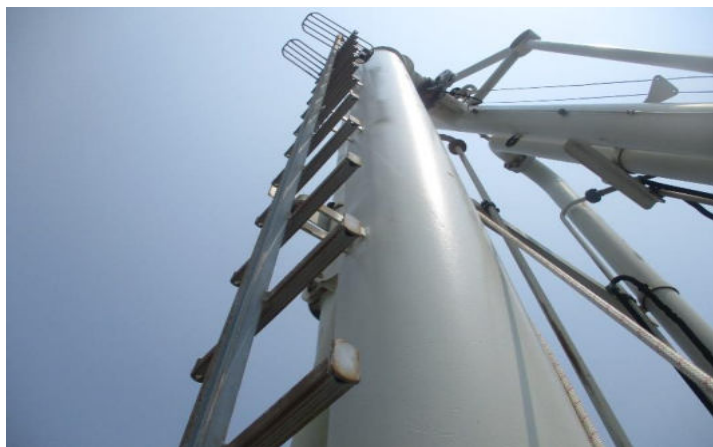
<p>Name of part:</p> <p>8"-LA-B Loading arm</p> <p>Findings:</p> <p>Normal condition</p>

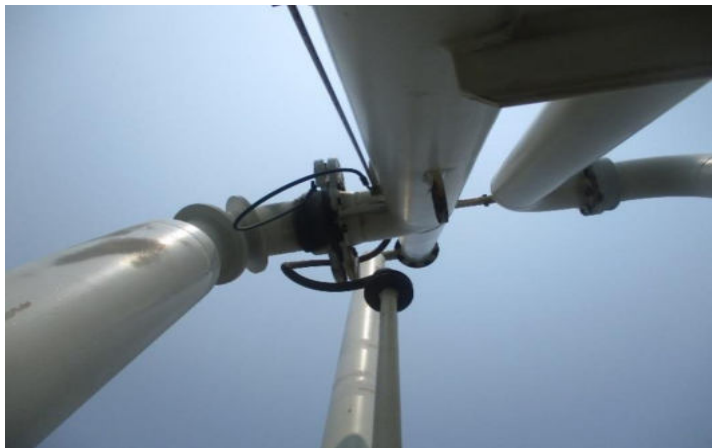
<p>Name of part:</p> <p>8"-LA-B Loading arm</p> <p>Findings:</p> <p>Normal condition</p>

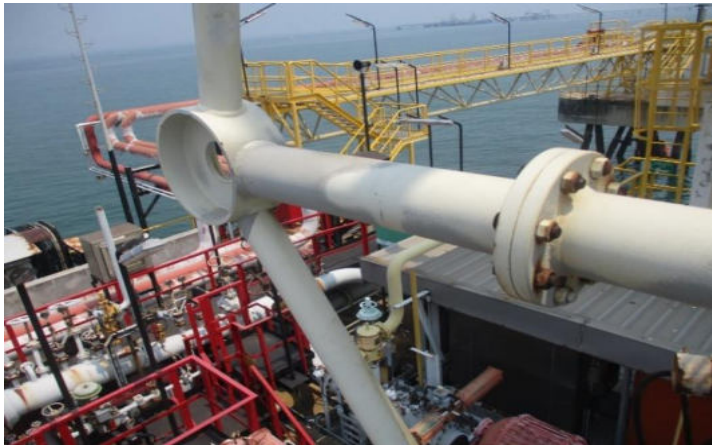
<p>Name of part:</p> <p>8"-LA-B Loading arm</p> <p>Findings:</p> <p>Normal condition</p>

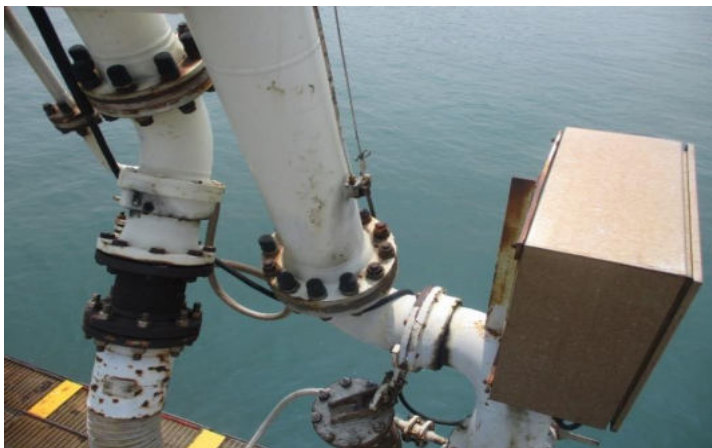
<p>Name of part:</p> <p>8"-LA-B Loading arm</p> <p>Findings:</p> <p>Normal condition</p>

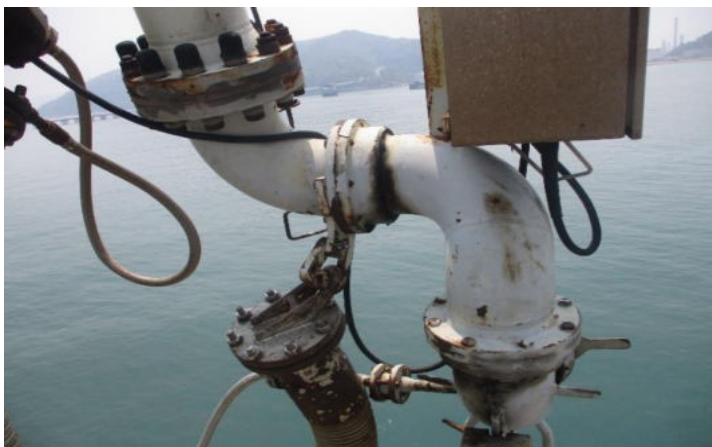
<p>Name of part:</p> <p>8"-LA-B Loading arm</p> <p>Findings:</p> <p>Normal condition</p>

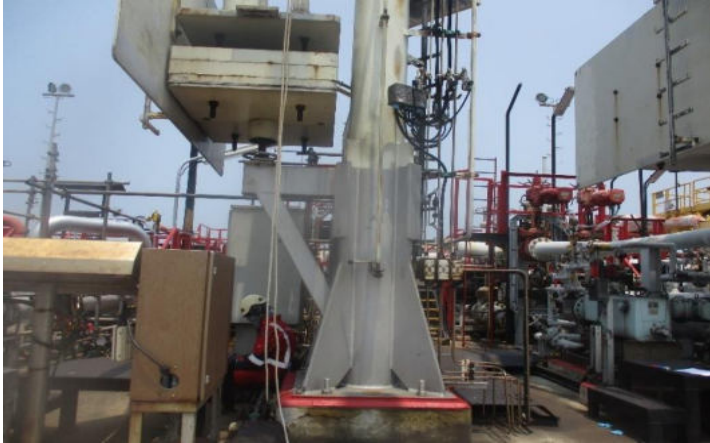
<p>Name of part:</p> <p>8"-LA-P vapor return</p> <p>Findings:</p> <p>Normal condition</p>

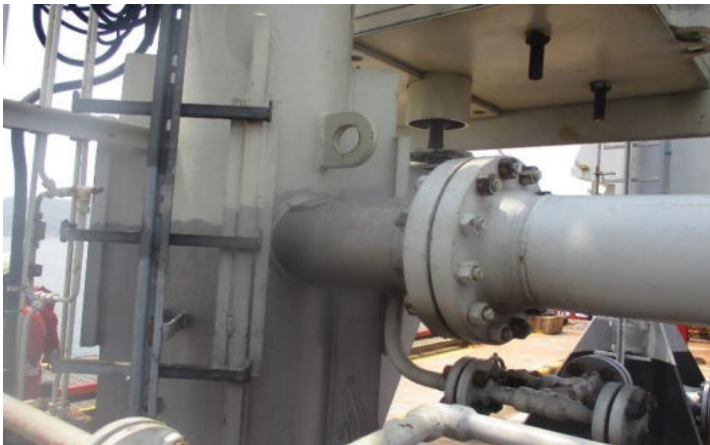
<p>Name of part:</p> <p>8"-LA-P vapor return</p> <p>Findings:</p> <p>Normal condition</p>

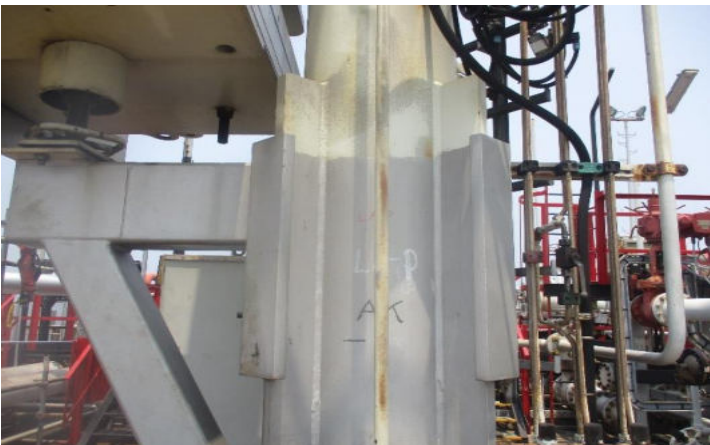
<p>Name of part:</p> <p>8"-LA-P vapor return</p> <p>Findings:</p> <p>Normal condition</p>

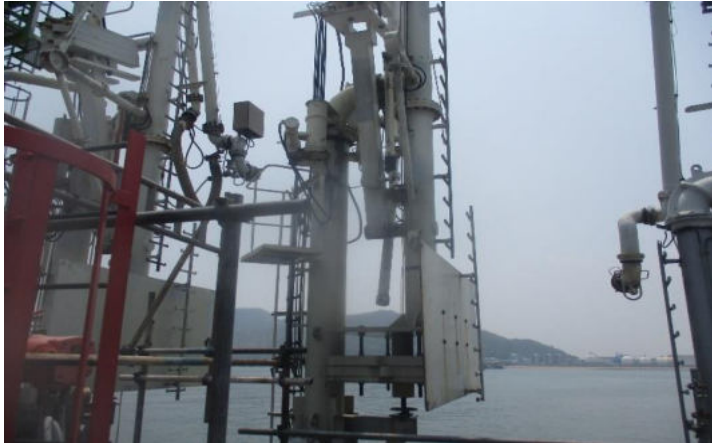
<p>Name of part:</p> <p>8"-LA-P vapor return</p> <p>Findings:</p> <p>Normal condition</p>

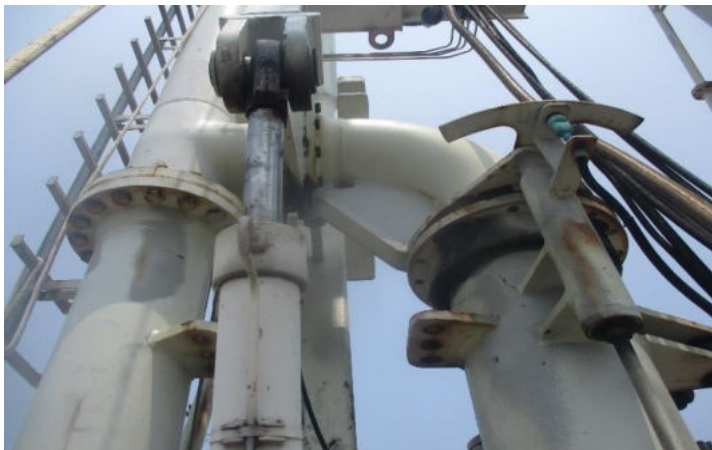
<p>Name of part:</p> <p>8"-LA-P vapor return</p> <p>Findings:</p> <p>Normal condition</p>

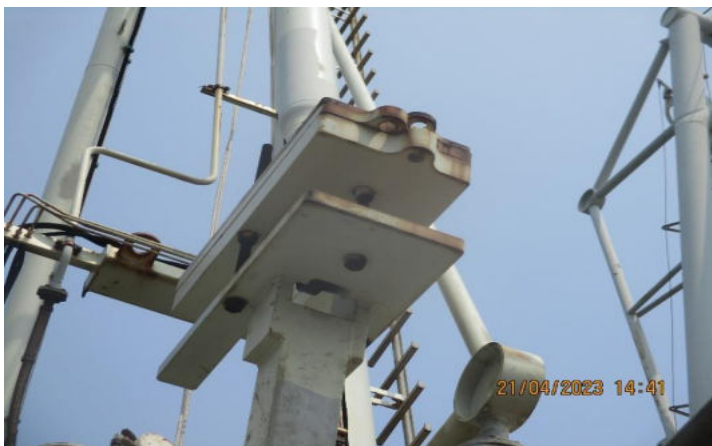
<p>Name of part:</p> <p>8"-LA-P vapor return</p> <p>Findings:</p> <p>Normal condition</p>

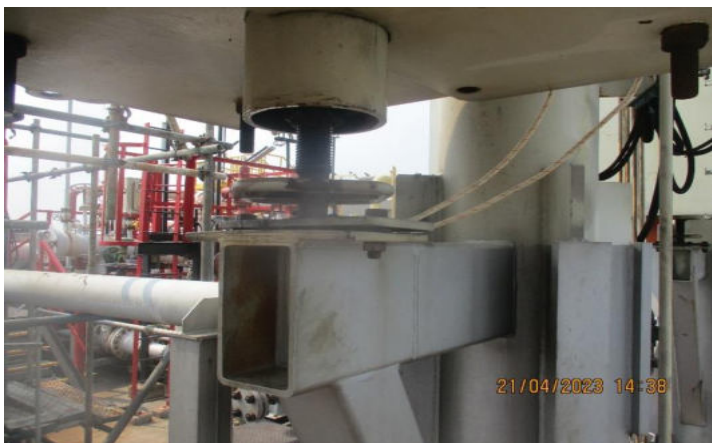
<p>Name of part:</p> <p>8"-LA-P vapor return</p> <p>Findings:</p> <p>Normal condition</p>

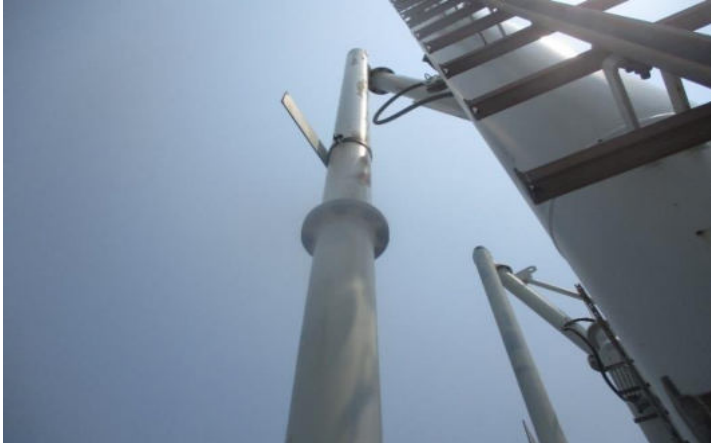
<p>Name of part:</p> <p>8"-LA-P vapor return</p> <p>Findings:</p> <p>Normal condition</p>

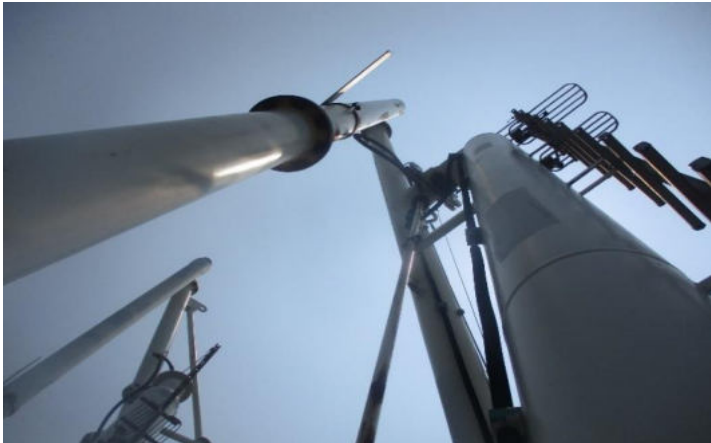
<p>Name of part:</p> <p>8"-LA-P vapor return</p> <p>Findings:</p> <p>Normal condition</p>

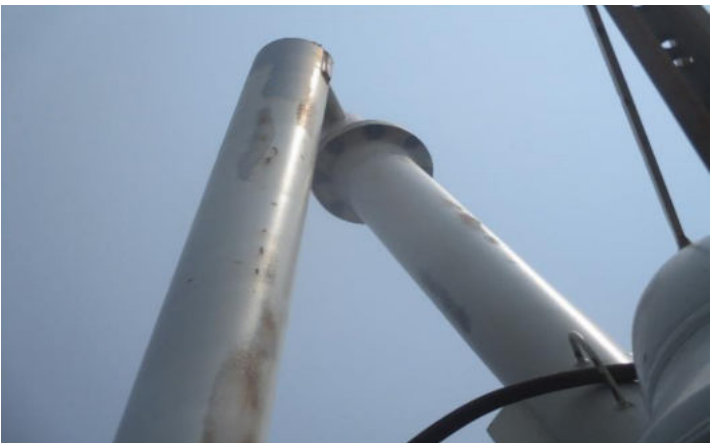
<p>Name of part:</p> <p>8"-LA-P vapor return</p> <p>Findings:</p> <p>Normal condition</p>

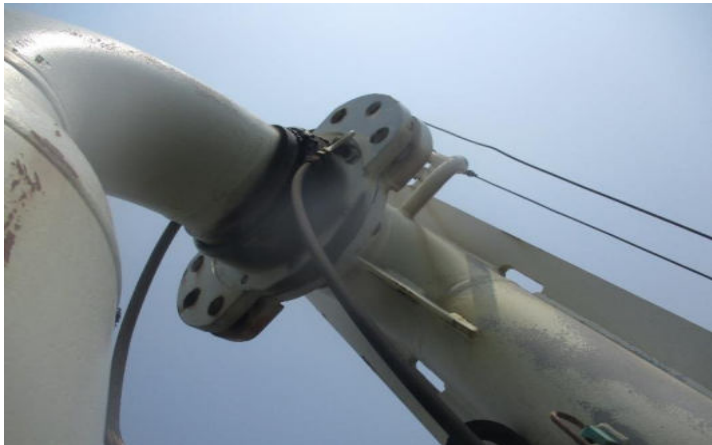
<p>Name of part:</p> <p>8"-LA-P vapor return</p> <p>Findings:</p> <p>Normal condition</p>
