Inspection Report

Subject / Title:
BD000166U02 SSUT, MO-60 KEOH, 2024, Inspection report

: SSUT Bangpoo GT12

: SGT-800

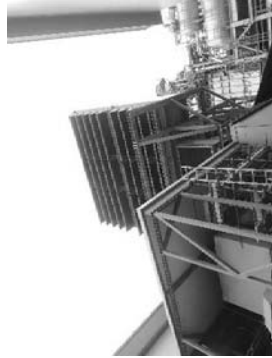
Intake filter housing seen from the ground condition. Intake filter housing elbow duct condition.

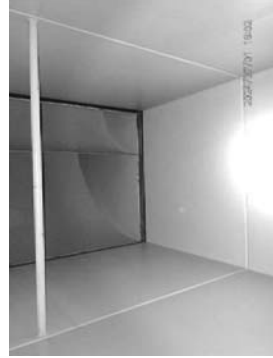
Intake filter housing wall inside overall condition.

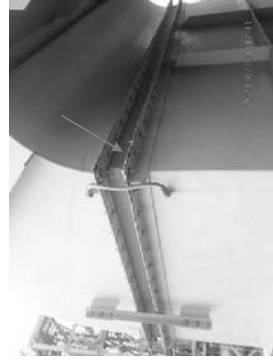
New expansion joint replaced since 2023.

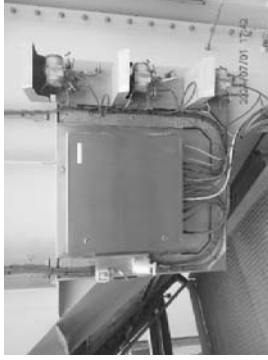
Intake filter housing instrument panel condition.

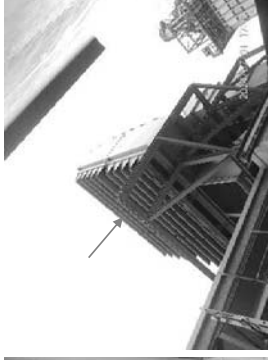
Weather hood intake side overall condition.

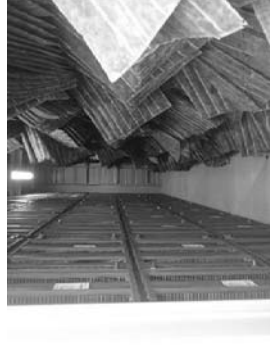
Inside filter housing overall condition.

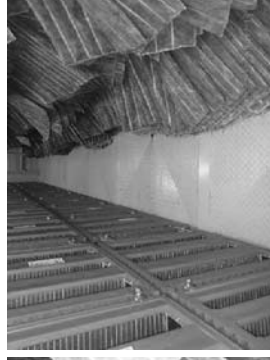
Cleanliness condition on intake housing floor.

- Cleaned filter housing, intake louvers and ventilation filter housing intake louvers.
- When replacing filters elements check for an open gap between filter element rubber seal and filter housing to ensure no unfiltered air can enter.
- Apply rusty protection lubricant on emergency door release mechanism.
- Active exit ventilation damper and monitoring damper condition in every 6 months.
- Removed oxidation on silencer units at top and bottom side by customer.
- Pre and fine filters were replaced during MO'60 inspection.

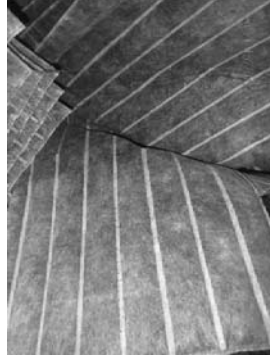
Pre-filter current condition during this outage.

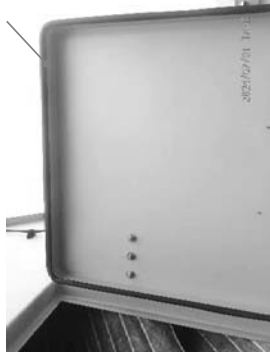
Rubber door seal good condition.

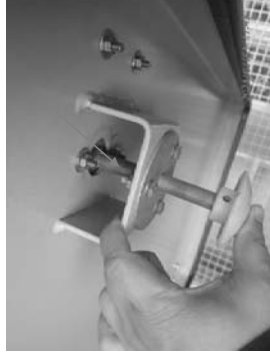
Emergency door release was in good condition.

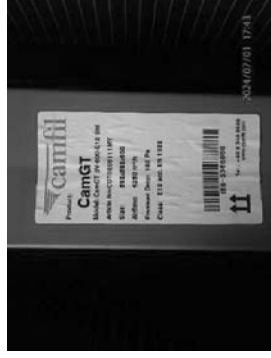
Fine filter element type 3V-600-E12 installed on site.

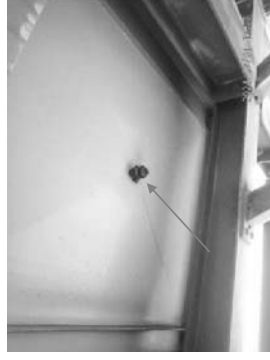
Drain port between pre and fine filter.

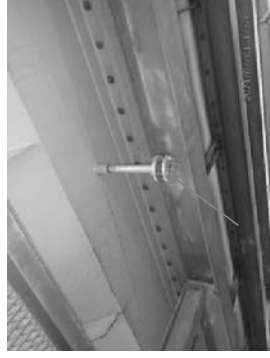
Drain port after fine filter.

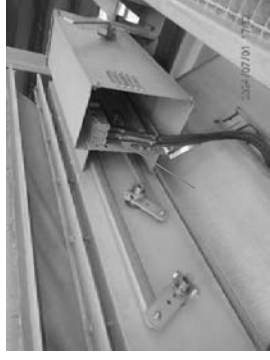
Damper ventilation outside condition.

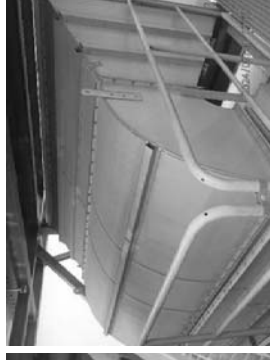
Ventilation filter housing overall condition.

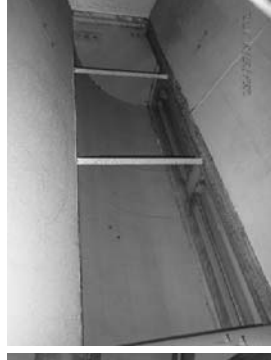
Inlet ventilation to enclosure ducting condition.

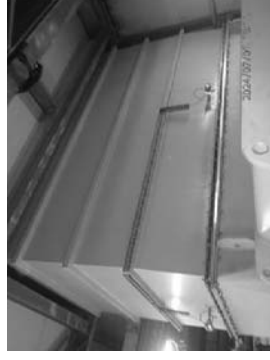
External existing modified silencer duct condition.

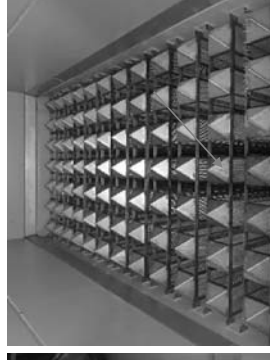
Inside existing silencer duct.

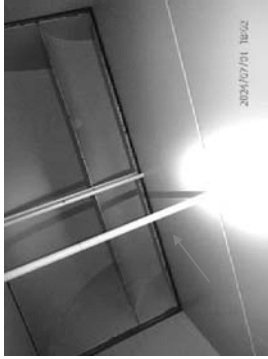
No water trace run from expansion joint at inner wall.

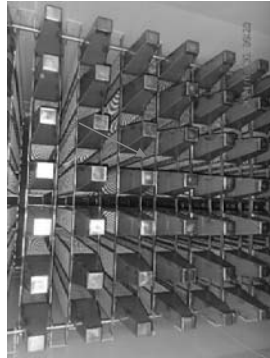
Inside existing silencer duct seen from inlet plenum.

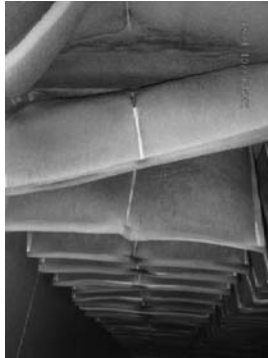
Ventilation filter as found condition.

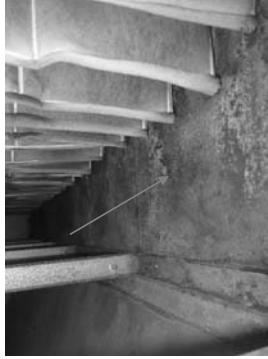
Ventilation filter housing floor condition.

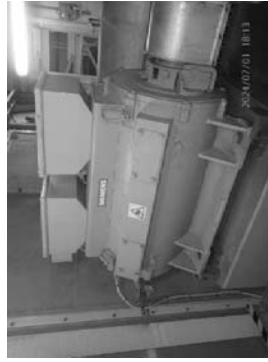
Starter motor overall condition.

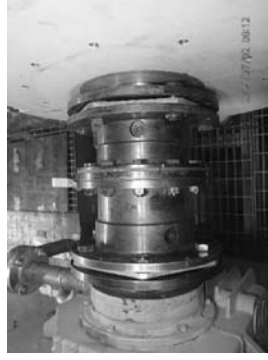
Flexible coupling overall condition.

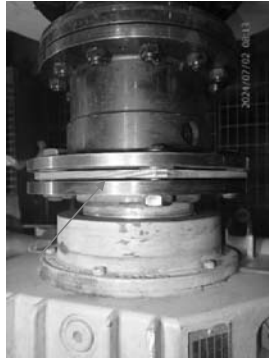
Shim pack at starter motor side condition.

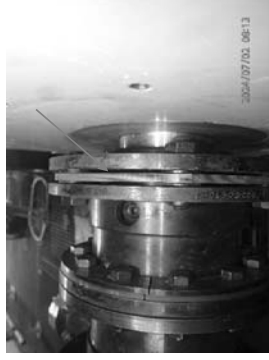
Shim pack at gearbox side condition.

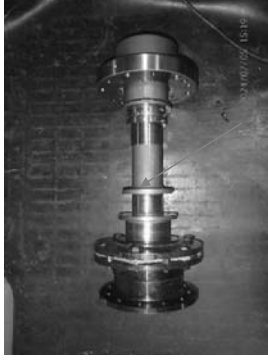
- Mild oil varnish found on SSS-clutch socket and thin layer of varnish on clutches mechanism.

SSS-Clutch overall condition.

- During re-assembly oil varnish found on SSS-Clutch has been cleaned.
- Monitoring lube oil varnish level and upgrade the VRU unit to include particle filtration.

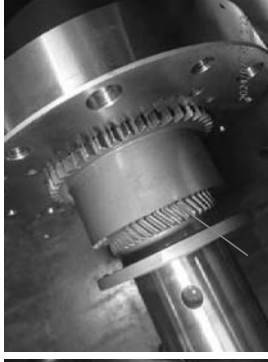
Sliding splines socket after cleaning condition.

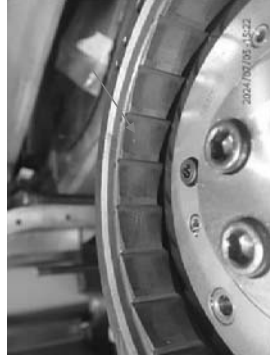
Ratchet side teeth cleaned condition.

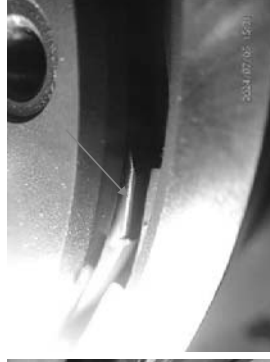
Starter motor clutch paw jaw as found condition.

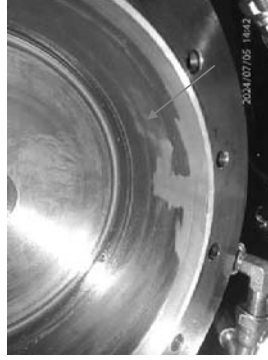
SSS-clutch lube oil chamber varnish condition.

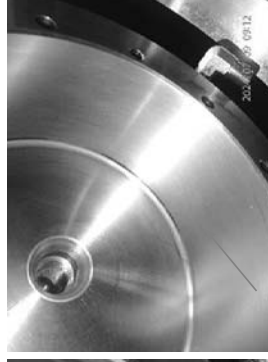
SSS-clutch lube oil chamber cleaned condition.

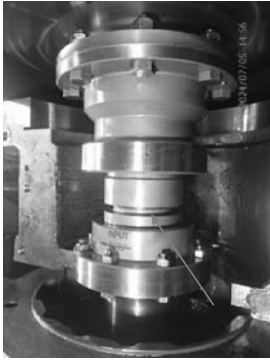
SSS clutch at back up motor side engage function improper.

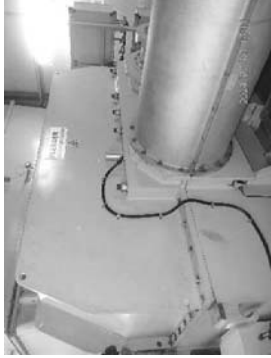
Gearbox casing condition seen from generator.

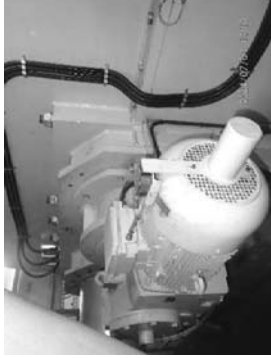
Gearbox casing condition seen from backup barring motor.

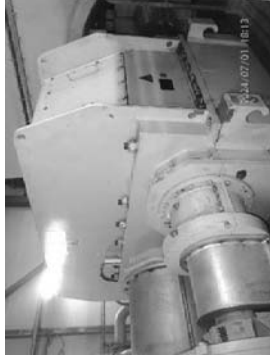
Gearbox casing condition seen from starter motor.

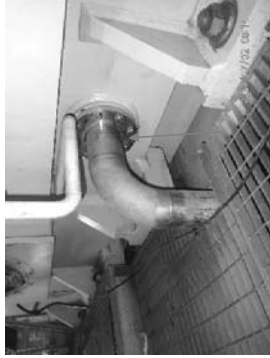
Lube oil supply line.

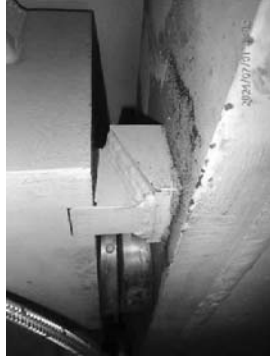
Example of foundation support and keys condition.

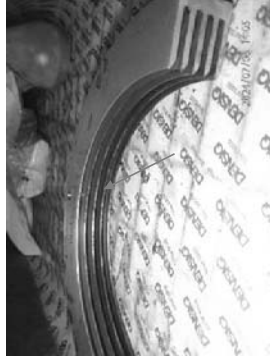
Oil seal with casing as found condition.

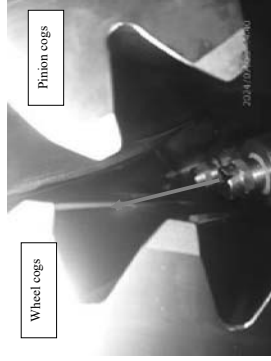
- Lube oil spray bar at bottom was misalign from engage point of gear teeth.

Oil spray bar previous angle incorrect position.

- Clean bottom casing section of the gear casing before reassembly.
- Replaced 4 jacking oil hoses.
- Adjusted lube oil spray bar to correct position according to engineering recommendation.

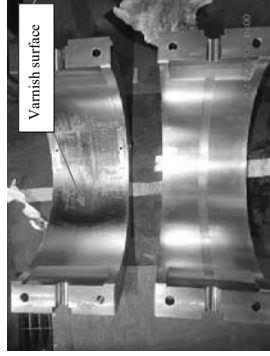
Bearing 11 overall condition before clean.

- All bearings surfaces have been cleaned from oil varnish film.
- Replaced bearing# 11 (ICSA21751-1), #12 (ICSA21763-1) with new condition.

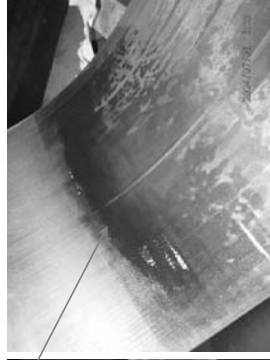
- Oil varnish deposit found on all 4 bearings surface.
- Observed bearing#21 surface changes at the bearing top surface in "push" direction.
- Some minor scratches were found.
- Observed bearing#12 surface changes at the bearing top surface in "push" direction.
- Overheated at loaded bearing area causing the babbit metal to be starting melted.
- Bearing#12 clearance is out of criteria.
- Gearbox supervisor measurement bearing#11 clearance is out of criteria.

Bearing 11 bottom-half with varnish condition.

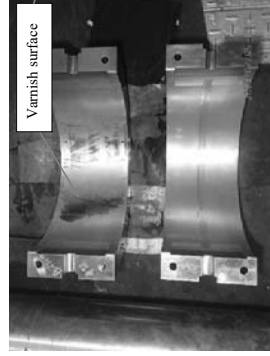
Bearing 12 overall condition before clean.

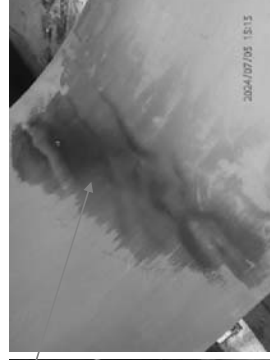
Bearing 12 bottom half with varnish condition.

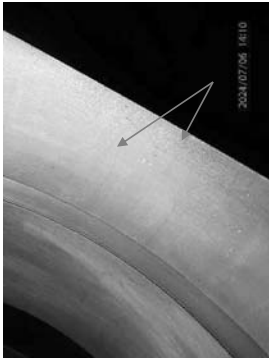
Bearing 12 bottom half found unsmooth surface.

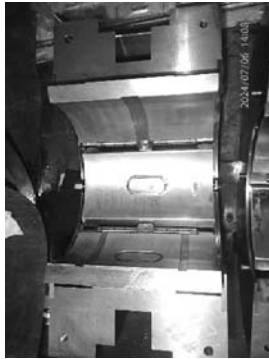
Bearing 21 bottom half overall condition before clean.

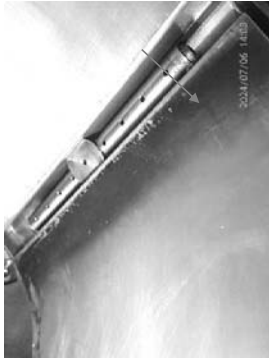
Bearing 21 top half varnish condition.

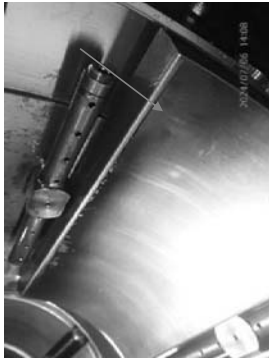
Bearing 21 top half varnish condition.

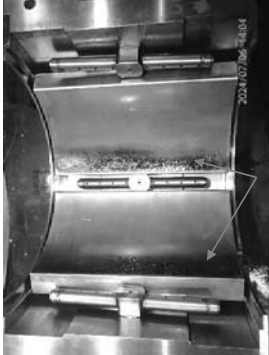
Bearing 22 top half overall condition before clean.

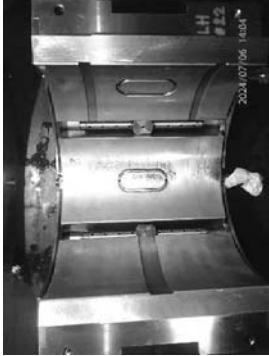
Bearing 22 bottom half overall condition before clean.

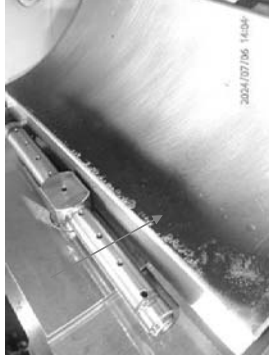
Bearing 22 bottom half cleaned condition.

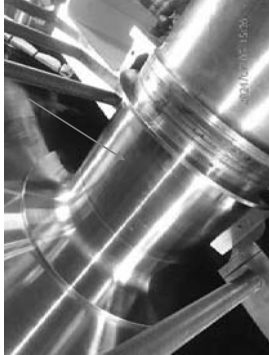
Low speed journal area on wheel shaft as found condition.

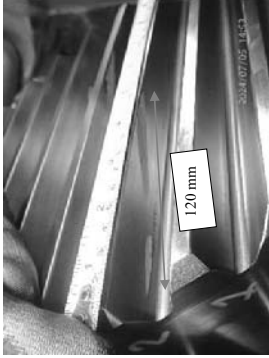
- Electro discharge marks observed at wheel and pinion cogs these marks have recorded.
- Erosion area observed at all wheel cogs active face drive end side. (Generator)
- The pitting defects was observed by FMT on erosion area.

Ref#2 electro discharge on wheel cogs (Gen side)

- Keep monitor electro discharge mark at wheel and pinion cogs turbine sides every next RMI inspection.
- Change the lube oil filters and lower the lube oil pressure to 170 kPa (to be verified with clean filters). The lube oil quality needs to be monitored regularly.
- A follow up inspection is required after 10000 OH where the progression of erosion on the marked cogs needs to be documented using macro pictures. Depending upon the result of the follow up, it may be required to grind the cogs.
- Considering that PAB/SGT-800/23-001 Flender gearbox recommendation regarding increased risk of wheel slippage is applicable for this gearbox, it is recommended that a spare wheel set be planned for contingency.

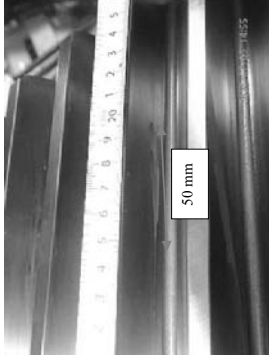
Ref#4 electro discharge on wheel cogs (Gen side)

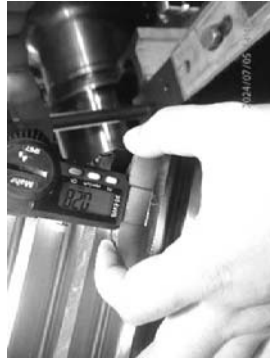
Example corrosion area depth about 0.28 mm.

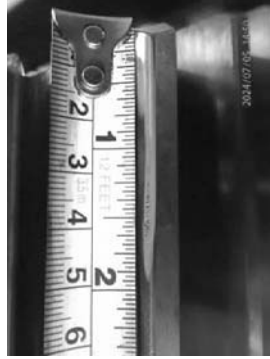
Example corrosion area length about 19 mm.

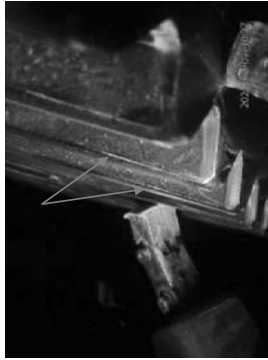
Example FMT photos on suspect wheel cogs area that shown relevant indications (Pitting)

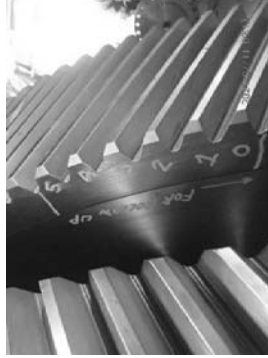
Reference location 6 positions at wheel cog are same erosion and electro discharge.

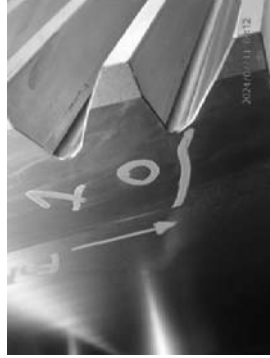
Reference position 0 with macro photos that use to follow up next 10,000 EOH.

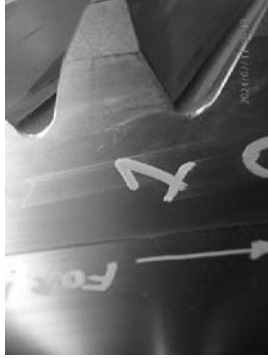
Reference position 1 with macro photos that use to follow up next 10,000 EOH.

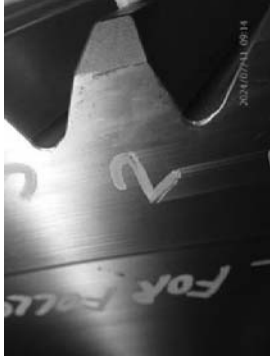
Reference position 2 with macro photos that use to follow up next 10,000 EOH.

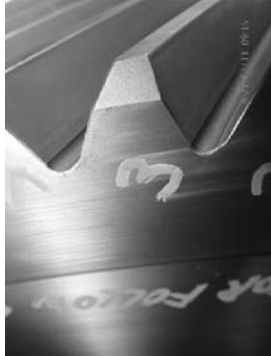
Reference position 3 with macro photos that use to follow up next 10,000 EOH.

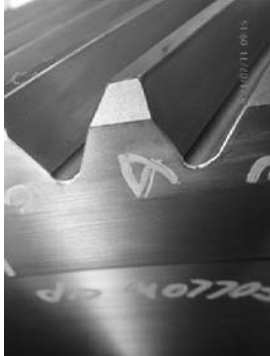
Reference position 4 with macro photos that use to follow up next 10,000 EOH.

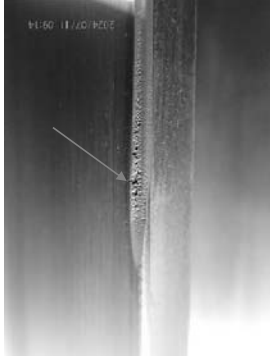
Reference position 5 with macro photos that use to follow up next 10,000 EOH.

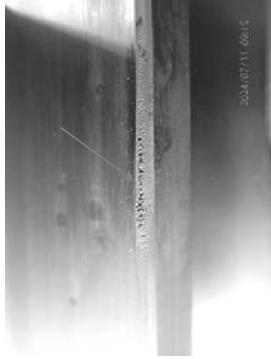
Reference position 6 with macro photos that use to follow up next 10,000 EOH.

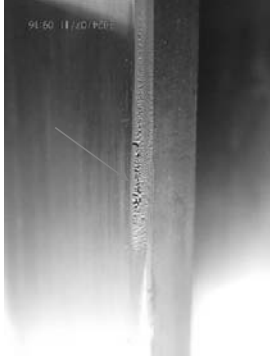
Reference position 7 with macro photos that use to follow up next 10,000 EOH.

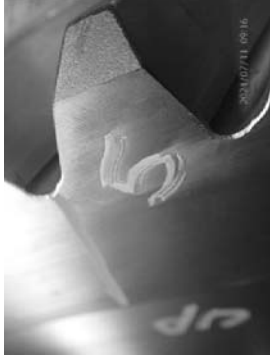
Reference position 8 with macro photos that use to follow up next 10,000 EOH.

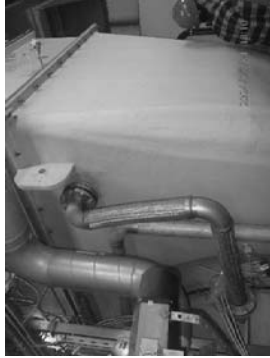
Inlet casing seen from left turbine side.

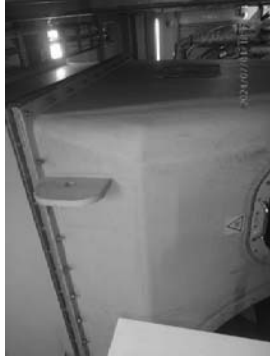
Inlet casing seen from right turbine side.

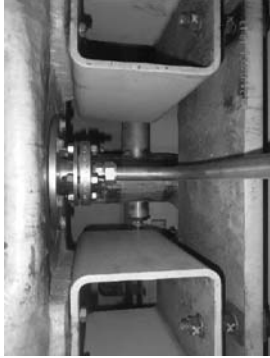
Inlet casing drain overall condition.

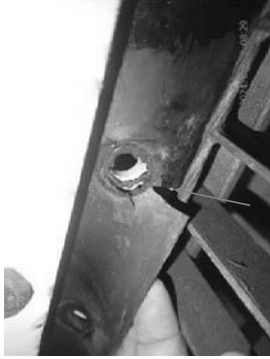
- Observed thread insert nuts not flat with inlet plenum inspection hatch area.
- Observed damaged at rubber gasket at inspection hatch.

Rubber seal was damaged condition.

- Clean and remove rusty inside of inlet plenum casing before unit back to operation.
- Replaced new rubber gasket at inspection hatch.
- Repaired thread inserts nuts according to instruction ICS167727.

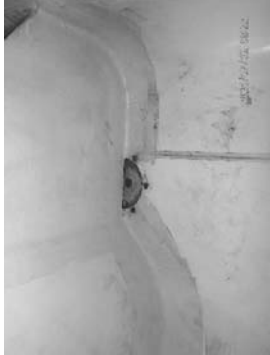
Inlet casing drain area seen from inside.

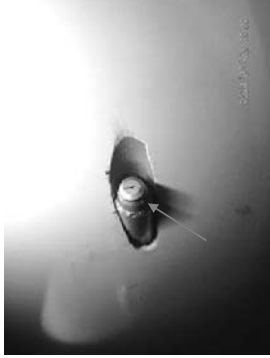
Compressor washing nozzle are good condition.

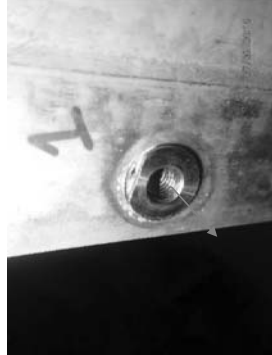
Example threaded insert nuts as found condition not flat with casing.

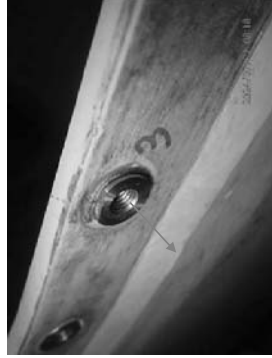
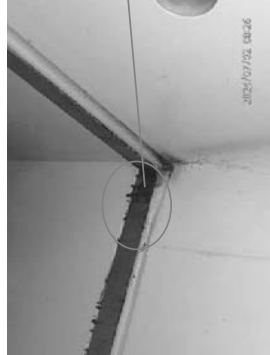
Example rusty observed inside inlet plenum at connecting joint duct between silencer and plenum.

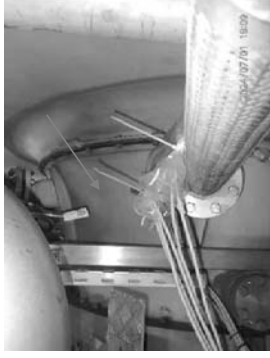
Inlet piece external condition seen from left side.

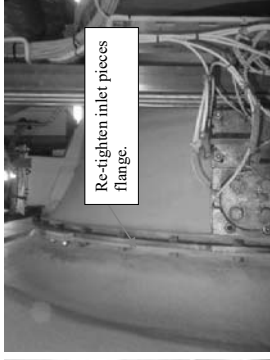
Inlet piece external condition seen from right side.

Re-tighten inlet pieces flange.

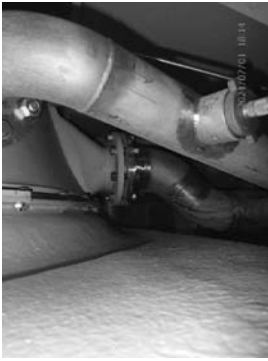
Lube oil supply line and return line at bearing 1.

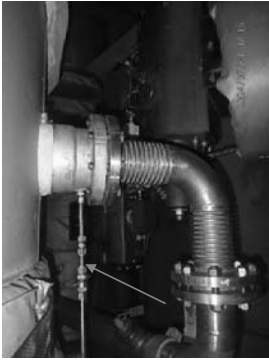
Jacking oil check valve to bearing 2 condition.

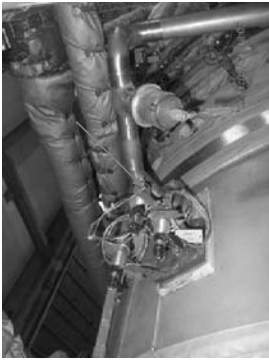
Lube oil supply to bearing 2 overall condition.

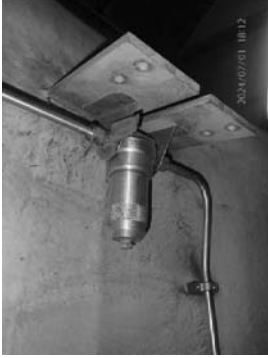
Compressor wash filter housing overall condition.

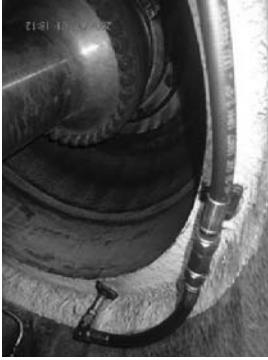
Compressor washes manifold overall condition.

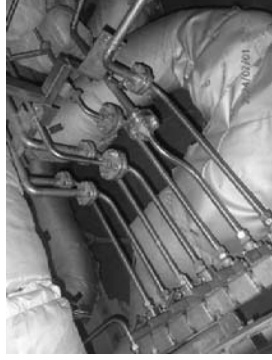
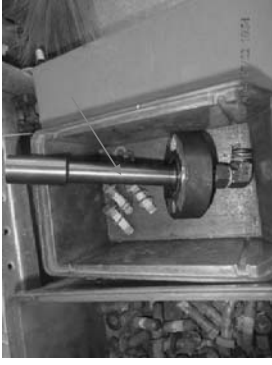
Drain ports control valves overall condition.

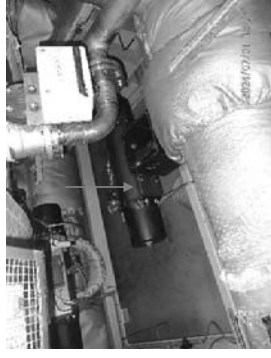
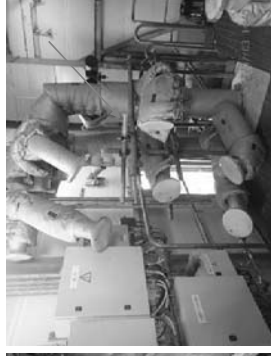
Example bleed pipes and valve outside condition with insulation.

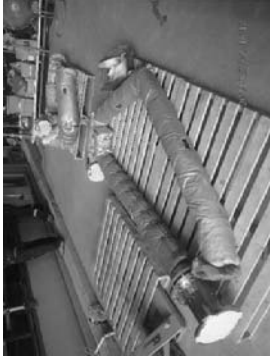
Cooling sealing air pipes around turbine section.

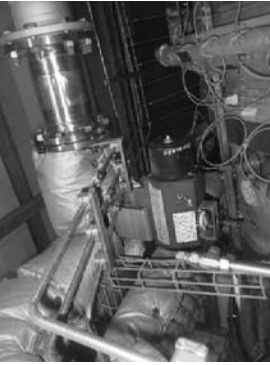
Example of cooling sealing air valve overall condition.

Cooling/sealing air pipes is in serviceable condition.

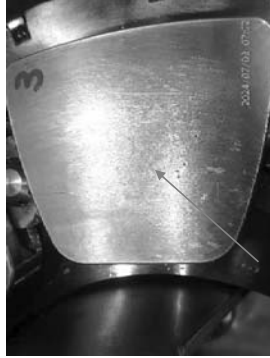
Axial thrust pads#3 over-heated area.

- The recommendation from product support related to core engine axial distance, the spacer shim behind compressor bearing would like adjusted to 1.55 mm.
- The recommendation is to replace the axial thrust bearing pads. The radial pads seem to only have scratches which should be smoothed. It is also recommended to take an oil sample for analysis.
- The lube oil quality needs to be monitored regularly.

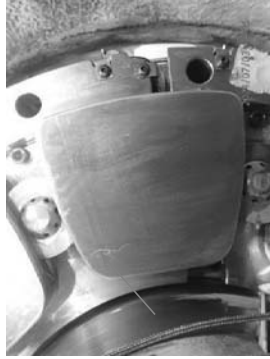
Example axial thrust pad#4 scratched mark.

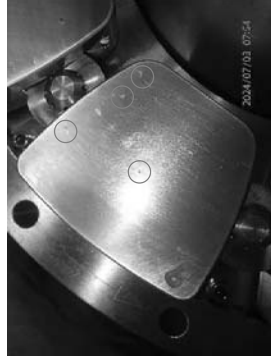
Example axial thrust pad #9 pitting damaged.

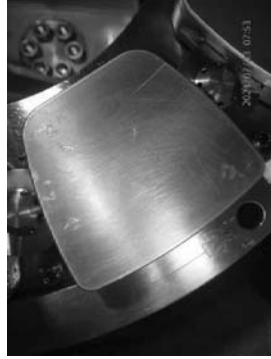
Example axial thrust pad #7 scratch mark.

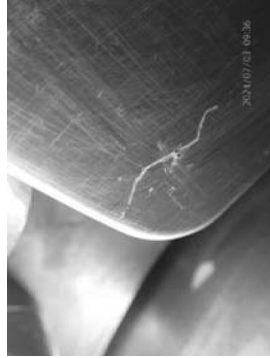
Closeup scratch mark on pad#4.

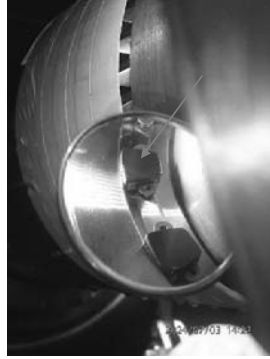
Example closeup reverse thrust pads condition.

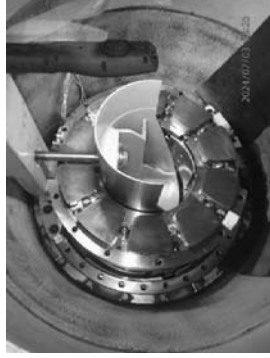
Example PT were performed on axial thrust pads and no relevant indication.

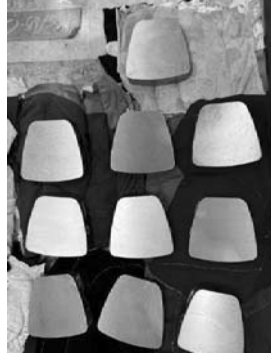
New axial thrust pads were provide by SSUT.

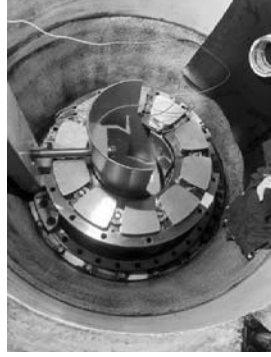
Installed new axial thrust pads during MP 60 inspection.

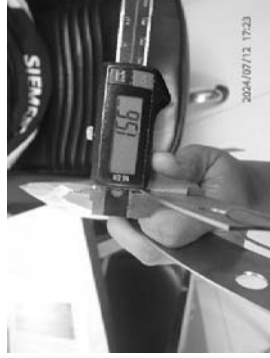
New spacer shim thickness is 1.55 mm.

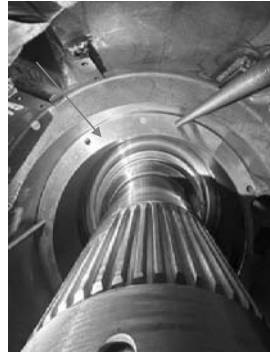
Installed new shim 1.55 mm in place behind bearing#1.

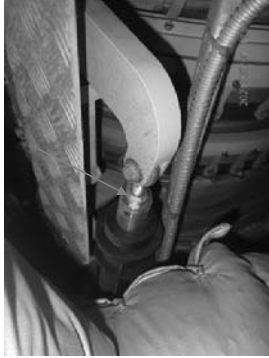
GV Actuator support bracket overall condition.

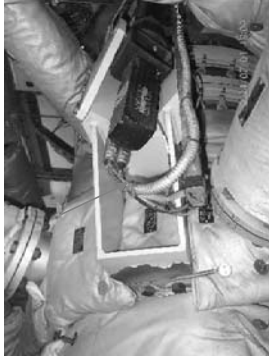
GV Actuator cable overall condition.

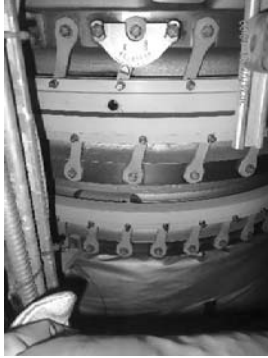
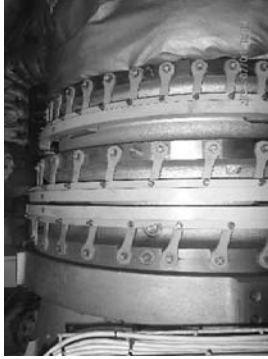
GV mechanism overall condition seen from left side. GV mechanism overall condition seen from right side.

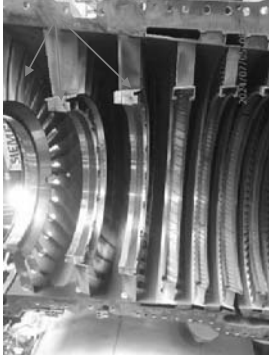
GV link arm control dismantling and shim replaced.

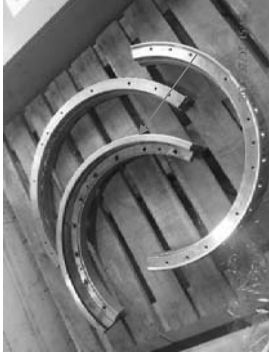
Inner ring was cleaned and installed back.

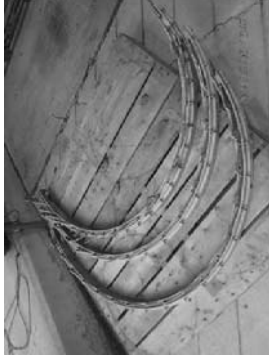
GV link arms dismantled and LYDT was installed.

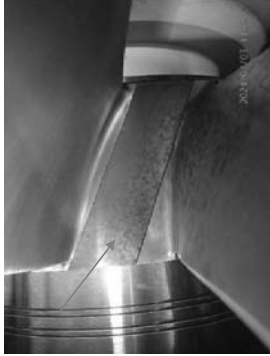
Compressor rotor stage 1 as found condition.

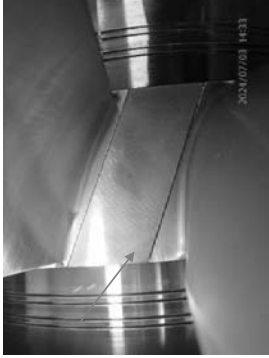
Compressor rotor stage 2 as found condition.

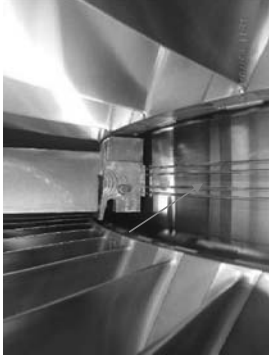
Turned seal condition between stage 2 and 3.

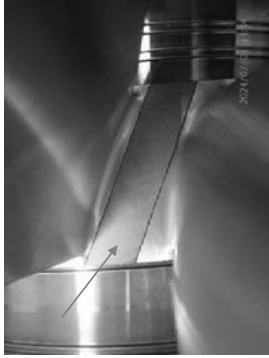
Compressor rotor stage 3 as found condition.

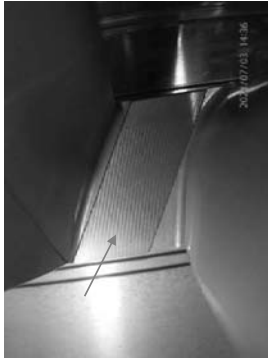
- Observed oxidation on compressor rotor between stage 5, 6, 7.
- Compressor rotor spigot grip (Turbine side) measurement within acceptance criteria.
- Observed high wear and loss material at compressor rotor spigot area and compressor coupling.
- Observed compressor rotor nuts threads were damaged during remove turbine module.

Compressor rotor stage 5 as found condition.

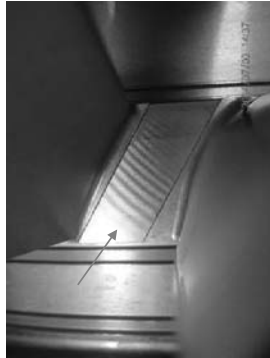
Compressor rotor stage 6 as found condition.

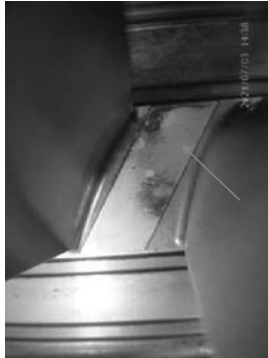
Compressor rotor stage 7 as found condition.

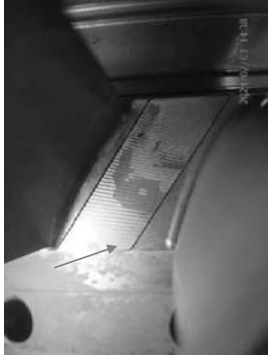
Compressor rotor stage 8 as found condition.

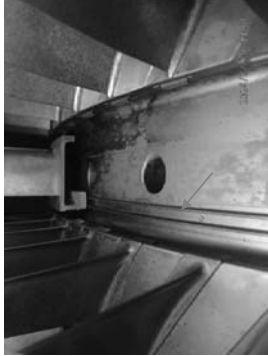
Turned seal condition between stage 8 and 9.

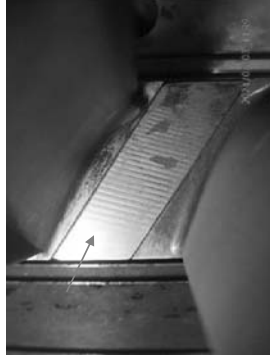
Compressor rotor stage 9 as found condition.

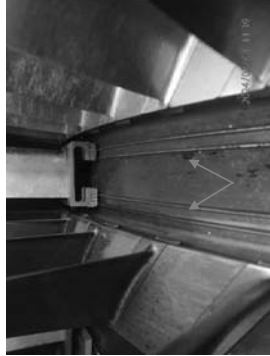
Turned seal condition between stage 9 and 10.

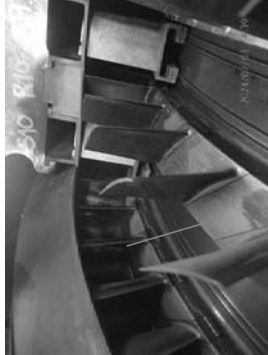
Compressor rotor stage 10 as found condition.

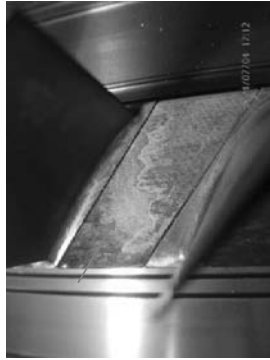
Compressor rotor stage 11 as found condition.

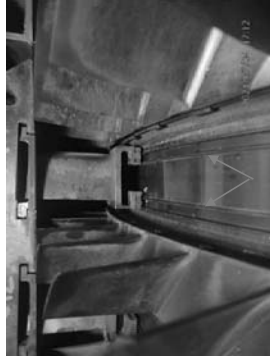
Turned seal condition between stage 11 and 12.

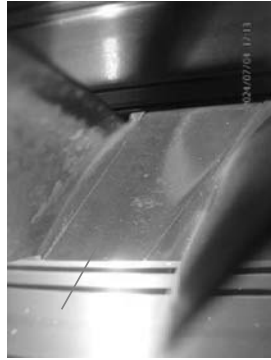
Compressor rotor stage 12 as found condition.

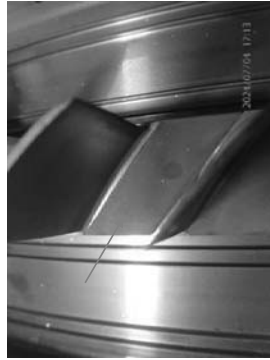
Compressor rotor stage 13 as found condition.

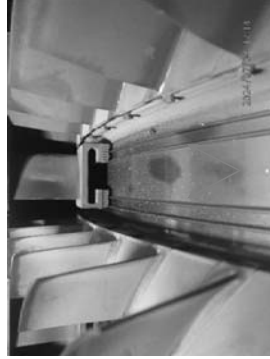
Turned seal condition between stage 13 and 14.

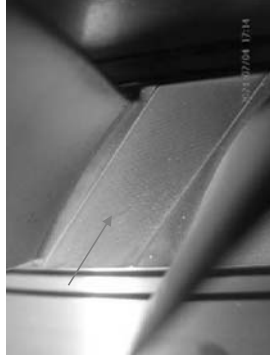
Compressor rotor stage 14 as found condition.

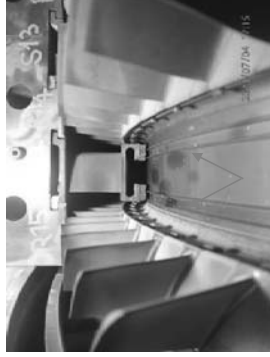
Turned seal condition between stage 14 and 15.

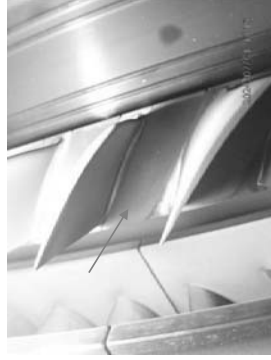
Compressor rotor stage 15 as found condition.

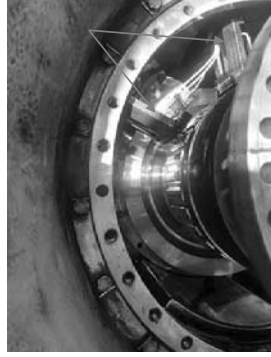
Vibration sensors and speed sensors before dismantled.

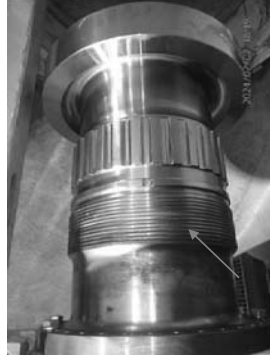
Compressor coupling caulked sealing edge.

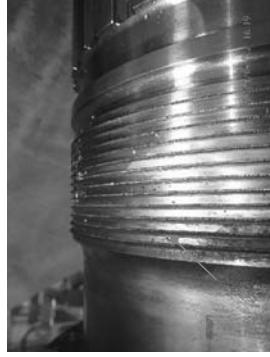
Caulked seal edge cleaned condition.

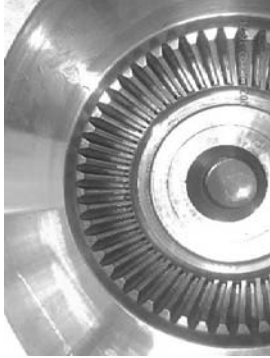
Compressor coupling spline overall as found.

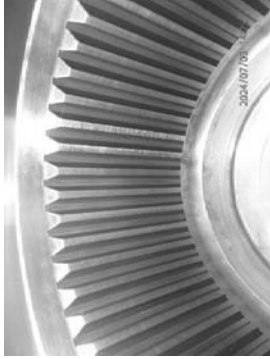
Closeup spline cleaned condition.

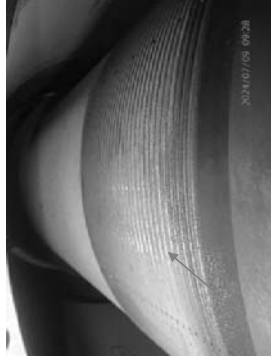
Close up turned central seal edge as found condition.

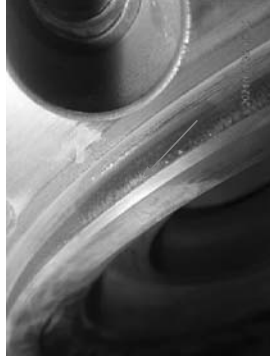
Intermediate shaft coupling.

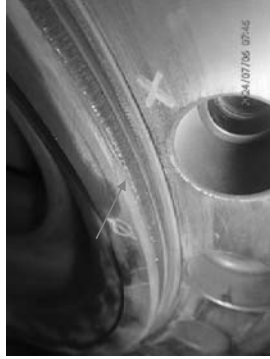
Spigot area as found condition.

- Replaced new rotor tie nuts and jack bolts.
- Polishing intermediate shaft spigot surface that installing with turbine disc stage 1.
- Monitoring compressor rotor oxidation surface at stage between 5, 6 and 7 during next major '120 inspection.
- Replaced of the new coupling. The damages are on the grip surface and there is a risk that there could be issues related to vibration when the Unit is started. A new coupling will give the best chance to start the machine without requiring machining the rotor and install an undersized coupling.
- The new compressor coupling and fretting marked on spigot area rotor need to follow up at next major inspection.
- After installing the new coupling, measure the M5, run out and axial clearances in the rear compressor to confirm that the reduction in shim thickness has resulted in expected adjustment of the rotor position.

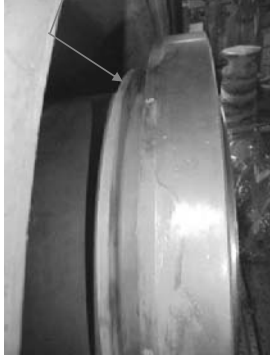
Applied PT on compressor rotor nuts area that found lacking mark from removal turbine module process.

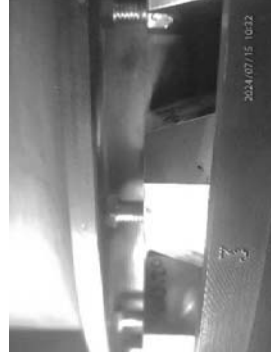
New rotor tie nuts were replaced during this outage.

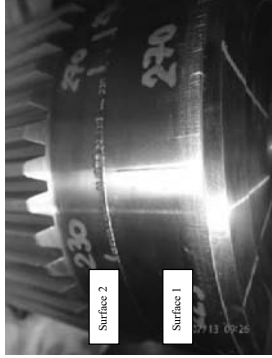
Example damaged spigot surface 1&2 at 225° position. Example damaged spigot surface 1&2 at 230-270° position.

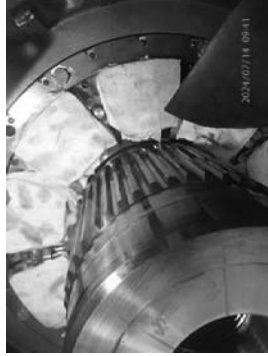
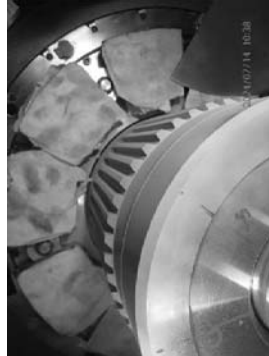
After polishing condition at 0° with PT acceptance. After polishing condition at 45° with PT acceptance.

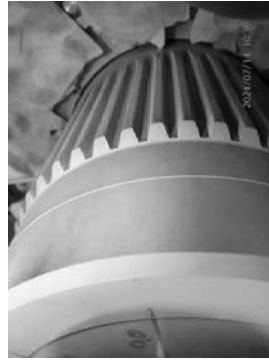
After polishing condition at 90° with PT acceptance. After polishing condition at 135° with PT acceptance.

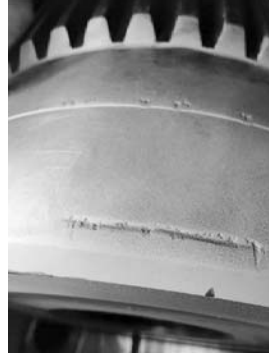
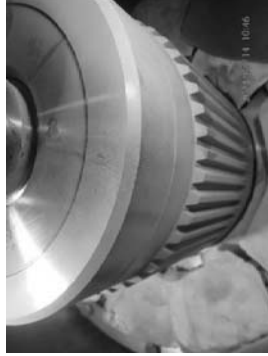
After polishing condition at 180° with PT acceptance. After polishing condition at 225° with PT acceptance.

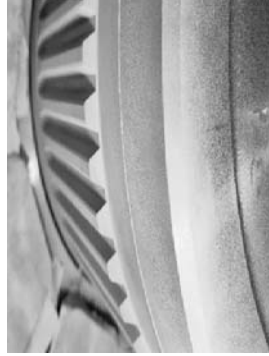
After polishing condition at 315° with PT acceptance.

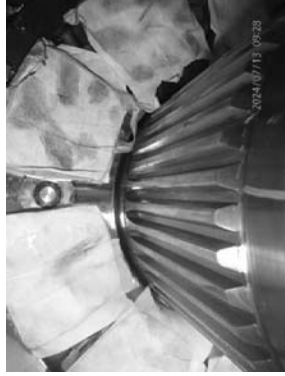
Spline surface 3 as found condition.

Example overview spline condition at 0° (CW)

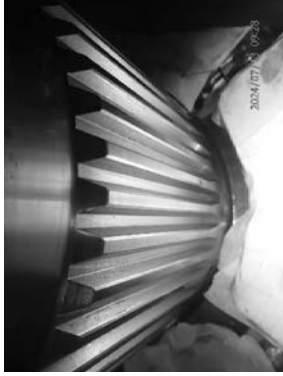
Example overview spline condition at 180° (CW)

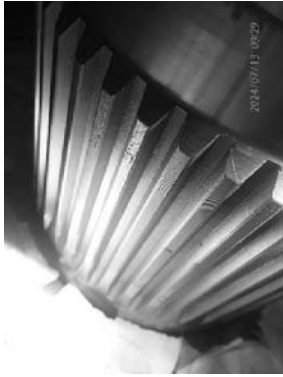
Example overview spline condition at 270° (CW)

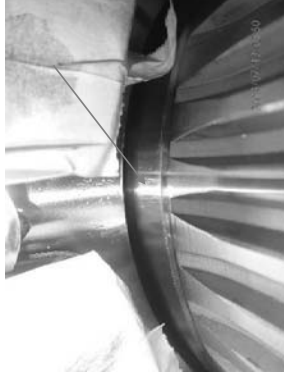
The surface 4 as found condition.

Example surface 4 area 0° (CW)

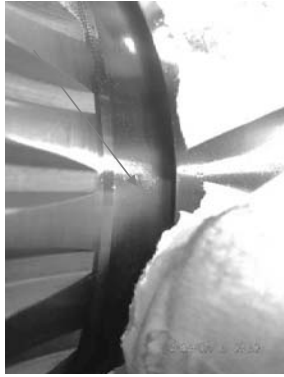
Example surface 4 area 90° (CW)

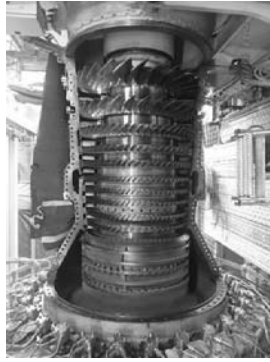
Compressor blades overall condition.

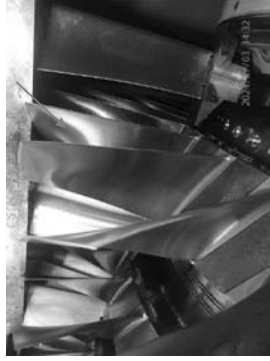
Compressor blades stage 1 as found conditions.

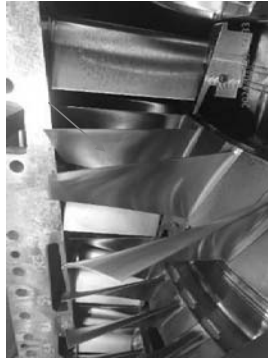
Compressor blades stage 2 as found conditions.

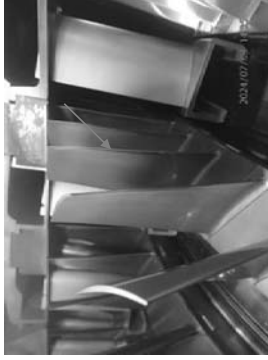
Compressor blades stage 4 as found conditions.

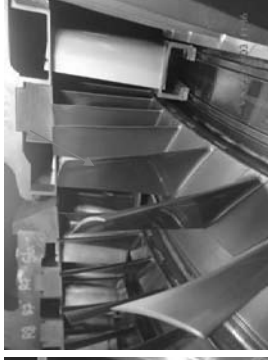
Compressor blades stage 5 as found conditions.

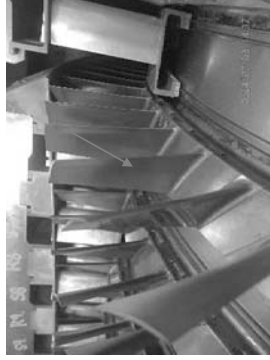
Compressor blades stage 6 as found conditions.

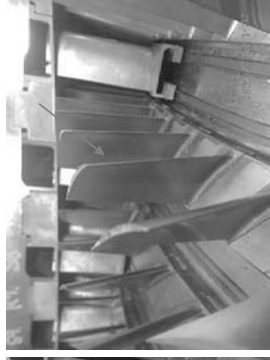
Compressor blades stage 7 as found conditions.

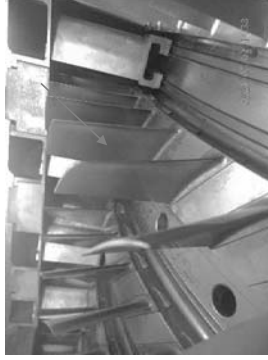
Compressor blades stage 8 as found conditions.

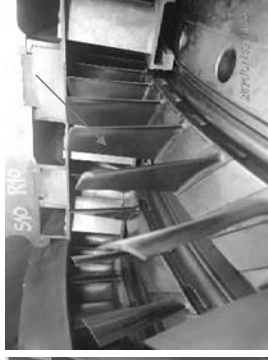
Compressor blades stage 9 as found conditions.

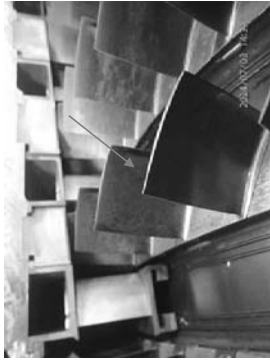
Compressor blades stage 10 as found conditions.

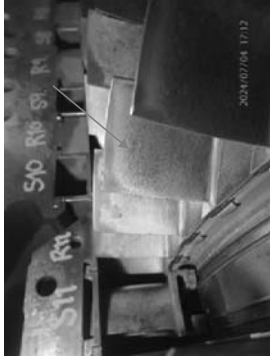
Compressor blades stage 11 as found conditions.

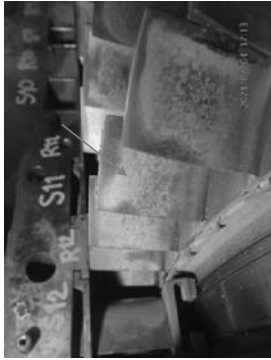
Compressor blades stage 12 as found conditions.

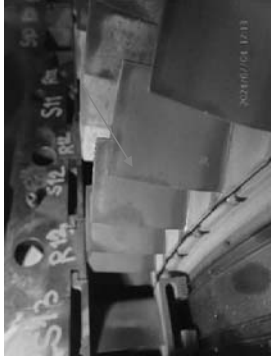
Compressor blades stage 13 as found conditions.

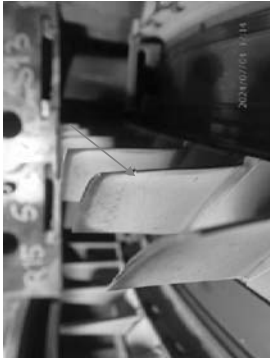
Compressor blades stage 14 as found conditions.

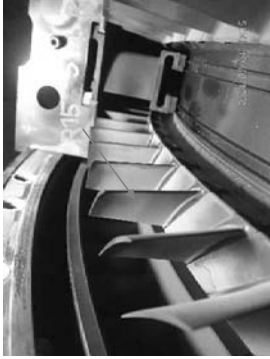
Compressor blades stage 15 as found conditions.

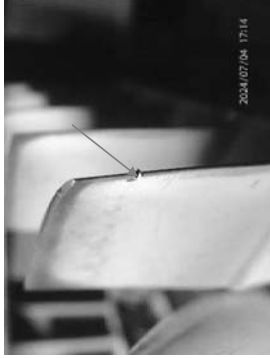
- Observed some compressor blades stage 13-15 have nick on leading edge blade.

Compressor blades stage 13-15 found nicks

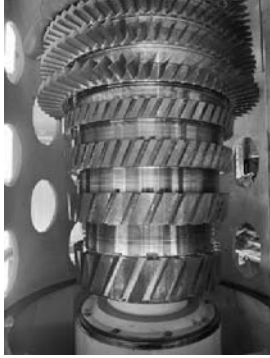
Removed first 4 stages blade to upgrade to B3 package.

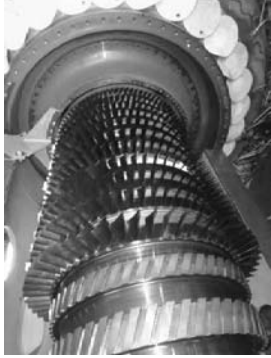
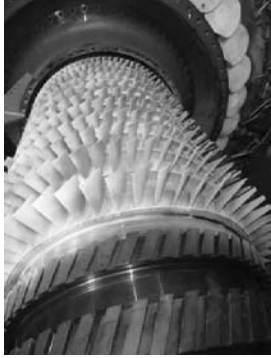
PT were performed on all compressor blades stage 5-15. No relevant indications

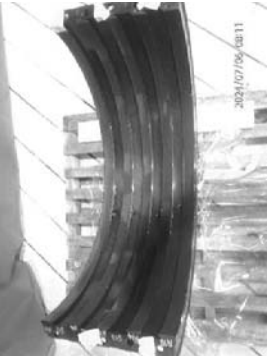
Rear inner casing (right side) as found overview.

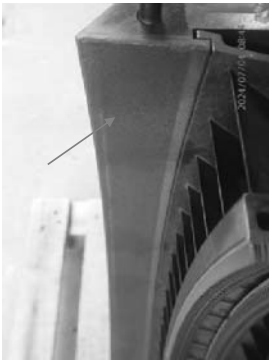
Abradable seal stage 11 as found condition.

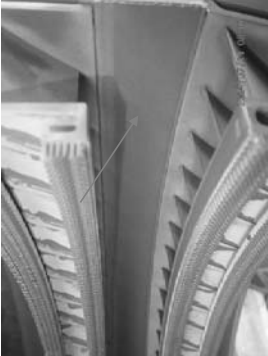
Abradable seal stage 14 as found condition.

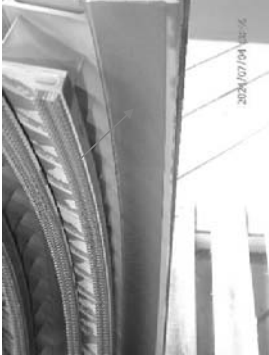
Abradable seal stage 15 as found condition.

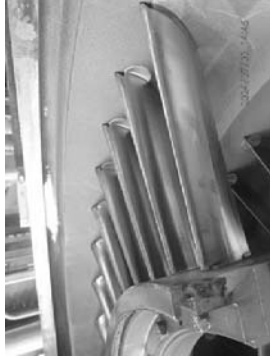
VGV stage 0 overall condition.

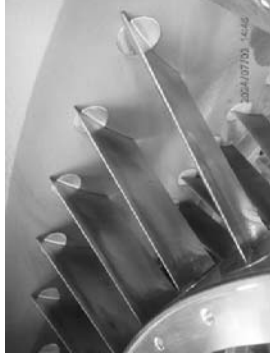
VGV stage 1 overall condition.

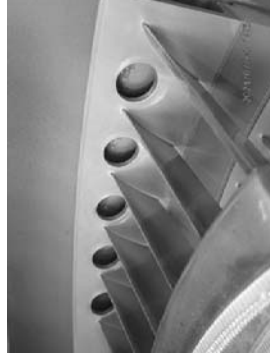
Overall GV stage 3 condition.

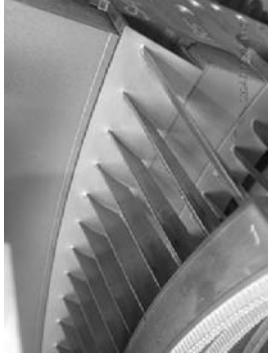
Overall GV stage 4 condition.

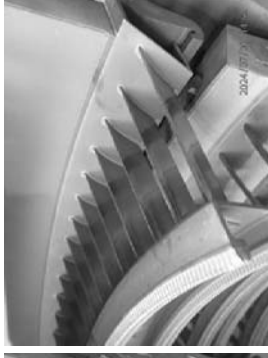
Overall GV stage 5 condition.

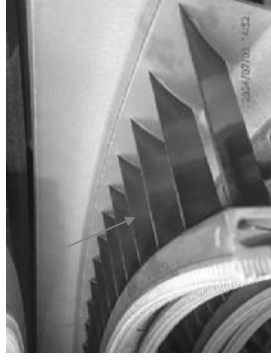
Overall GV stage 6 condition.

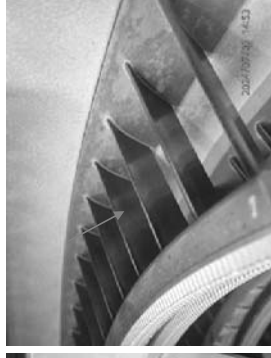
Overall GV stage 7 condition.

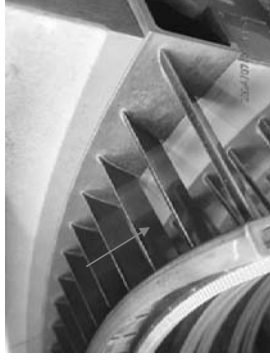
Overall GV stage 8 condition.

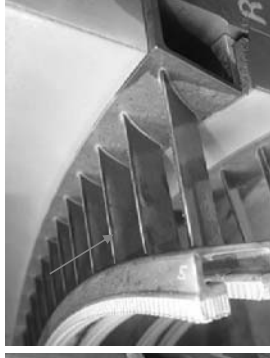
Overall GV stage 9 condition.

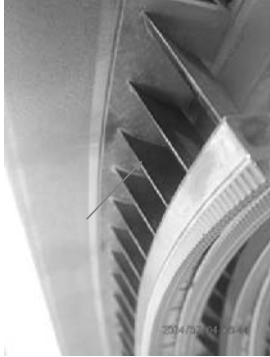
Overall GV stage 11 condition.

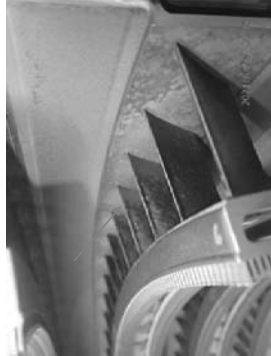
Overall GV stage 12 condition.

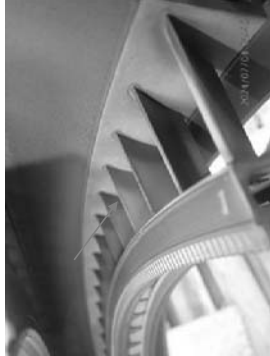
Overall GV stage 14 condition.

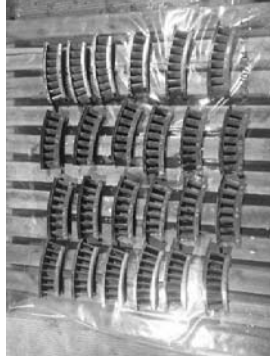
Overall GV stage 15 condition.

- Perform compressor wash every 10,000 hours to keep compressor at their best possible performance condition.

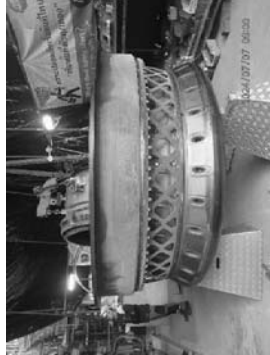
Combustor unit overall condition.

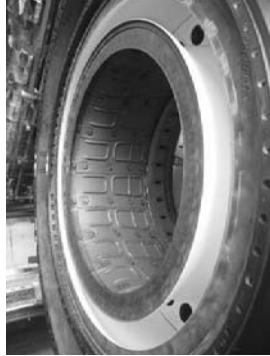
Inner heatshield overall condition.

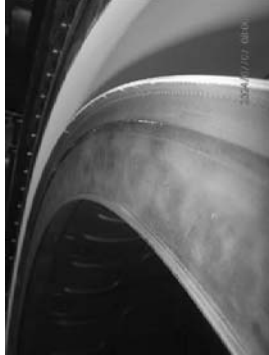
- Based on dimension measurement protocol turbine flange and diaphragm out of criteria.

Overall inner outlet ring and diaphragm condition.

- Replaced new turbine flange and diaphragm during this major inspection. (More detail in IFR from ROSE team)

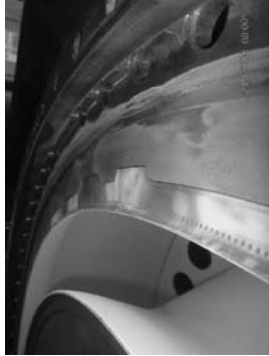
Overall outer outlet ring and diaphragm condition.

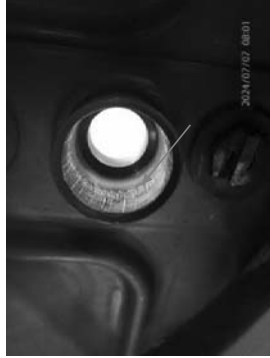
As condition flame detector hole was fretting.

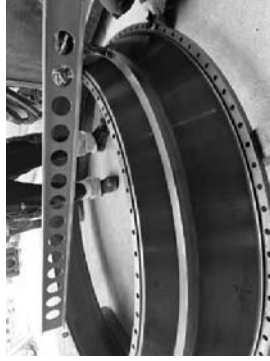
Original diaphragms have measurement by ROSE.

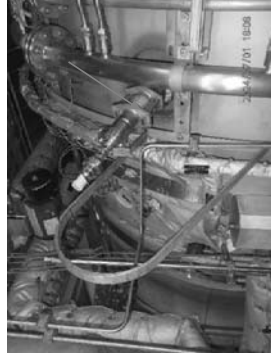
Flame detector at left and right side machine dismantled.

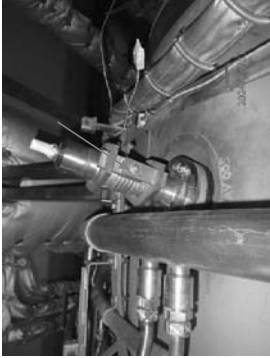
Ignitor body overall after dismantled.

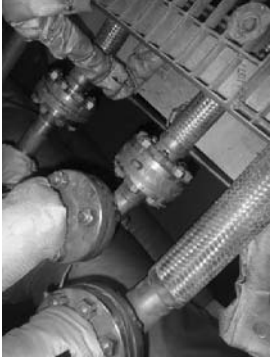
Main gas fuel supply tie-in overall condition.
