Inspection Report

Subject / Title:
BD000166U02 SSUT, MO-60 KEOH, 2024, Inspection report

: SSUT Bangpoo GT12

: SGT-800

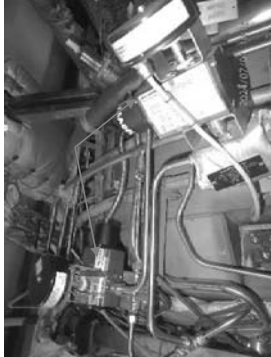
Ignition valves overall condition.

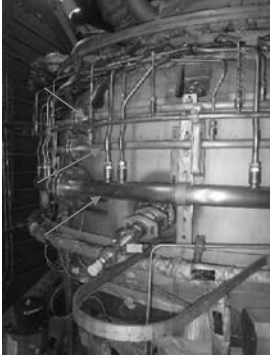
Fuel manifold around central casing left side condition.

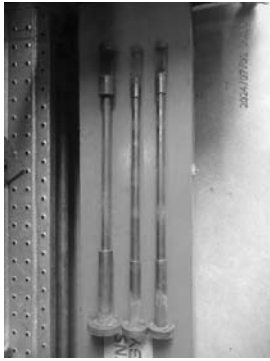
Rotor blocking bar as found condition.

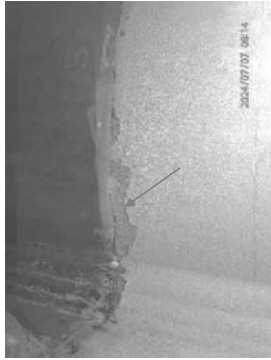
- Observed flaked aluminum coating that applied in 2023 at compressor discharge casing.

Aluminum coating peel off at overlap joint.

- Blend removed flake aluminum coating at between new and existing coating.
- Follow up aluminum coating condition at next HGP'90 inspection.

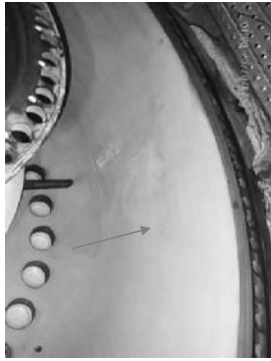
The sealers coating as found condition.

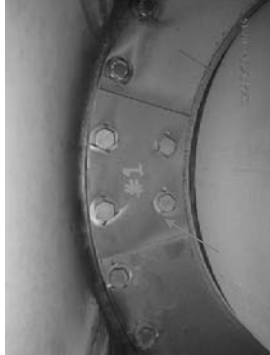
Example central seal segments before dismantling, no bolts damage.

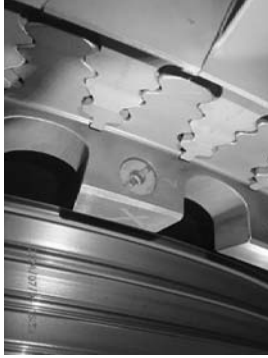
- Observed turbine disc stage 2 wear and smearing on fir-tree active face at pressure and suction sides.
- Observed balancing weight at BP5 hole position 7, 9 and 11.

Installed weight on BP5 hole position 7.

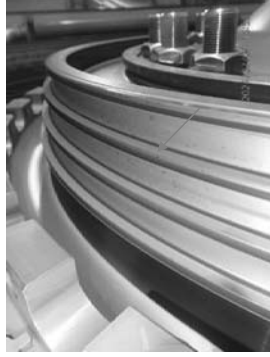
Closeup on journal area and condition.

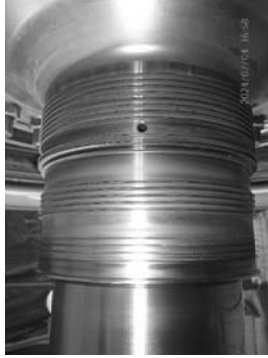
Turned sealing edges inner as found condition.

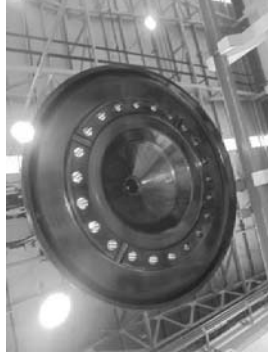
Caulked sealing edges overall condition.

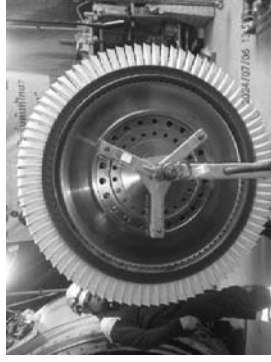
Example of blade 2 upstream overall condition.

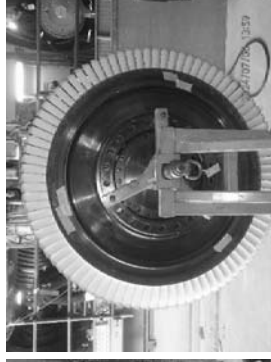
Example of blade 2 downstream overall condition.

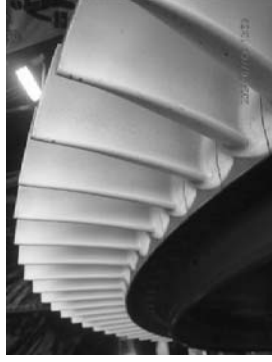
Example blade 2 leading edge overall condition.

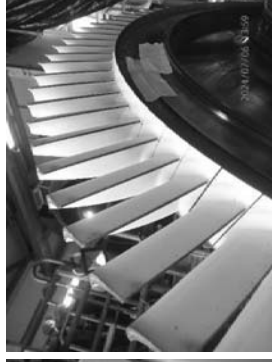
Example blade 2 trailing edge cooling passages condition.

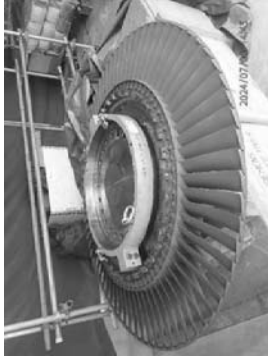
Example of downstream blade stage 3.

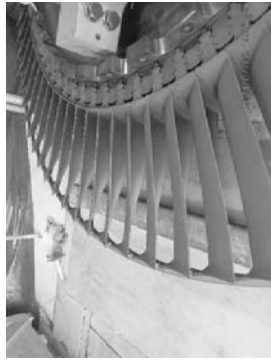
Example of turbine blades 3 trailing edge side.

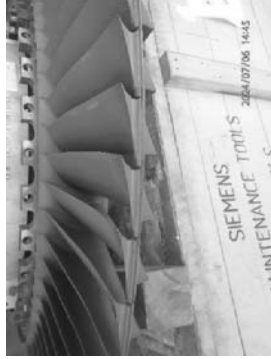
Example of turbine blades 3 tip condition.

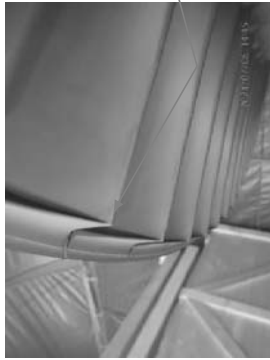
- Turbine blade stage 1, 2 and 3 were replaced at FO September 2023.
- Observed rubbing mark at turbine blade tip stage 3.

Example of blades 3 minor rubbing at leading edge.

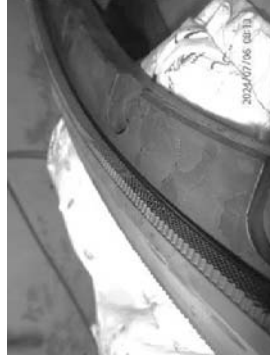
Swirl generator honeycomb is good condition..

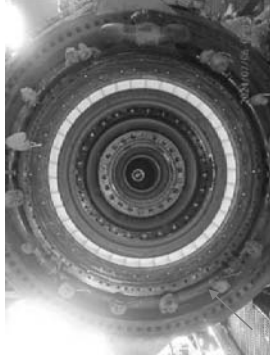
Turbine G1 stage 1 overall condition.

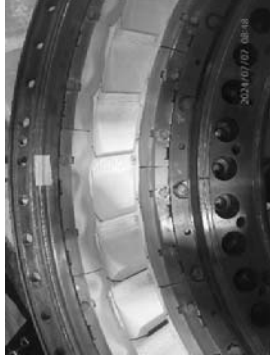
G1/1 overall condition before dismantling.

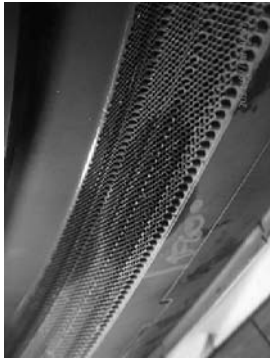
- Inner/Outer vane plates found TBC minor oxidation.
- Observed wear on honeycomb area and fretting mark on contact surface with combustor at main inner ring.

Main inner ring honeycomb as found wear condition.

- The main inner ring needs to follow wear of honeycomb and fretting mark at contact area with combustor at next HGP'90 inspection.

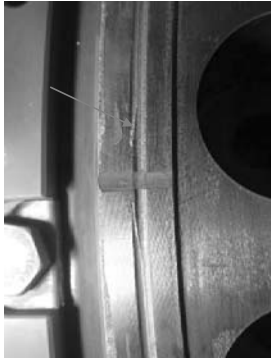
Main inner ring fretting mark were close to limit of serviceable condition.

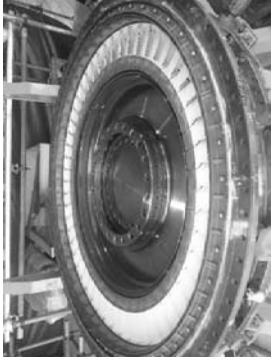
Guide vane stage 2 assembly overall condition.

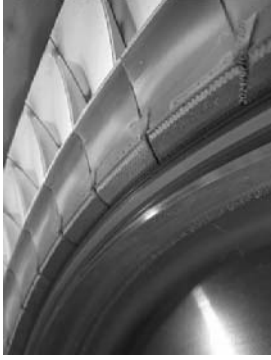
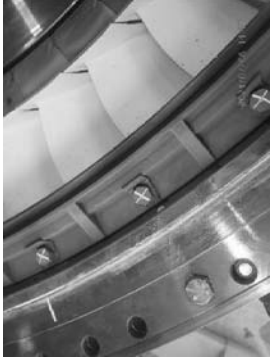
Rear hook GV2 condition.

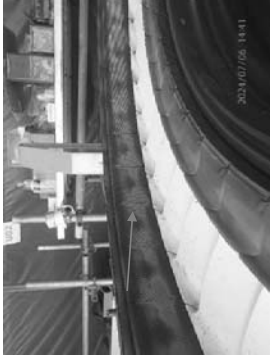
- Minor oxidation on GV2 stator heat shields.
- Observed GV2 1 flexible hoses are deformation.
- Observed fretting mark on GV3 locking ring.

Heat shield as found condition.

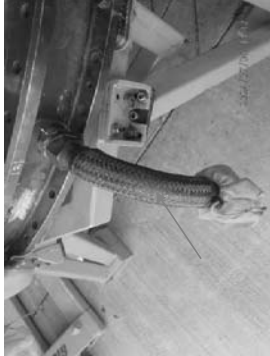
Flexible hoses was replaced 1 hose.

- Replaced 1 flexible hoses for guide vane stage 2.

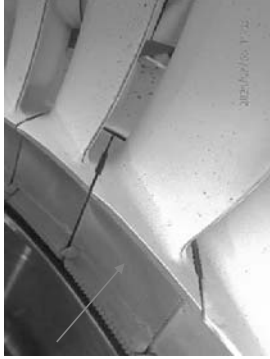
No axial contact mark on G12.

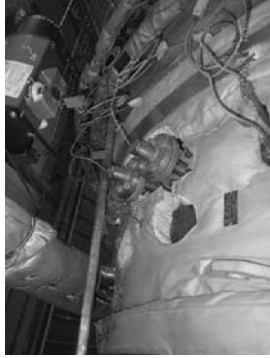
Temperature sensor housings overall condition.

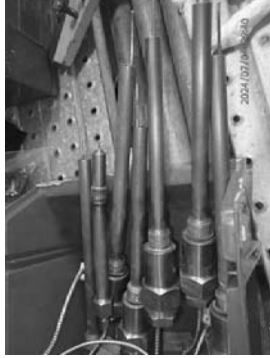
C1 probe end thread as found condition.

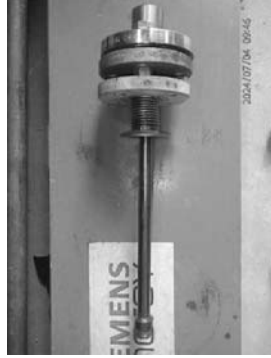
Instrument housing as found condition.

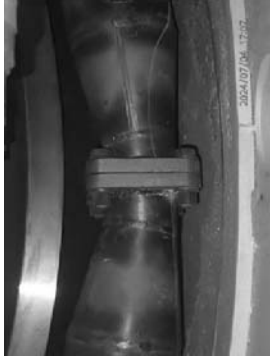
Big round pipes flanged as found condition.

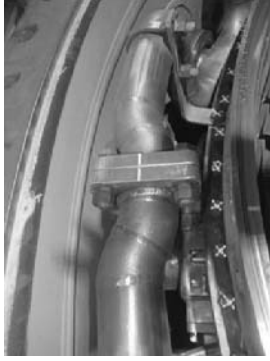
Small round pipe bottom side as found condition.

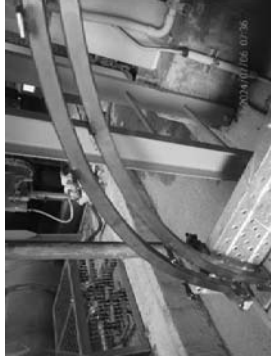
- Observed 1 support bracket on cooling manifold square pipes broken.

Support square brackets were broken.

- Welded repair broken 1 square support cooling pipe brackets during this outage.

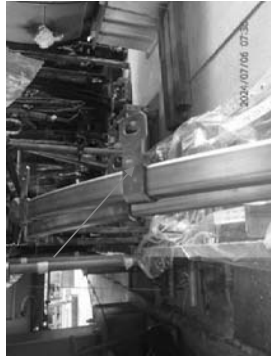
PT weld seal on big square pipe.

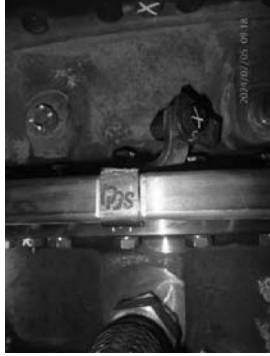
Support ESC brackets were broken.

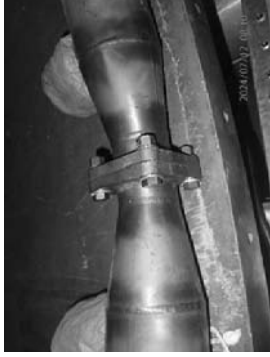
Replaced new gasket on big roll pipe.

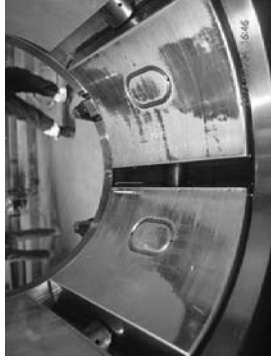
Example radial pads at bottom side.

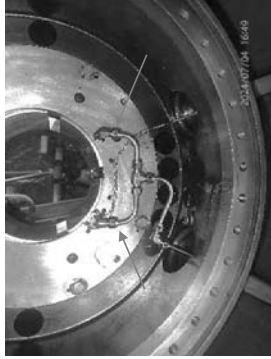
Jacking oil tubing that connect to bottom pads.

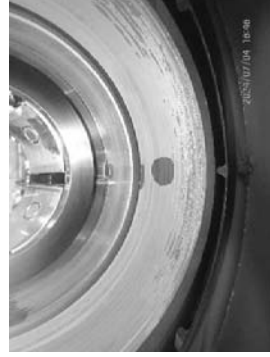
- Observed 6 rear inner insulation cassettes crack.
- Minor wear mark on sealing ring 1, 2, 3 area and front L-profile.
- Observed initial crack around rear L-profile at connecting joint segment.

Sealing ring 1,2,3 area overall condition.

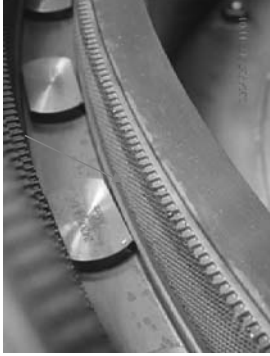
Inner sealing ring honeycomb overall condition.

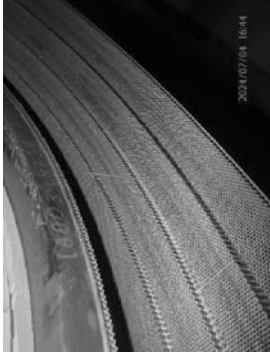
Outer sealing ring honeycomb overall condition.

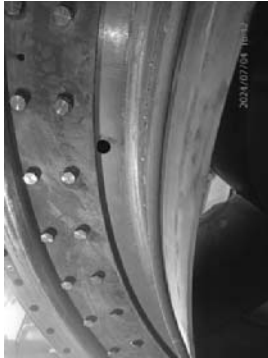
Front lip of outer heatshield overall condition.

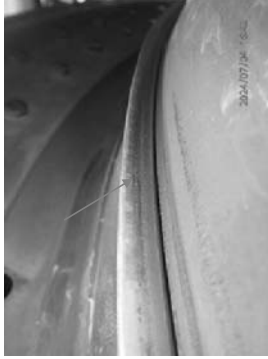
Front L-profile wear mark around circumference.

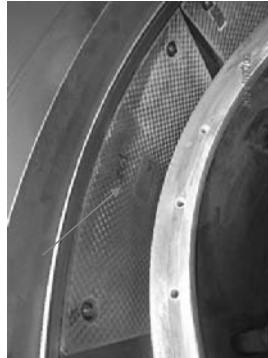
Insulation cassettes at top side not damage.

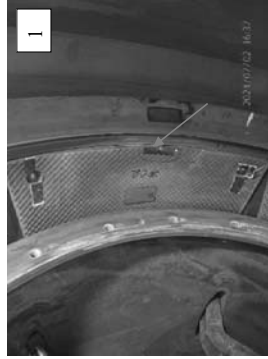
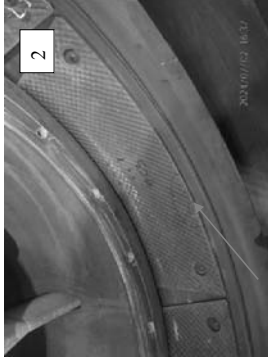
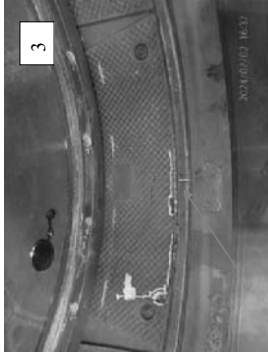
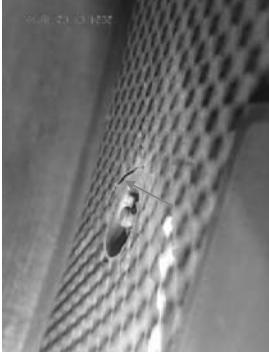
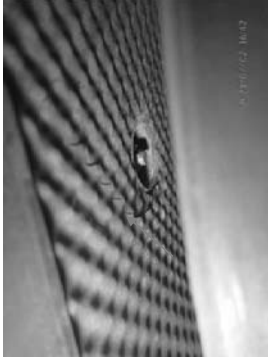
Insulation cassettes damaged at position 1.

Insulation cassettes damaged at position 2.

Insulation cassettes damaged at position 3.

Insulation cassettes damaged at position 4.

Insulation cassettes damaged at position 5.

Insulation cassettes damaged at position 6.

- Replaced 4 insulation cassettes rear inner with new cassettes 2424558-1.
- Insulation cassettes at position 1 and 2 repaired by spot welding.
- Follow 2 rear inner insulation cassettes during next HGP'90 inspection.
- Weld repair rear L-profile 4 joints completed.

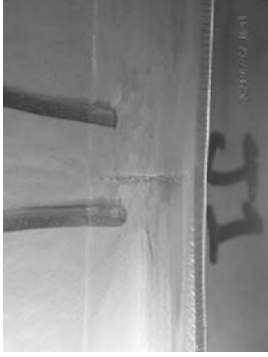
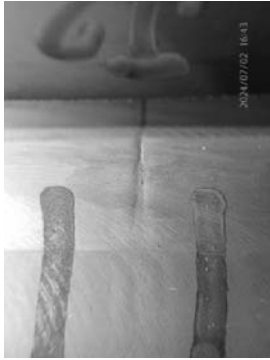
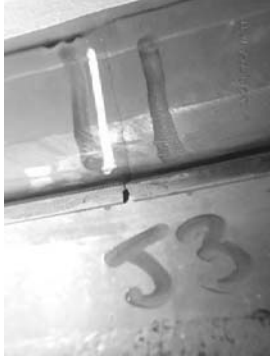
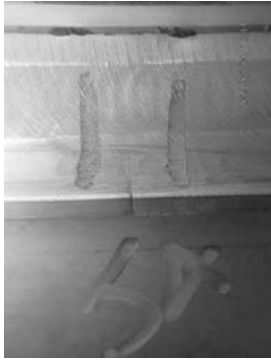
Rear L-profile damaged at position J1.

Rear L-profile damaged at position J2.

Rear L-profile damaged at position J3.

Rear L-profile damaged at position J4.

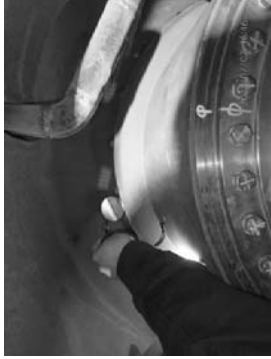
No damage on weld seam behind bearing housing.

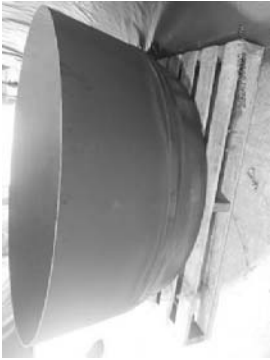
Outlet cone overall condition.

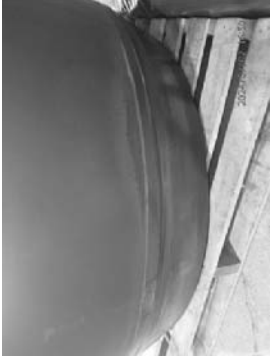
No fretting mark on contact area with rear L-profile.

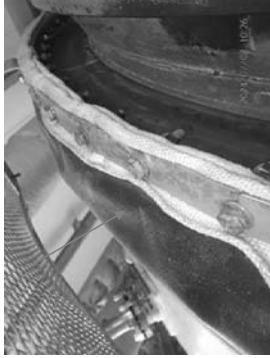
As found fabric bellow is good condition.

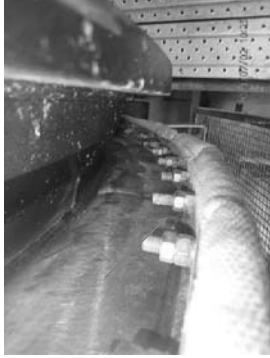
The outlet bellow bolts were good condition.

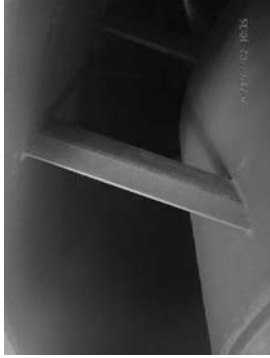
- Cracks observed on the front and rear support weld seams, noticed in previous inspection report.
- Observed bolts and nuts around exhaust diffuser and inner cone were damaged.

All front struts observed crack at inner/outer weld seam.

- Front support struts weld seams had been repaired by customer.
- Replaced new bolts and nuts according to E1B101059154M.

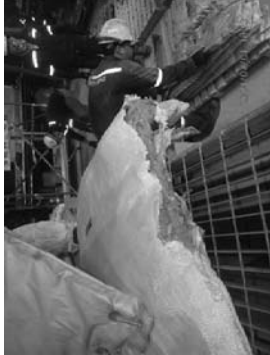
Example insulation around compressor area.

- Customer schedule repairs on the severely damages insulations during this major inspection maintenance period.

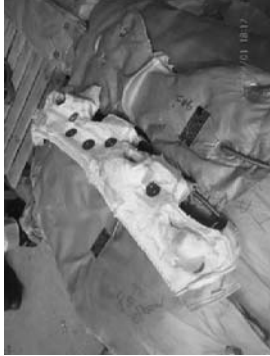
- Insulation found teared at cooling sealing and bleeding pipe.
- Insulation pillows around turbine exhaust cone area found tear and damages.

Example insulation on turbine and exhaust area.

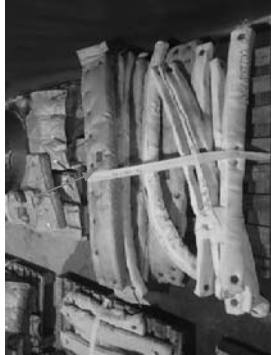
Example of insulation as found condition.

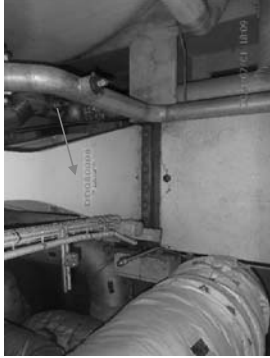
Front support condition on the right side.

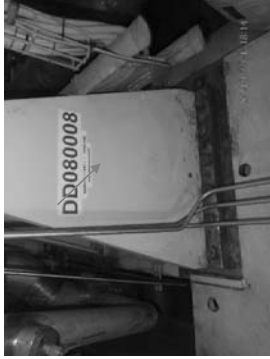
Front support condition on the left side.

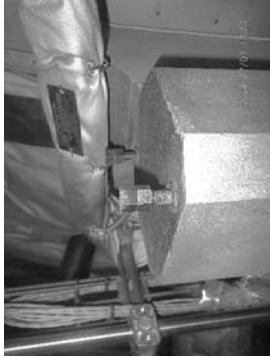
Left central casing side support condition.

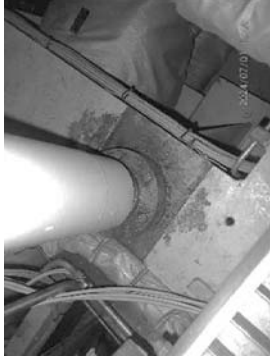
Left central casing side support foundation.

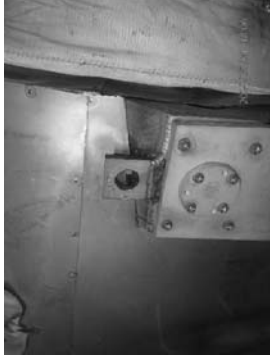
Left side support connection.

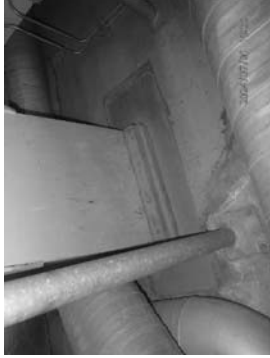
Left side support foundation condition.

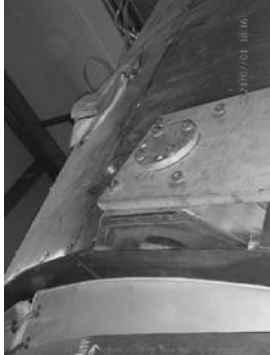
Right side support connection.

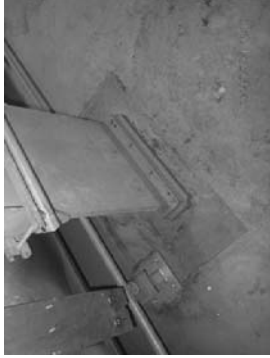
Right side support foundation condition.

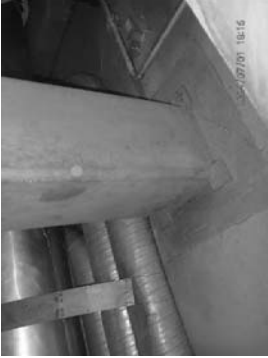
Right side support connection.

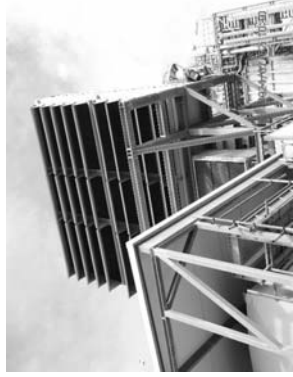
Overview conditions for air intake filter housing.

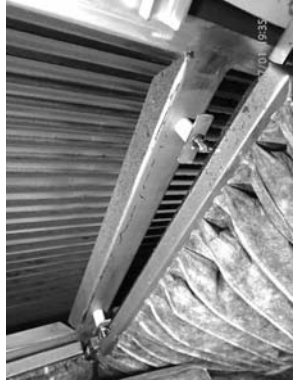
- Dust collected on weather louvers both intake filter and ventilation filter.
- Found door rubber seal at filter housing entrance room was damaged.
- The customer has been replaced prefilter filter elements.
- Contamination conditions noticed on final filter elements.
- Observed rust and corrosion around flat bar plate of fabric bellow expansion joint seen inside the clean air path internal wall upper side of inlet silencer.
- Condensing conditions noticed on clean air side after final filters.
- Ventilation filter housing intake louvers found dust collected.

Weather louvers conditions for intake filter.

- Cleaned filter housing, intake louvers and ventilation filter housing intake louvers.
- When replacing filters elements check for an open gap between filter element rubber seal and filter housing to ensure no unfiltered air can enter.
- Apply rusty protection lubricant on emergency door release mechanism.
- Active exit ventilation damper and monitoring damper condition in every 6 months.
- Removed oxidation on silencer units at top and bottom side by customer.
- Pre and fine filters were replaced during MO'60 inspection.

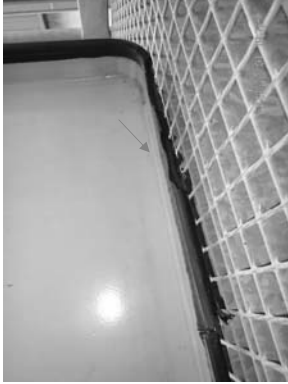
Rubber seal conditions at filter housing entrance door.

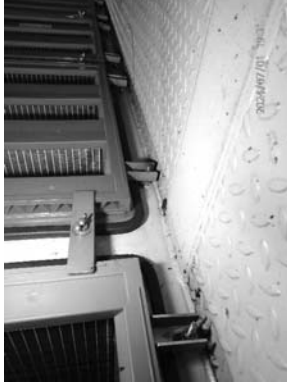
Floor conditions inside filter housing room.

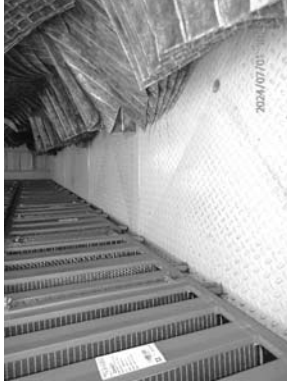
Pre-filter elements overall condition.

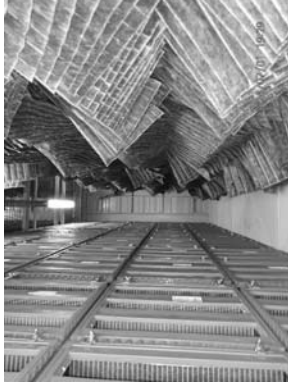
Overview conditions inside filter housing room.

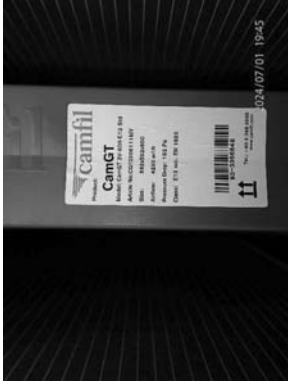
Present installation for final filter elements.

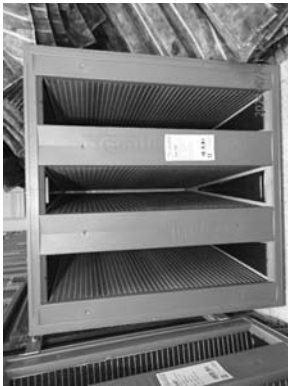
Final-filter elements overall condition.

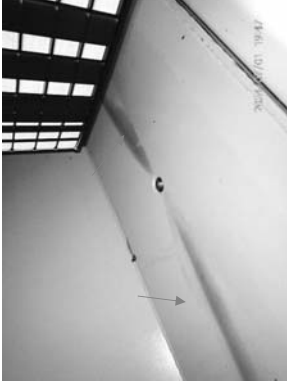
Condensing conditions noticed on clean air side behind final filters. Internal wall conditions for clean air side.

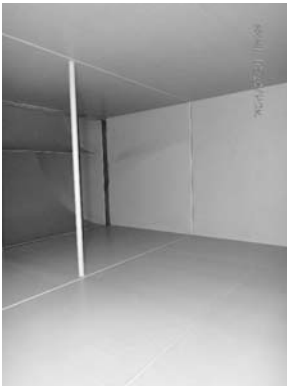
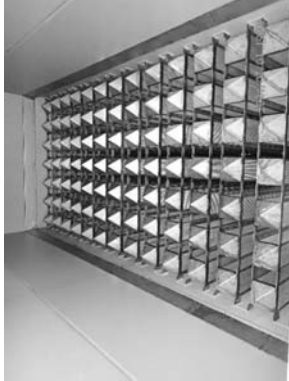
Overview conditions for inlet silencer seen from top side. Corrosion conditions on silencer unit column.

- Clean and remove rusty inside of inlet plenum casing before unit back to operation.
- Replaced new rubber gasket at inspection hatch.
- Repaired thread inserts nuts according to instruction ICS167727.

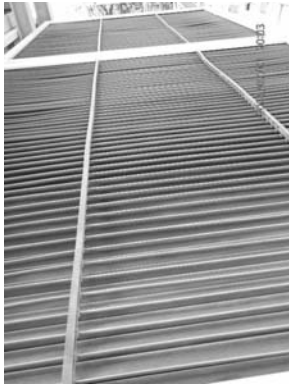
Intake louver condition for Ventilation room.

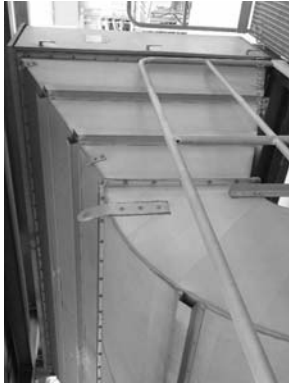
Overview conditions around ventilation filter housing room.

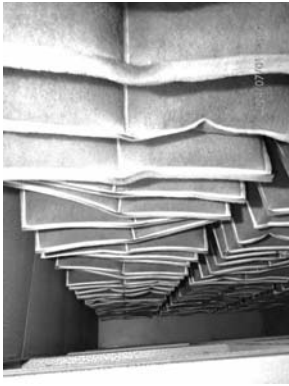
Overview conditions inside ventilation filter housing.

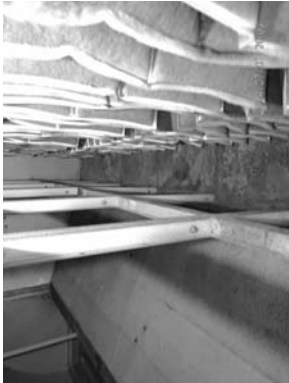
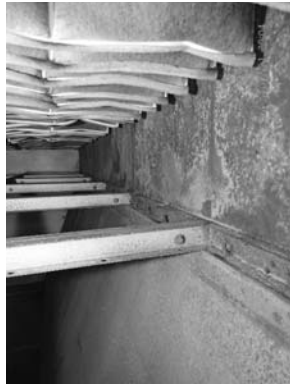
Floor conditions inside ventilation filter housing.

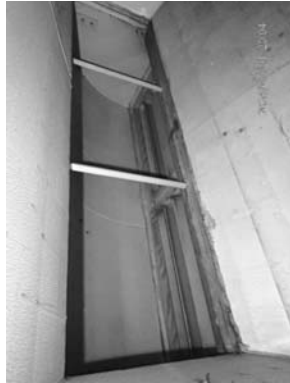
Ventilation inlet intake channel to Gas turbine enclosure.

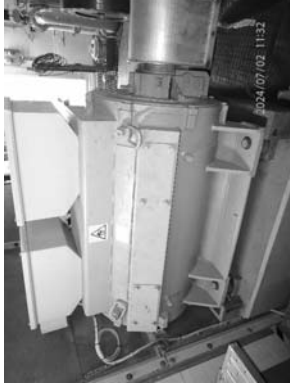
Starter motor overall condition.

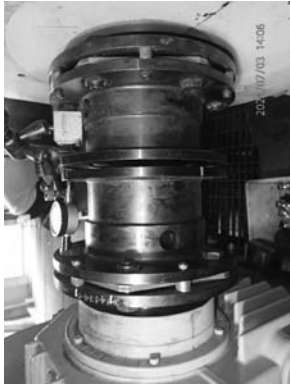
Flexible coupling overall condition.

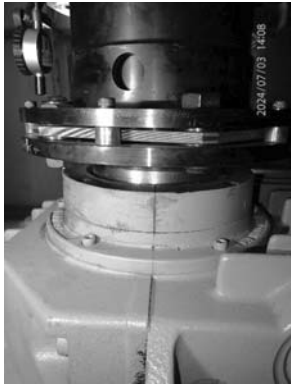
Shim pack at starter motor side condition.

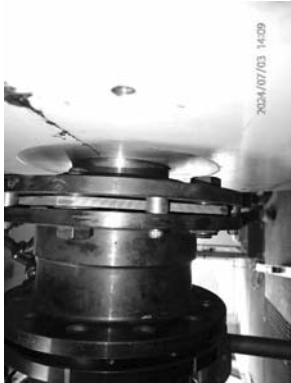
Shim pack at gearbox side condition.

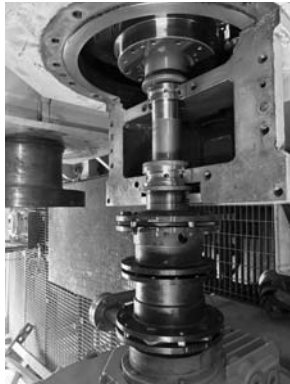
- Observed oil varnish and sludge inside the lube oil chamber, clutches socket of SSS-clutches.

SSS-Clutch connected with flexible coupling overall condition. SSS-Clutch overall condition.

- During re-assembly oil varnish found on SSS-Clutch has been cleaned.
- Monitoring lube oil varnish level and upgrade the VRU unit to include particle filtration.

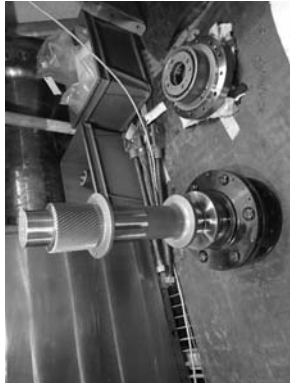
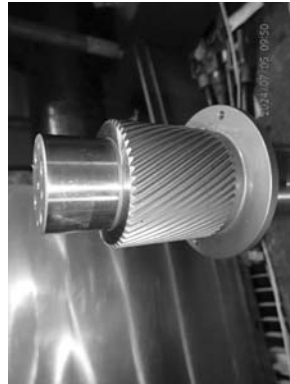
Sliding splines gear overall condition.

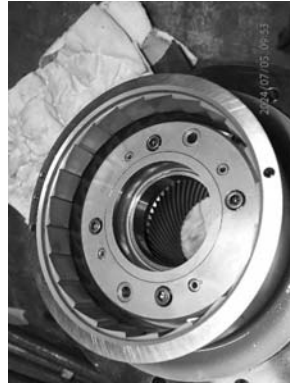
Ratchet tooth overall condition.

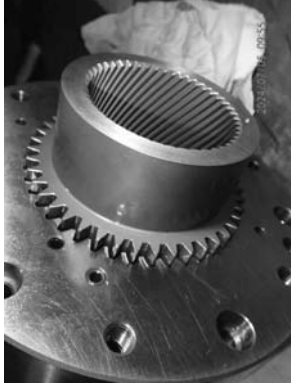
Overview condition for tooth on clutch gear.

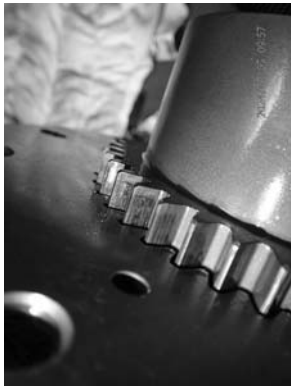
Closed view on clutch teeth.

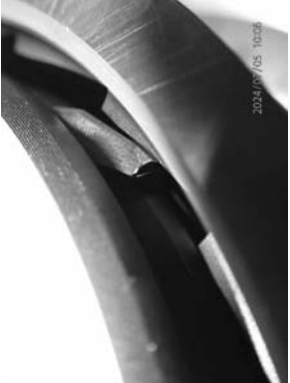
High speed paw jaw condition for left side.

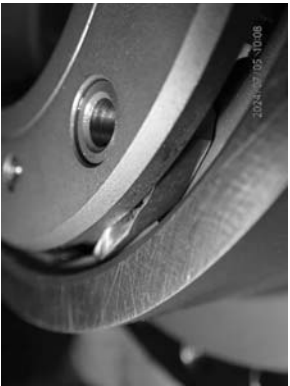
High speed paw jaw condition for right side.

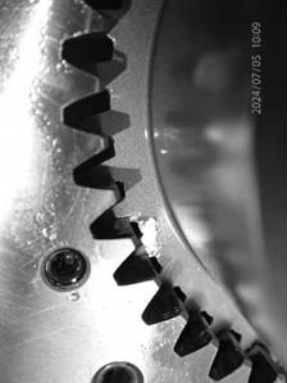
Closed up view on teeth from the ratchet gear view in profile.

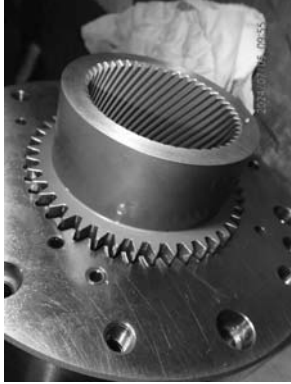
Sliding female splines socket as found condition.

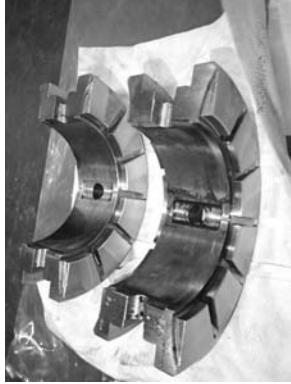
Clutch socket as found condition.

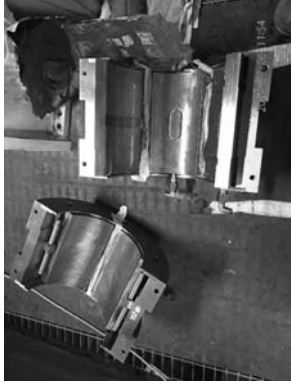
SSS-Clutch bearing 32 overall condition.

Overview conditions for PT test on SSS-clutch bearing 31 and 32.

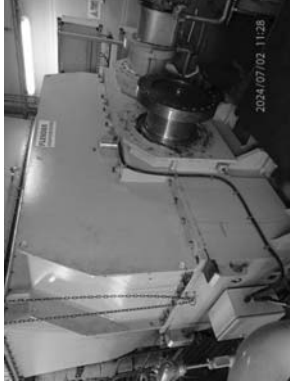
Gearbox casing overall seen from generator side.

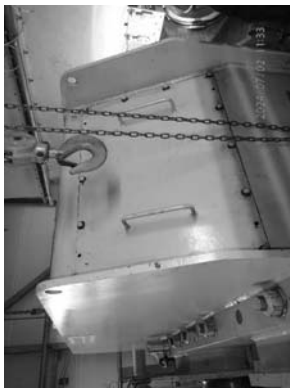
Gearbox casing overall seen from starter motor side.

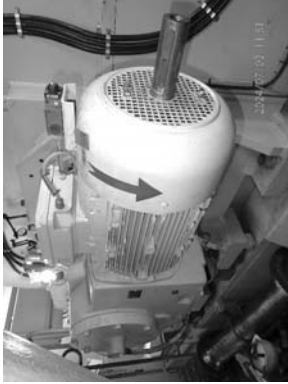
Backup barring motor side overall condition.

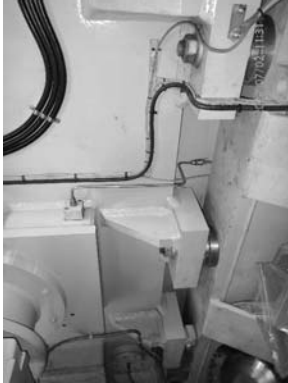
Gearbox foundation support and key overall condition.

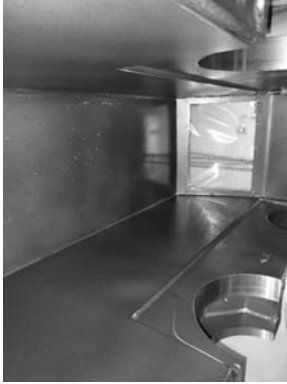
Example of under top lid condition.

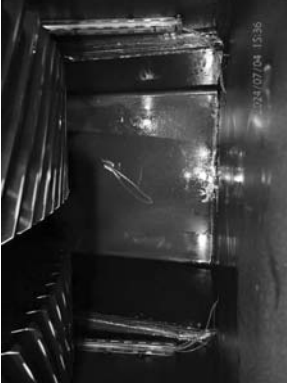
Example of oil bath bottom condition.

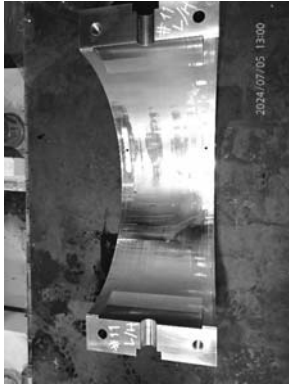
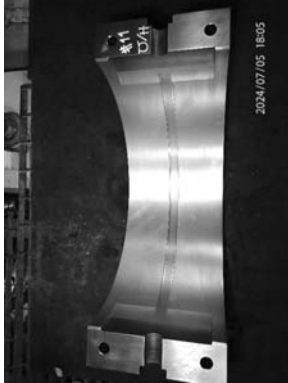
- Observed minor burnt marks on babbit bearing surface for lower halves of bearing #11 & #12.
- Minor floating surface and pitting marks were observed after cleaning for lower halves of bearing#11 and #12.

Bearing 11 top half overall condition before clean.

Bearing 11 bottom half overall condition before clean.

Bearing 11 top half overall condition after cleaned.

Bearing 11 bottom half overall condition after cleaned.

- Keep new set on bearing #11, #12 and #21, #22 for spare with complete set, in case those pads need to be change in next major shutdown while gearbox inspection.
- Continue to monitor condition of varnish builds up on bearings, shaft journal surface and gears teeth from lube oil sampling analysis result.

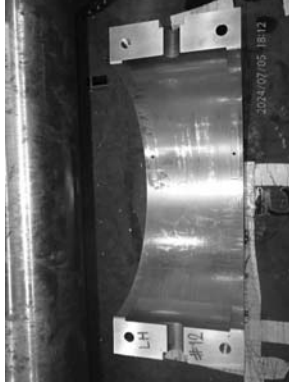
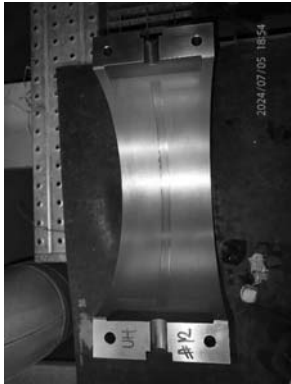
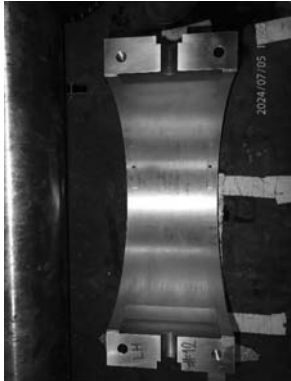
Bearing 12 top half overall condition before clean.

Bearing 12 bottom half overall condition before clean.

Bearing 12 top half overall condition after cleaned.

Bearing 12 bottom half overall condition after cleaned.

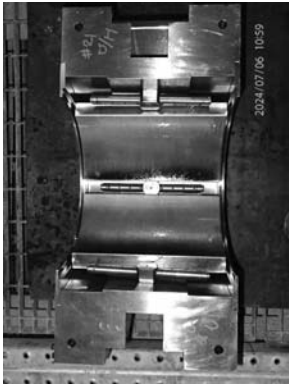
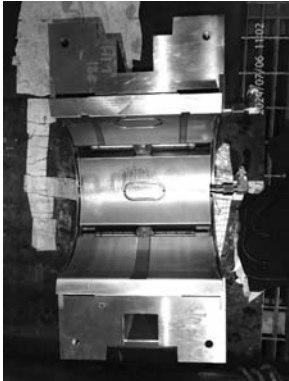
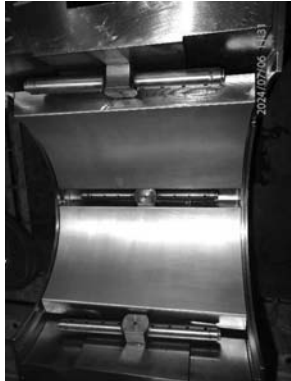
- Observed overheated area on bearing pads surface for upper halves of bearing#21 and#22.

Bearing 21 top half overall condition before clean.

Bearing 21 bottom half overall condition before clean.

Bearing 21 top half overall condition after cleaned.

Example of closeup condition on the top pad of bearing 21.

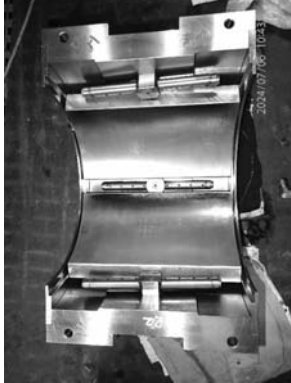
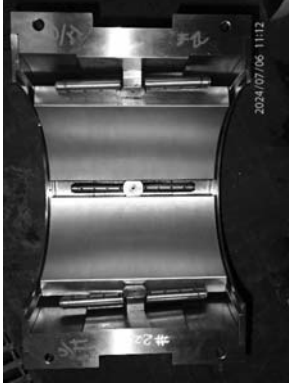
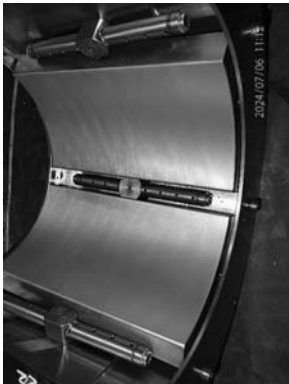
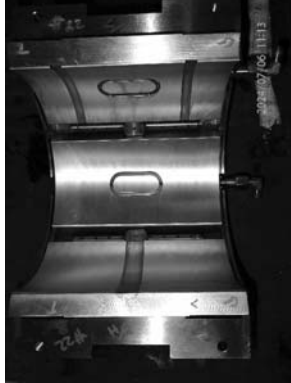
Bearing 22 top half overall condition before clean.

Bearing 22 bottom half overall condition before clean.

Bearing 22 top half overall condition after cleaned.

Closeup condition on the top pad of bearing 22 top half.

Bearing 22 bottom half overall condition after cleaned.

Closeup condition on the pad of bearing 22 bottom half.

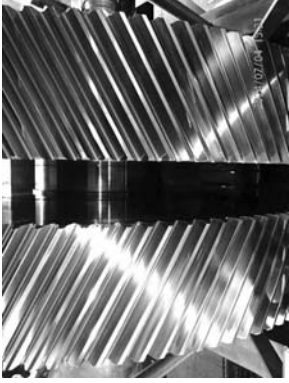
Wheel cogs overall condition.

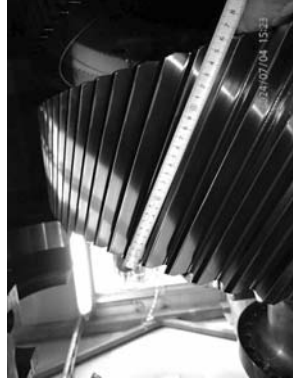
Example of white mark on wheel cogs generator side (left) and turbine side (right).

- Check condition of varnish builds up on cogs during next inspection. Performed oil sampling analysis every six months to keep track of lubrication oil condition.
- Monitor white marks condition during next inspection for any progression or changes of pattern.

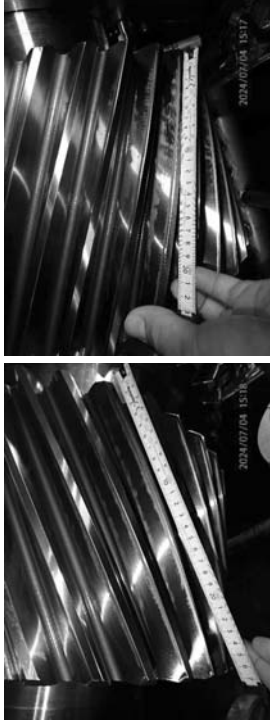
Example of white mark on pinton cogs starter motor side (left) and turbine side(right).

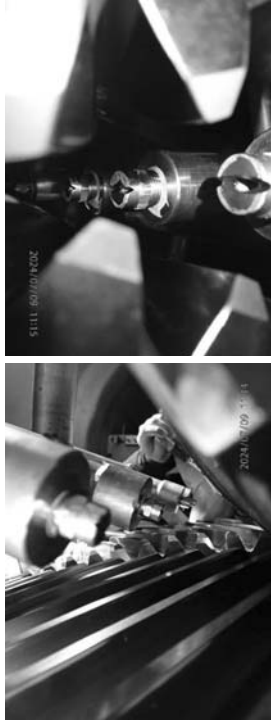
Example view on tip nozzle oil sprays after direction adjustment (left-top manifold and right-bottom manifold).

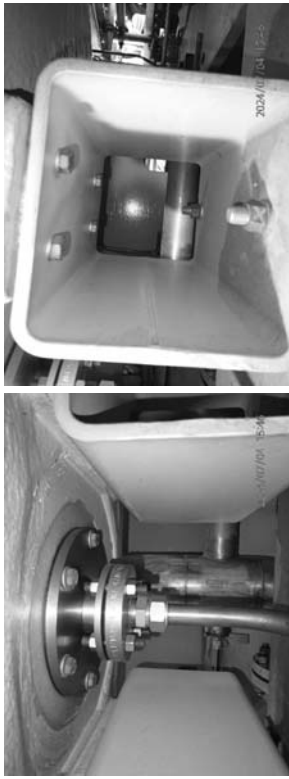
- Found dirt collected at inlet casing drain area.
- Observed rust and corrosion around flat bar plate of fabric bellow expansion joint seen inside the clean air path internal wall bottom side of inlet silencer.
- Found insert nuts loose several locations around inlet casing manhole.

Inlet casing drain overall conditions.

Inlet casing foundation support overall condition.

- Clean inside of inlet casing prior to return to operation.
- Remove corrosion found at flexible joint area.
- During alignment checked, foundation support will be re-torquing again.

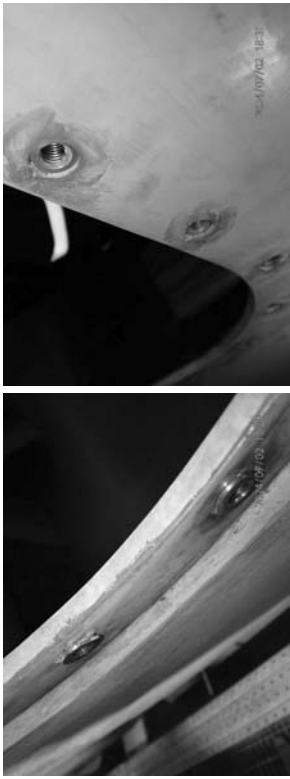
Example view for condition on insert nut around inlet casing manhole.

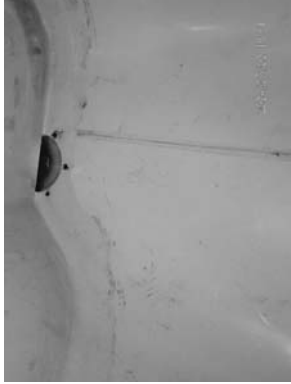
Dirt found collected at inlet casing drain area inside seen from left side and right side of plenum.

- The customer has been performed for rust removal all points inside the inlet plenum casing, flat bar plate, silencer and support silencer.

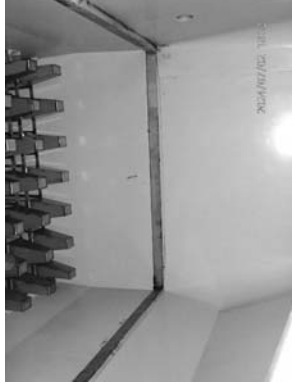
Corrosion notices at flat bar plate for flexible joint connection.

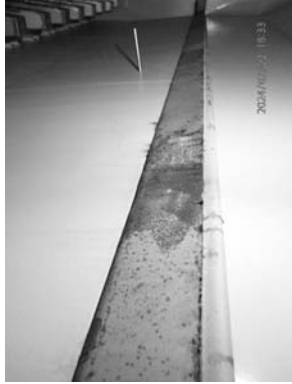
Corrosion condition found at the flexible joint area.

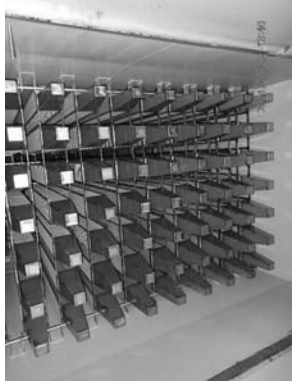
Silencer exit flow side seen from inlet casing side.

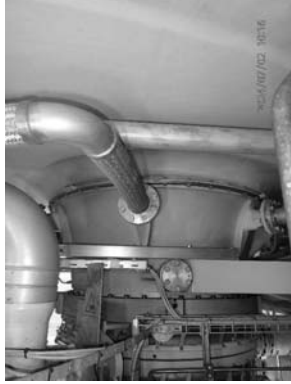
- Minor contamination stain was observed on compressor inlet piece go into compressor inlet guide vane.
- Oil seal bearing# 1 cover found dirty from mist oil.

External condition of inlet piece left side.

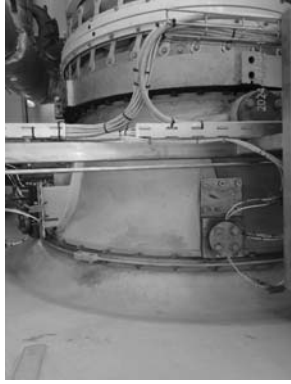
External condition of inlet piece right side.

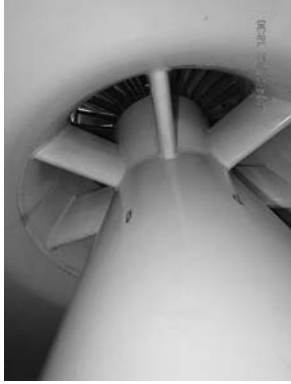
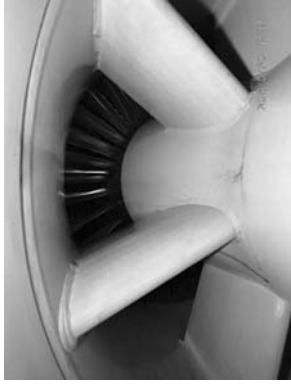
Inlet piece internal overall condition.

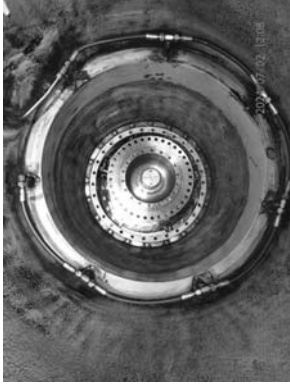
Bearing 1 seal cover condition.

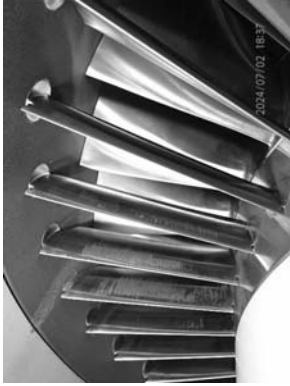
Area in front of IGV entrance.

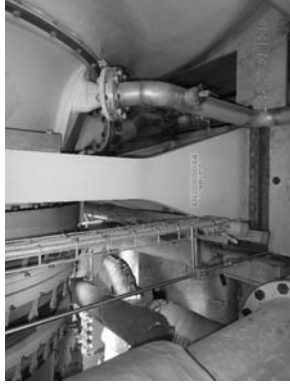
Lube oil supply line to bearing 1.

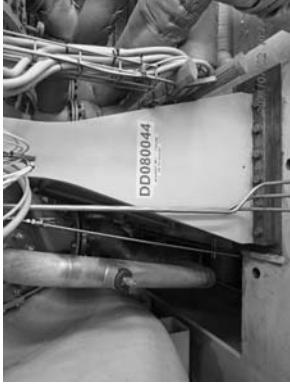
Lacking oil pipe to bearing 1 overall condition.

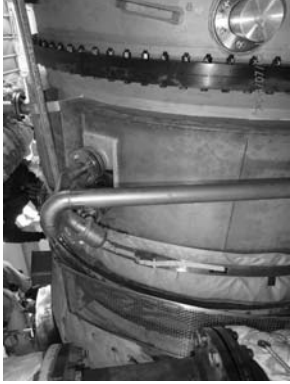
Lube oil supply to bearing 2 overall condition.

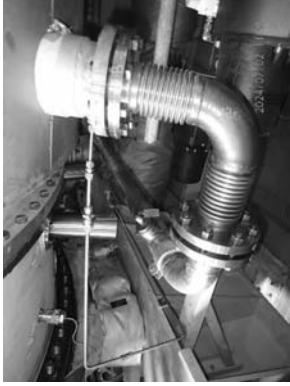
Lube oil return line from bearing 2 before dismantling.

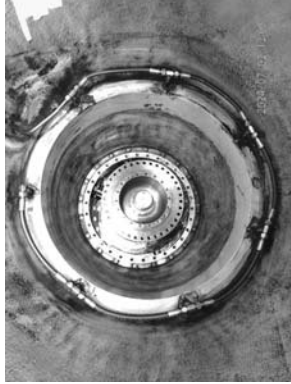
Compressor washes manifold overall condition.

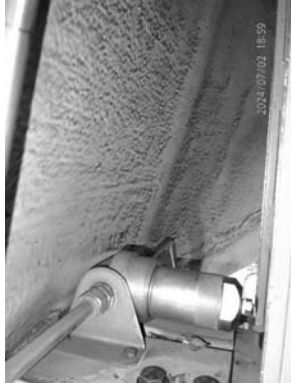
Compressor wash filter housing overall condition.

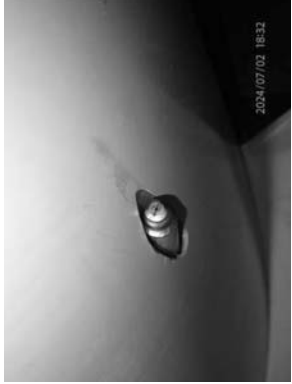
Compressor wash spray nozzle overall condition.

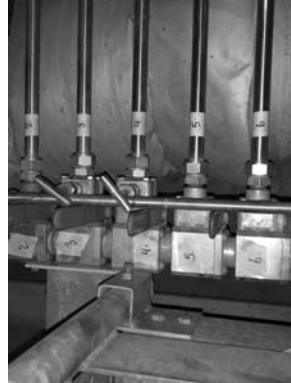
Drain ports control valves overall condition.

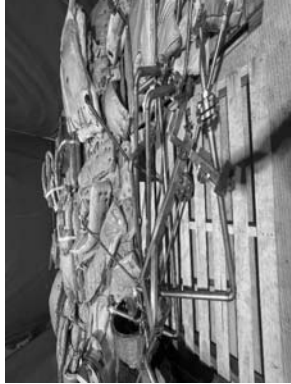
All drains overall condition..

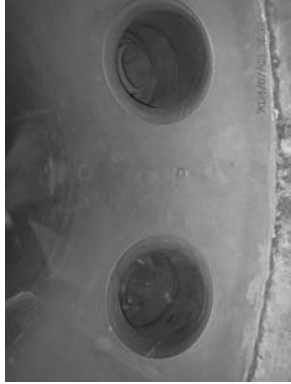
Bleed pipe exits overall condition.

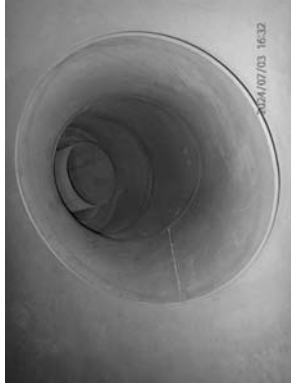
Condition on right bleed pipe.

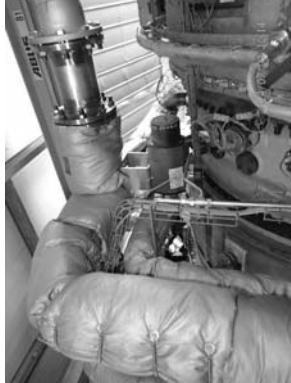
Cooling sealing air pipe overall condition.

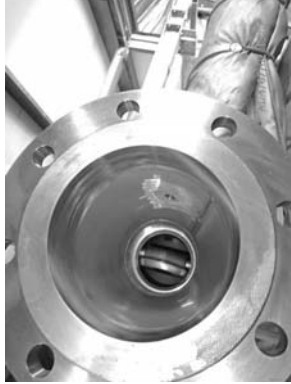
Butterfly valve condition inside the pipe.

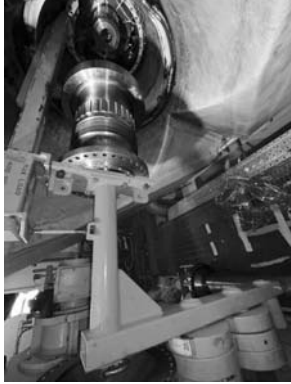
Coupling on Bearing I overall condition.

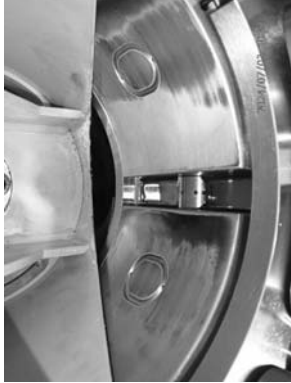
- Axial and radial bearing pads found minor scratches marked on some pads.
- Light oil varnish deposit noticed on bearing surface.

Example of as found condition on radial jacking oil pads.

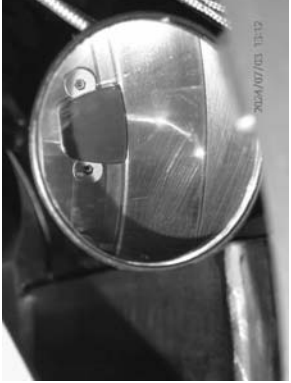
Example of trust axial pads overall condition.

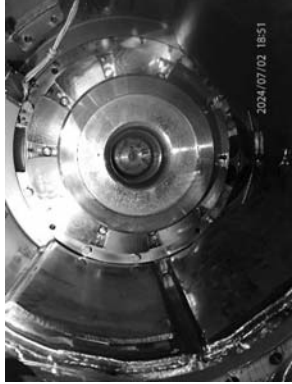
Axial thrust pads as found overall condition.

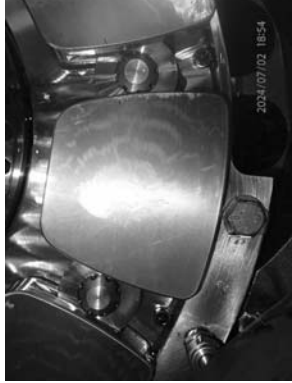
Close view on axial thrust pads before clean.

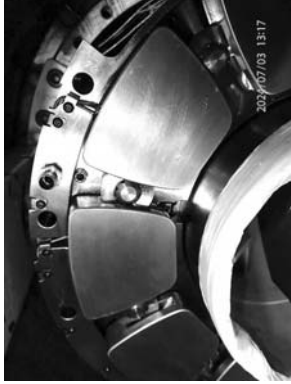
Example of axial pad after cleaned condition.

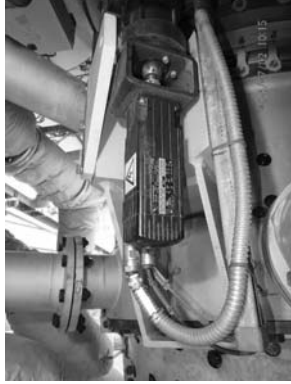
GV actuator support bracket overall condition.

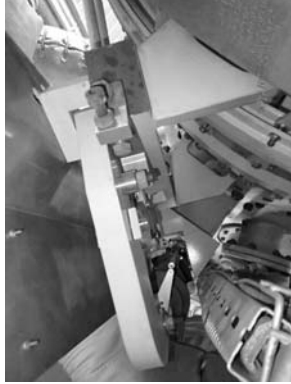
GV actuator arm linkage overall condition.

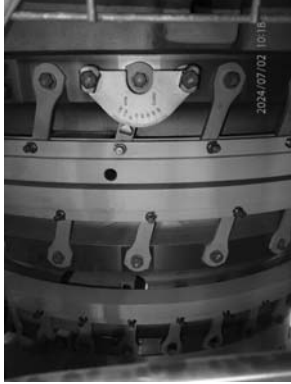
Guide vane mechanism overall condition left side.

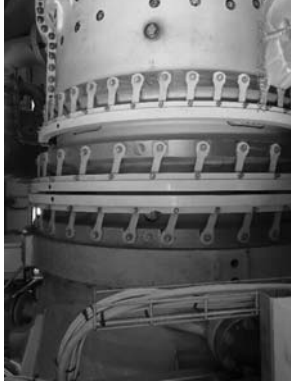
Guide vane mechanism overall condition right side.

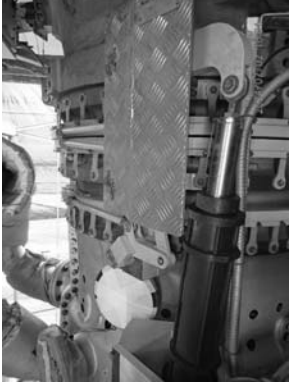
Guide vane mechanism overall condition top side.

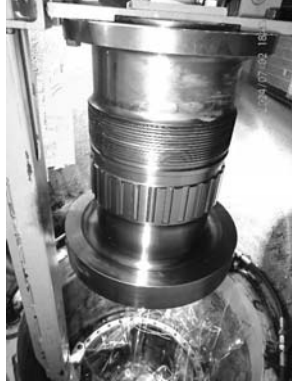
- Measure height of sealing edges on coupling 1 and visual inspection on splines. No remarks found.
- Minor red deposits have been observed at the compressor rotor stage#12 to stage #15.

Compressor coupling as found condition.

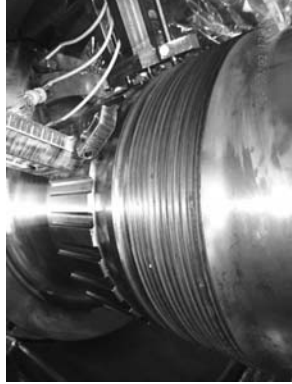
Compressor coupling caulked sealing edges condition.

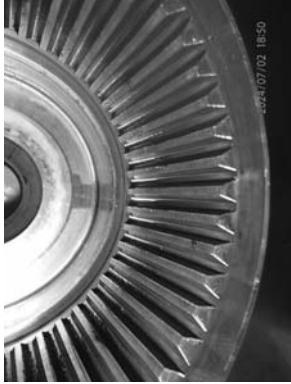
Example closeup on coupling spline condition.

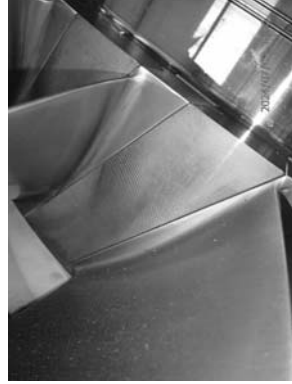
Example of compressor rotor stage 1 condition.

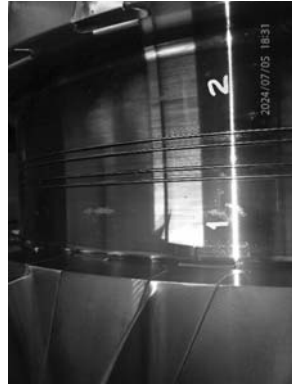
Example of corrosion found between stages 1-2.

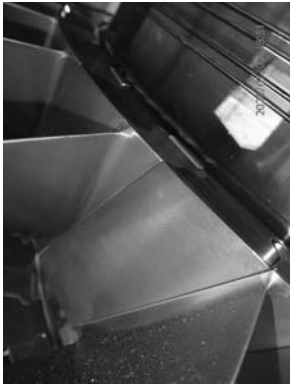
Example of compressor rotor stage 2 condition.

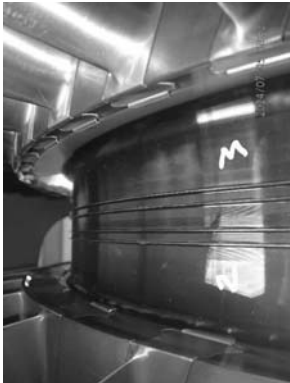
Example of corrosion found between stages 2-3.

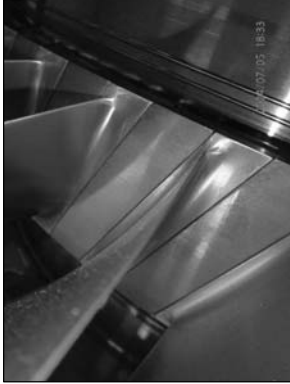
Example of compressor rotor stage 3 condition.

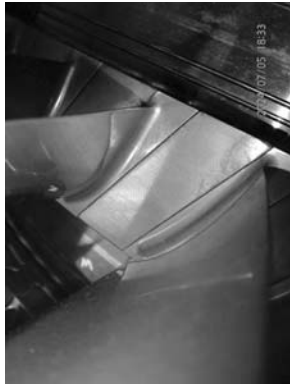
Example of compressor rotor stage 4 condition.

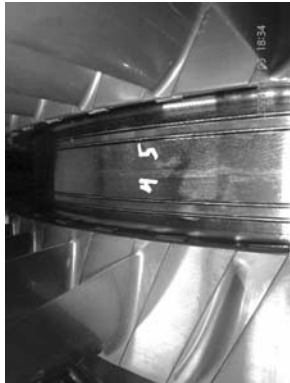
Example of corrosion found between stages 4-5.

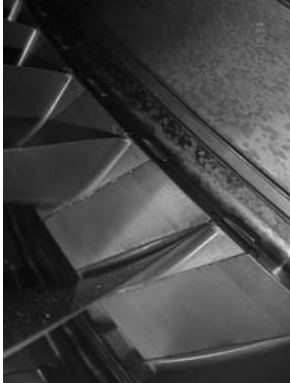
Example of compressor rotor stage 5 condition.
