Inspection Report

Subject / Title:
BD000166U02 SSUT, MO-60 KEOH, 2024, Inspection report

: SSUT Bangpoo GT12

: SGT-800

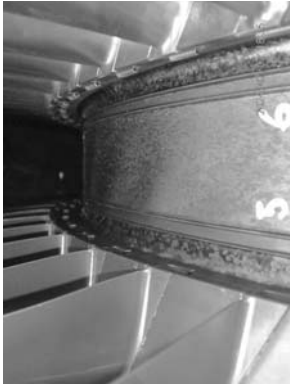
Example of corrosion found between stages 5-6.

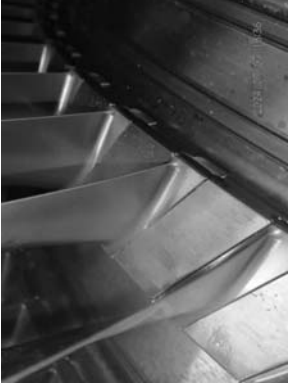
Example of compressor rotor stage 6 condition.

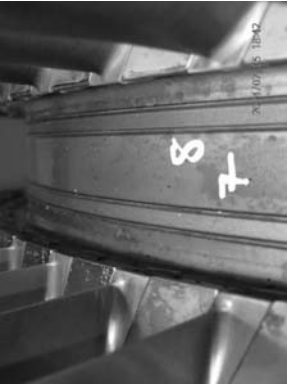
Example of corrosion found between stages 7-8.

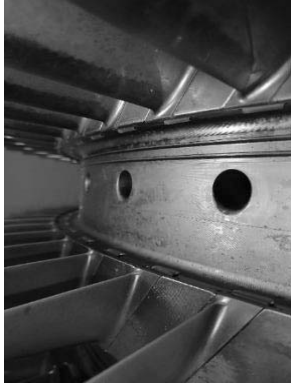
Example of corrosion found between stages 8-9.

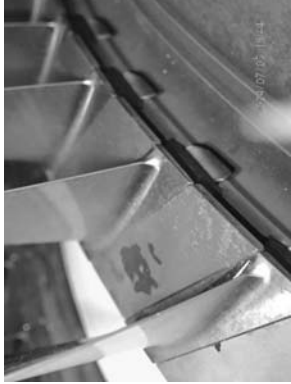
Example of compressor rotor stage 9 condition.

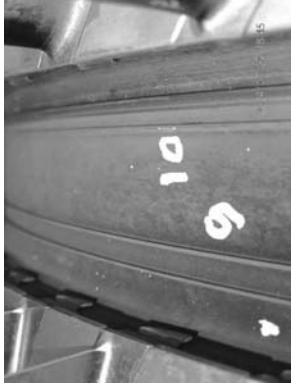
Example of corrosion found between stages 9-10.

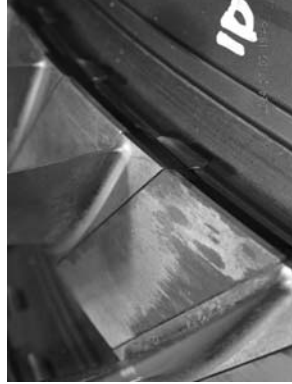
Example of compressor rotor stage 10 condition.

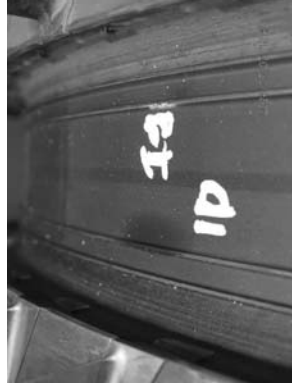
Example of corrosion found between stages 10-11.

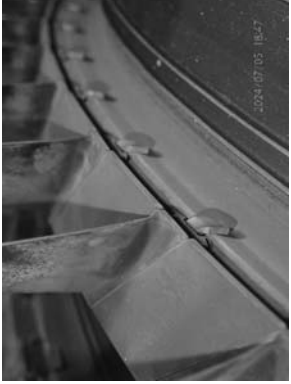
Example of compressor rotor stage 12 condition.

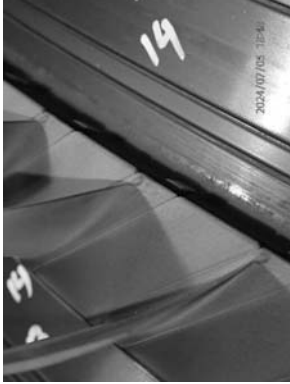
Example of compressor rotor stage 14 condition.

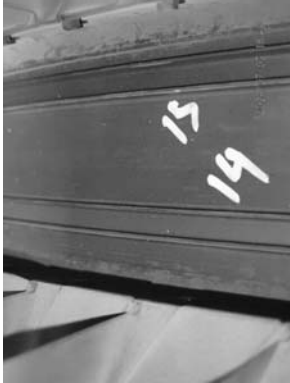
- Measure height of sealing edges on coupling 1 and visual inspection on splines. No remarks found.
- Minor red deposits have been observed at the compressor rotor stage#12 to stage #15.

Example of corrosion found between stages 14-15.

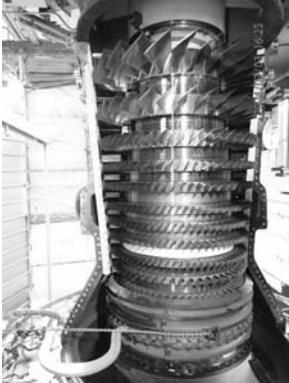
Balancing weight location on BP2.

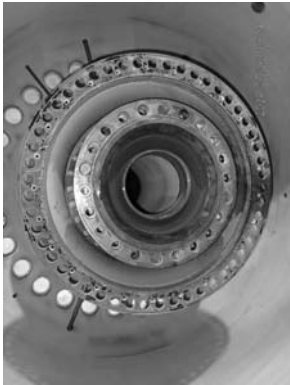
Compressor rotor spigot fit area overall condition.

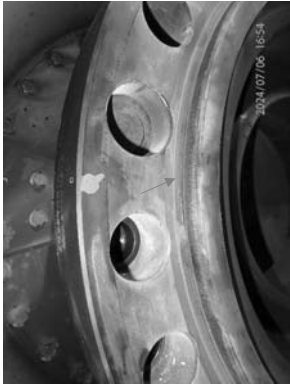
Example close view on spigot fit surface condition.

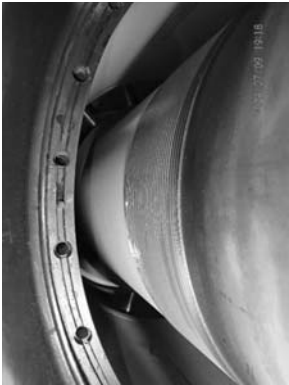
Compressor rotor turned seals at bottom location.

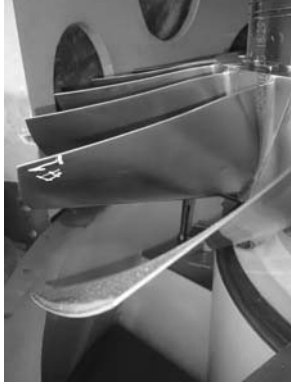
Compressor blades stage 1 overall condition.

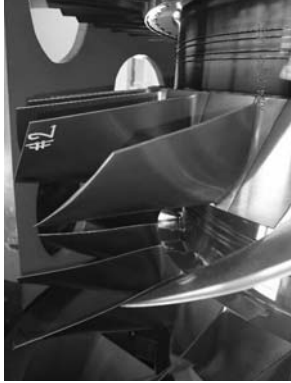
Compressor blades stage 2 overall condition.

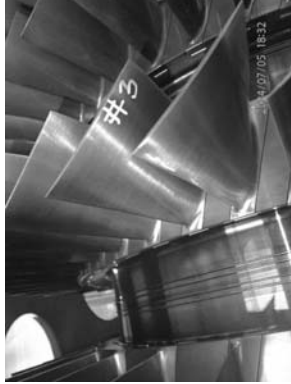
Compressor blades stage 3 overall condition.

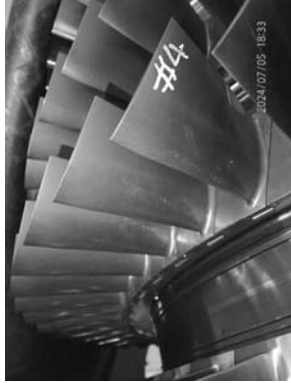
Compressor blades stage 4 overall condition.

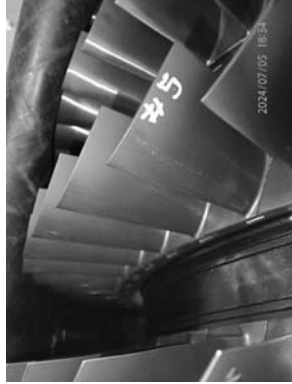
Compressor blades stage 5 overall condition.

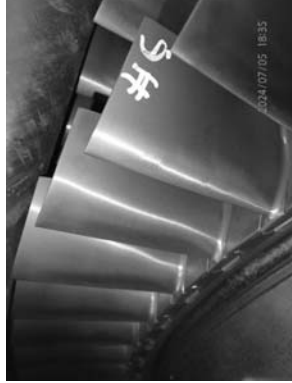
Compressor blades stage 6 overall condition.

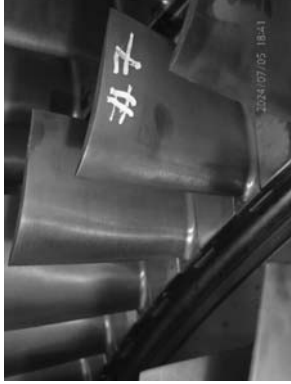
Compressor blades stage 7 overall condition.

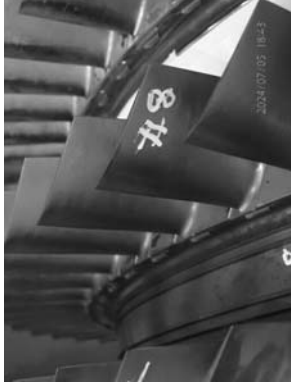
Compressor blades stage 8 overall condition.

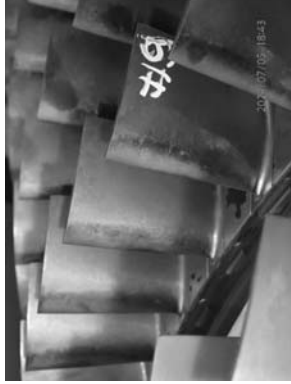
Compressor blades stage 9 overall condition.

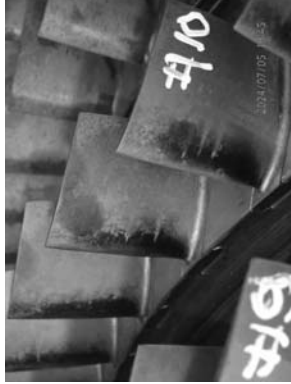
Compressor blades stage 10 overall condition.

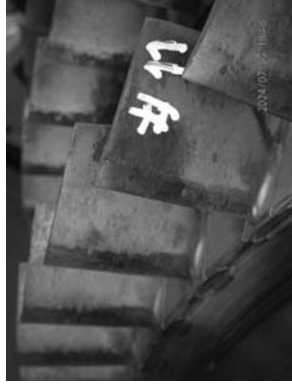
- Minor red deposits have been observed at the compressor blades stage#12 to stage #15.

Compressor blades stage 11 overall condition.

- Dry ice blasting performed for cleaning of corrosion on compressor blades.

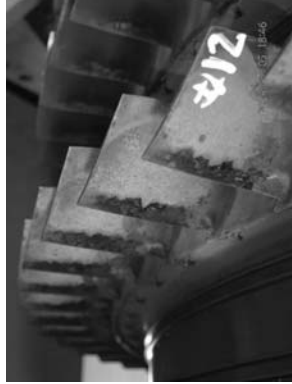
Compressor blades stage 12 overall condition.

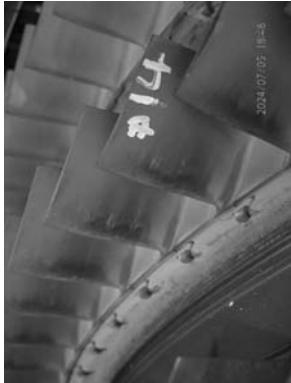
Compressor blades stage 14 overall condition.

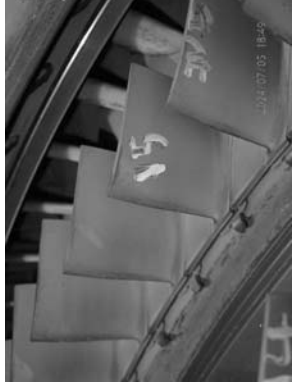
Compressor blades stage 15 overall condition.

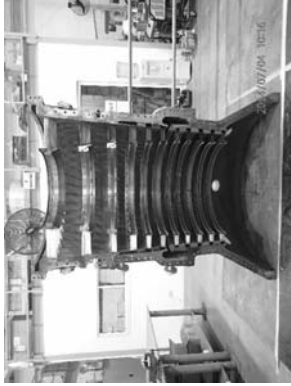
Compressor casing left half inside - outside view overall condition.

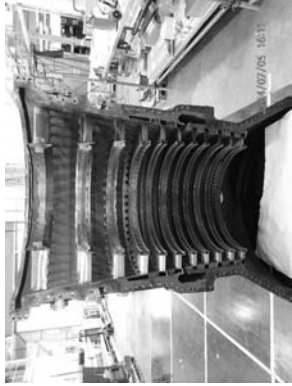
Compressor casing right half inside overall condition.

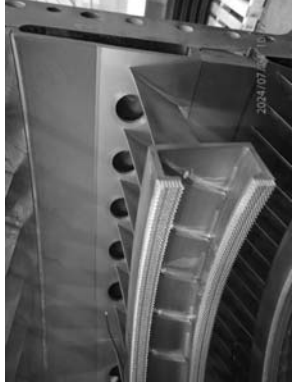
- Minor wear marks noticed on all stages of abrasible seals.

Condition of abrasible seal stage 3.

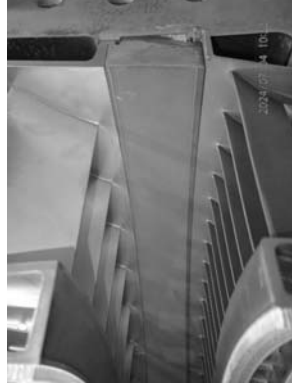
Condition of abrasible seal stage 4.

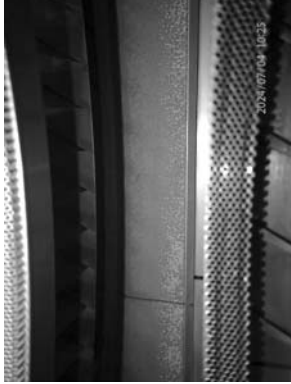
Condition of abrasible seal stage 6.

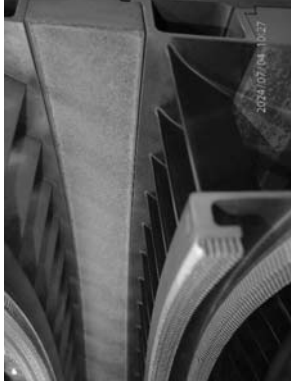
Condition of abrasible seal stage 7.

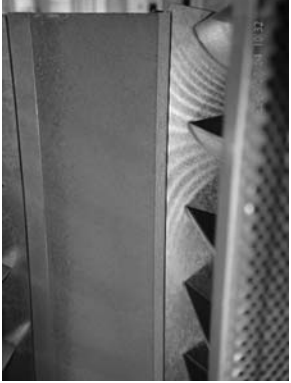
Condition of abrasible seal stage 9.

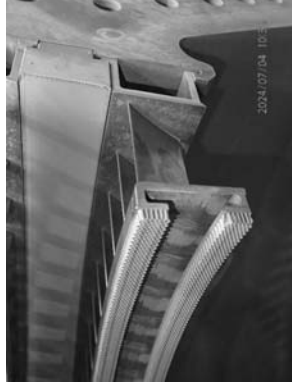
Condition of abrasible seal stage 10.

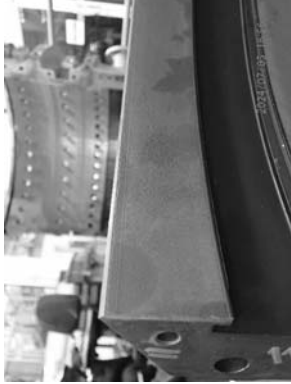
Example of abradable seal stage 11 overall condition.

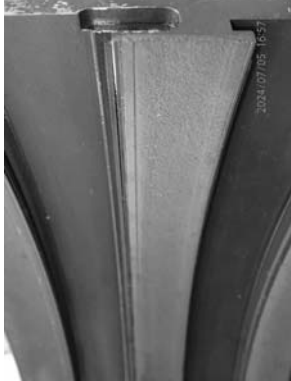
Example of abradable seal stage 12 overall condition.

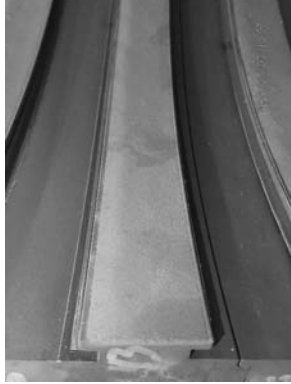
Example of abradable seal stage 13 overall condition.

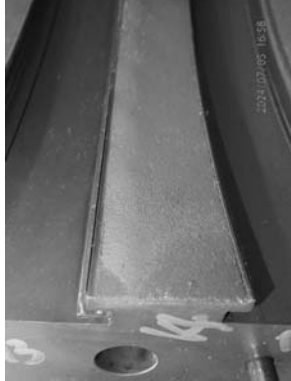
Example of abradable seal stage 14 overall condition.

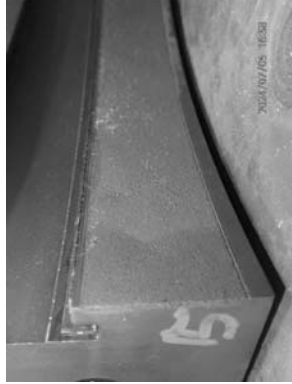
Example of abradable seal stage 15 overall condition.

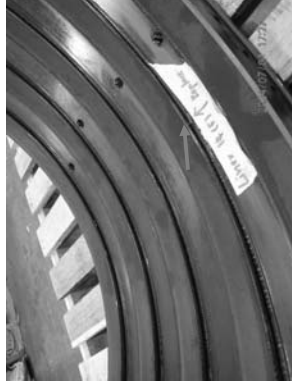
- Minor wear marks noticed on all stages of abrasible seals.
- Found damaged on spacer ring front liner inner stage#14.

Spacer ring front liner stage 14 found damaged.

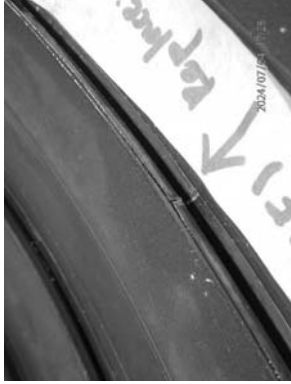
Close up view around damaged point on spacer ring front liner stage 14.

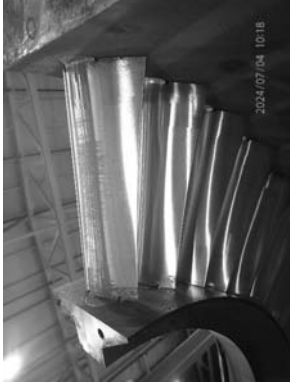
VGV stage 0 overall condition.

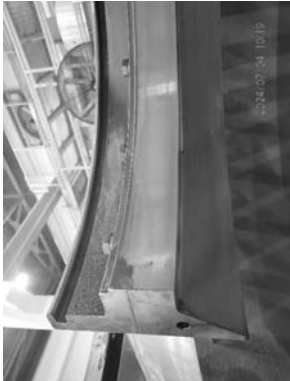
VGV stage 0 inner ring condition.

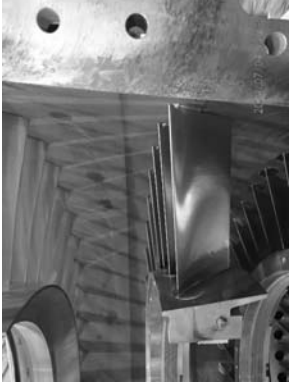
VGV stage 1 overall condition.

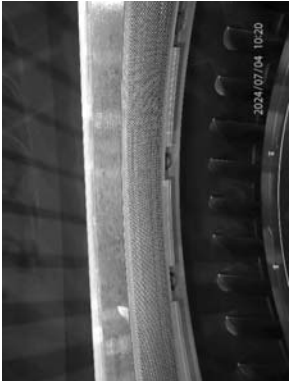
VGV stage 1 inner ring and honeycomb overall condition.

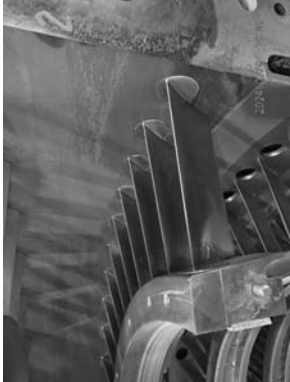
VGV stage 2 overall condition.

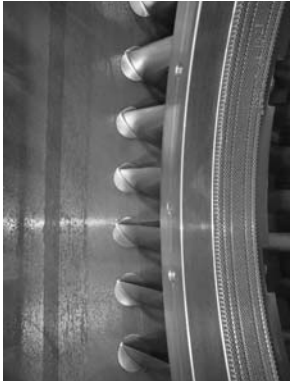
VGV stage 2 inner ring and honeycomb overall condition.

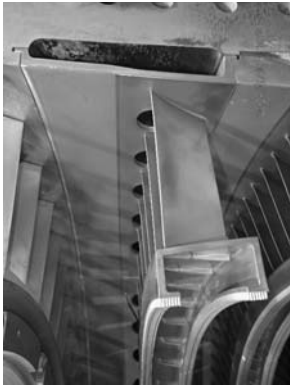
- Honeycomb wears within tolerance limit observed on all stages.
- Relevant cracks indication found by PT on guide vane segments compressor stator stage #3, #10 and #15.

Example of guide vanes stage 3 overall condition.

- Compressor guide vanes stage #3, #10 and #15 have been changed complete set with new spare during this MO 60 inspection.
- Compressor guide vanes were cleaned by dry ice blasting to remove corrosion.

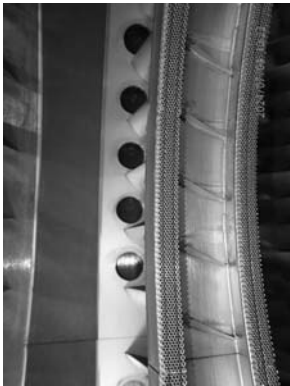
Example of guide vanes stage 3 honeycomb wear condition.

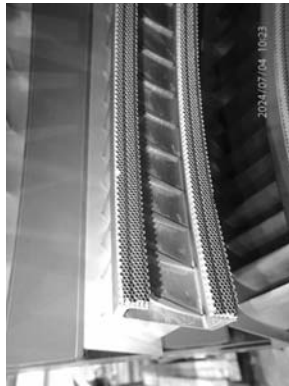
Example of guide vanes stage 4 honeycomb wear condition.

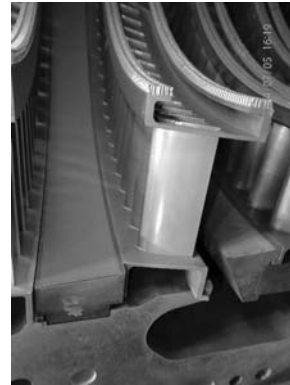
Example of guide vanes stage 5 overall condition.

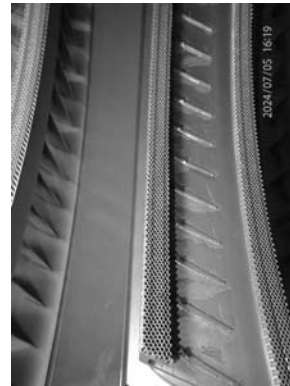
Example of guide vanes stage 5 honeycomb wear condition.

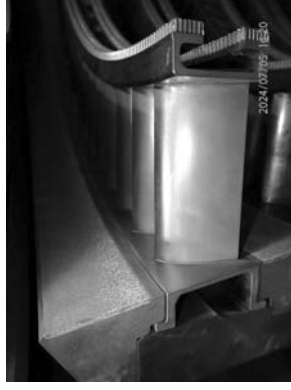
Example of guide vanes stage 6 overall condition.

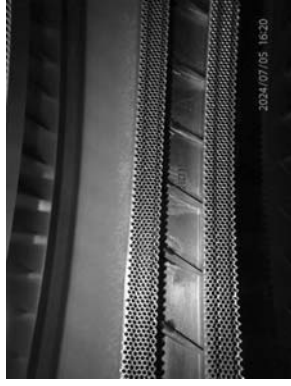
ple of guide vanes stage 6 honeycomb wear condition.

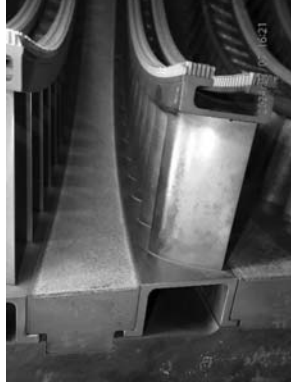
Example of guide vanes stage 7 overall condition.

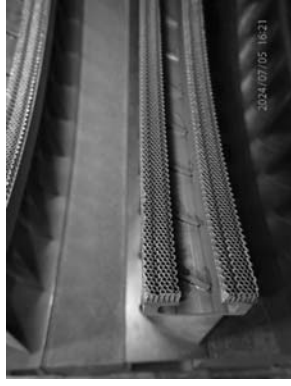
ple of guide vanes stage 7 honeycomb wear condition.

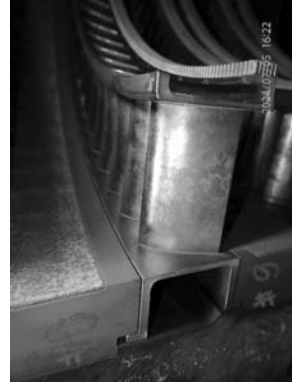
Example of guide vanes stage 8 overall condition.

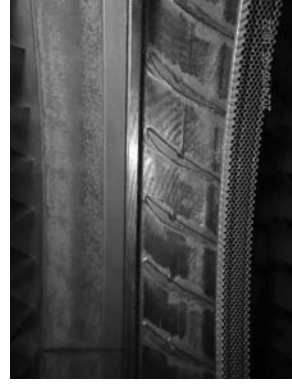
ple of guide vanes stage 8 honeycomb wear condition.

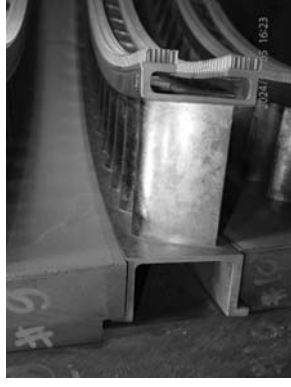
Example of guide vanes stage 9 overall condition.

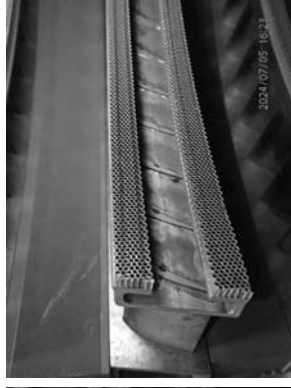
2 of guide vanes stage 9 honeycomb wear condition.

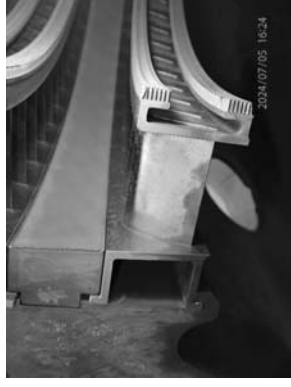
Example of guide vanes stage 10 overall condition.

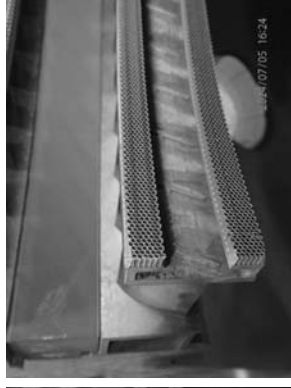
2 of guide vanes stage 10 honeycomb wear condition

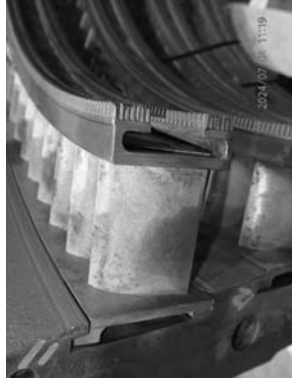
Example of guide vanes stage 11 overall condition.

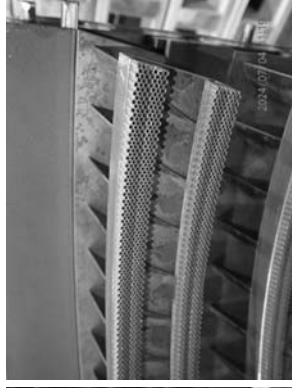
of guide vanes stage 11 honeycomb wear condition

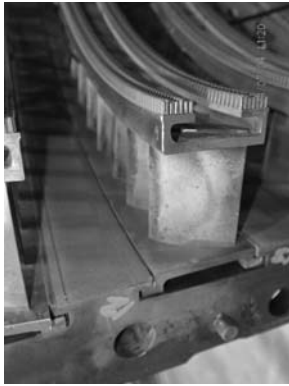
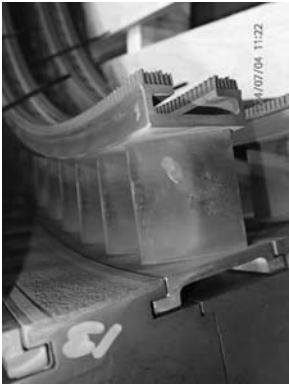
Example of guide vanes stage 12 overall condition. Example of guide vanes stage 12 honeycomb wear condition.

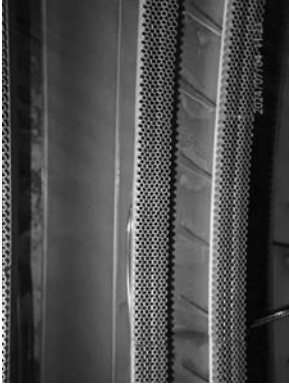
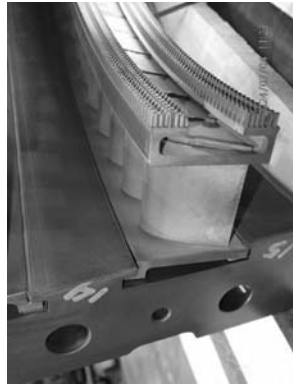
Example of guide vanes stage 13 overall condition. Example of guide vanes stage 13 honeycomb wear condition.

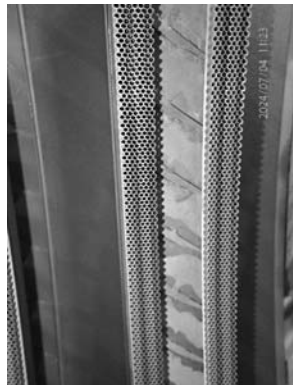
Example of guide vanes stage 14 overall condition. Example of guide vanes stage 14 honeycomb wear condition.

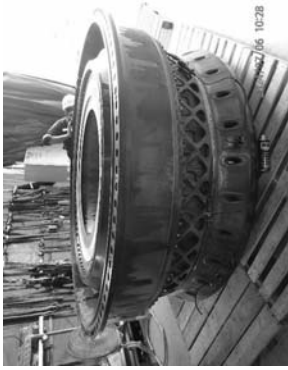
Combustor after removed overall condition.

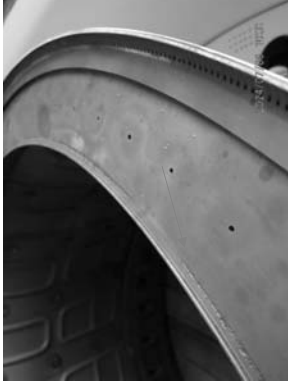
- Fretting from contact with main inner ring at inner diaphragm sealing.
- Observed debris deposit inside combustion chamber and turbine flange.
- Combustor has been replaced with the new part as according to the document for MO 60 maintenance plan.
- Combustor diaphragm and turbine flange were geometrically deformations which lead to the deviation of relative rotor to stator position from normal operating values.

Fretting condition at combustor contact area.

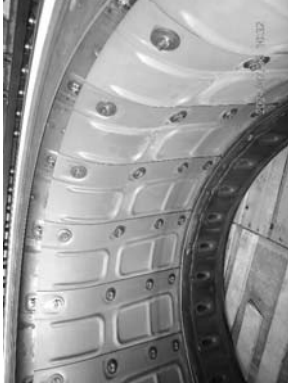
Inner heatshield seen from turbine side overall condition. Combustion diaphragm and turbine flange disassembly.

- The recommendation from engineering support team, is to adjust this relative rotor to stator position to reduce the risk in axial contact between turbine stator and rotor parts, and to

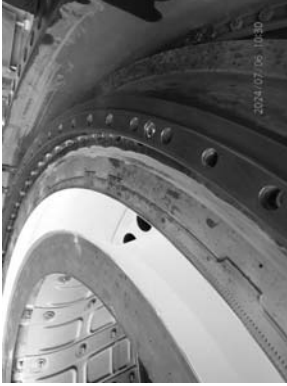
Example of outer outlet ring cooling holes.

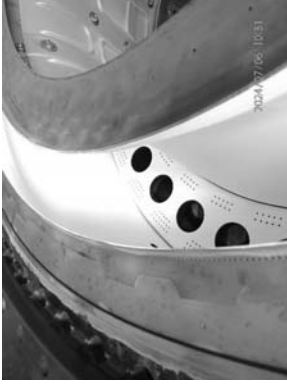
Example of inner outlet ring cooling holes.

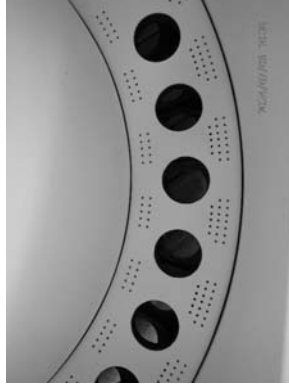
Front panel inner/outer wall TBC condition.

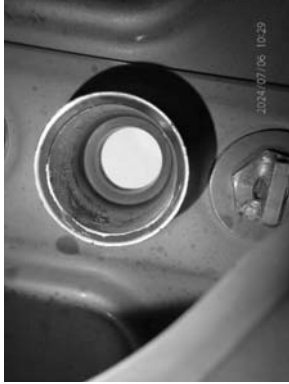
Example of fretting condition at flame detector port.

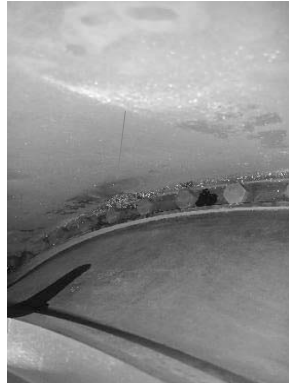
Debris deposit around Turbine flange.

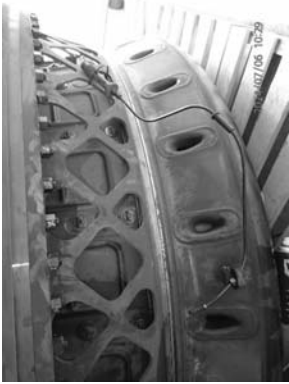
Pulsation tubes as found condition.

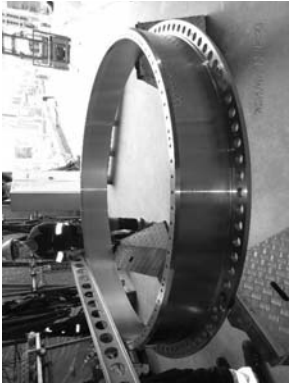
New turbine flange during performed the measurement.

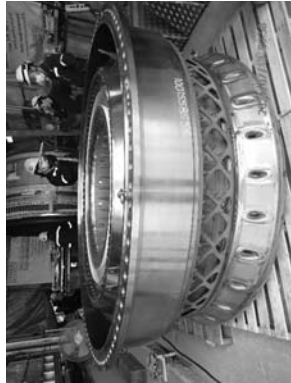
New complete set of combustor, turbine flange and diaphragm.

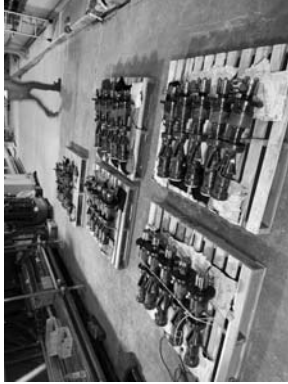
All removal burners as found condition.

- Burner replacement according to SGT-800 M0 60 inspection maintenance plan.
- Old set of burners will be sent back to Siemens Energy for further inspection and refurbish.

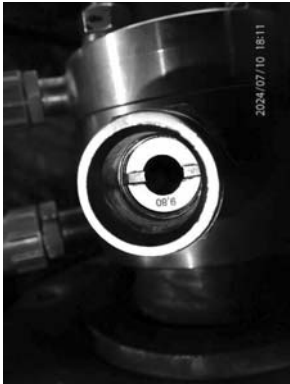
Example condition in main gas fuel port.

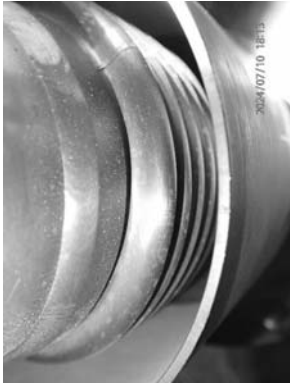
- Minor deformed of outer bellow noticed.
- Fretting at hood sealing and at pilot flame piston ring area.
- Fuel injector burner has been replaced during this MO 60 inspection.
- TBC loss at tip.

Example of minor deformed on outlet bellow condition.

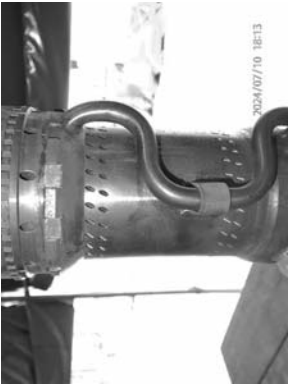
Example of pilot fuel pipe condition.

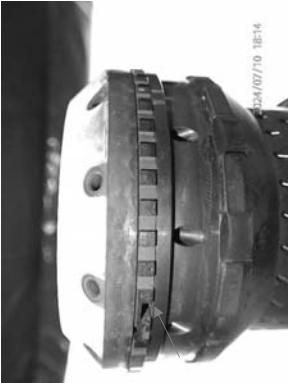
Example of fretting at pilot flame piston ring condition.

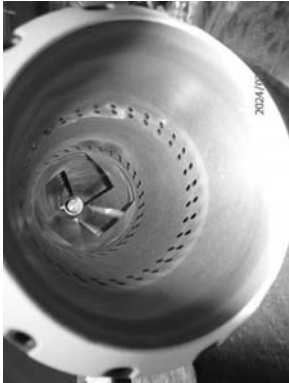
Example of inside mixing chamber condition.

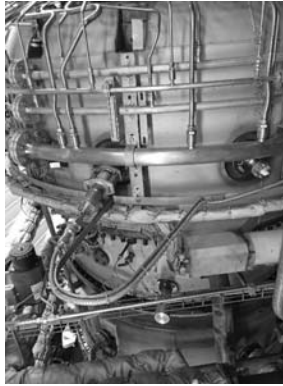
Result:
- No remark.

Flame detector overall condition before dismantling (MBA10CQ0005-left and MBA10CQ010-right).

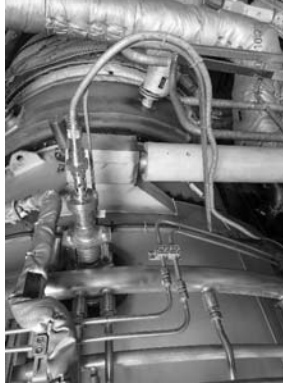
Flame detector body overall condition.

Flame detector is in serviceable conditions.

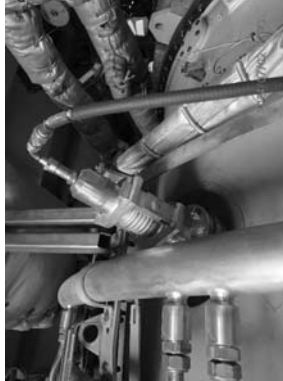
Ignitor body overall condition.

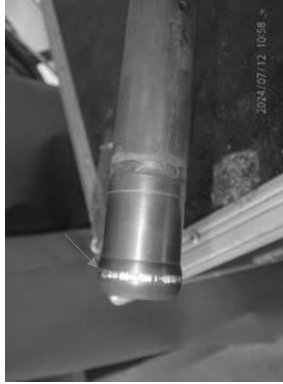
Result:
- Minor fretting found on the tip fitting sphere area.

Condition of fretting at tip area.

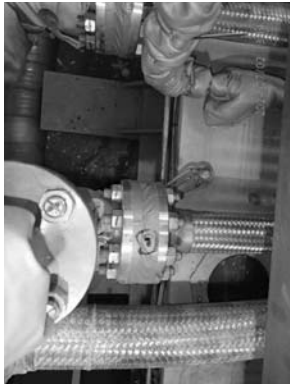
Main gas fuel supply tie-in overall condition.

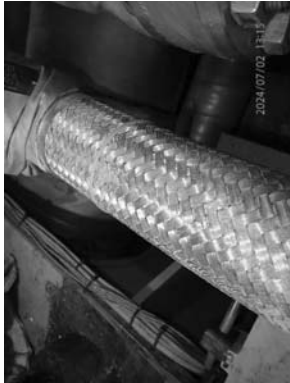
Example of flexible hose condition.

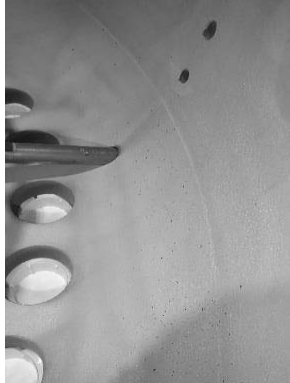
Central casing drain area internal condition.

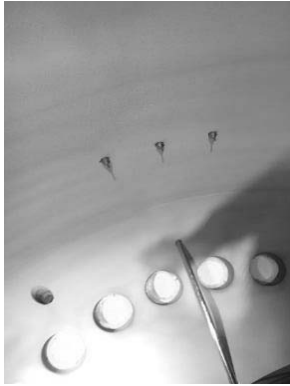
Central casing inside as found condition.

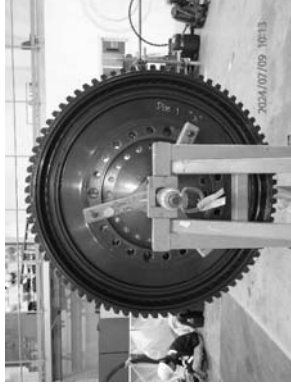
Disc 1 "X" side overall condition.

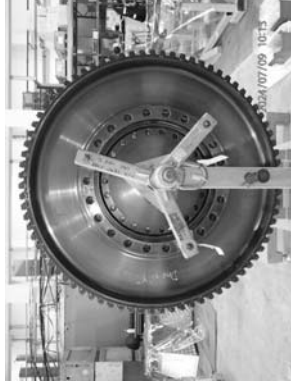
Disc 1 "Y" side overall condition.

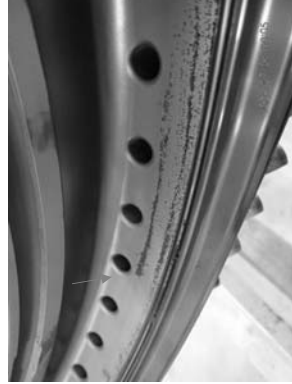
- Found fine dark particles at front of turbine disc 1 blades cooling entrance.
- Found fine dark particles, debris in the root of disc #2 groove.
- Fretting observed on root of TD#2 root and groove.
- Found gap between locking plates and sealing plates of turbine blade stage #1 "X and Y" sides were over than acceptable range.
- Sealing ring 1 has been replaced during this inspection from reason new design, which following to maintenance activity list.

Example of fine dark particles in front of cooling intake to blades "X" side and around the sealing plate "Y" side.

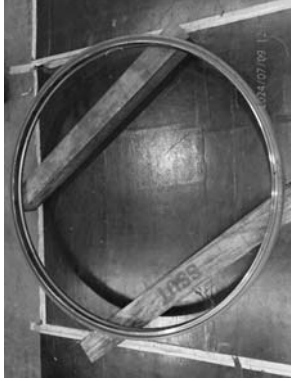
Sealing ring (Old) between disc 1-2 overall condition.

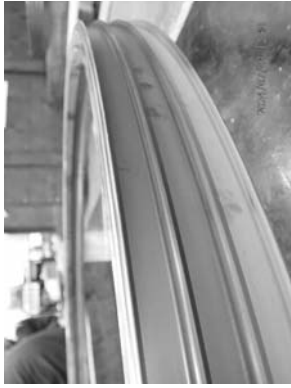
Close up on sealing ring 1-2 seating slot.

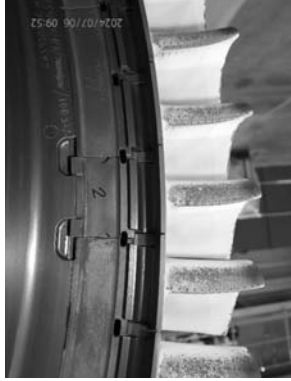
Actual gap at Blade 1 position 2 upstream side.

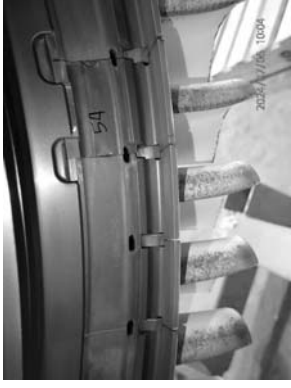
Gap checked at Blade 1 position 54, upstream side.

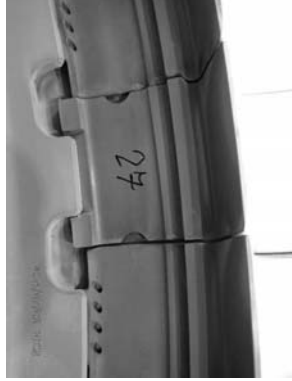
Example view for actual gap at Blade 1 position 27 (left) and 52 (right) for downstream side.

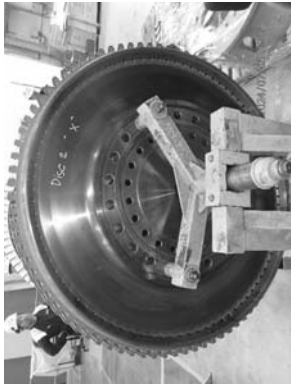
Disc 2 "X" side overall condition.

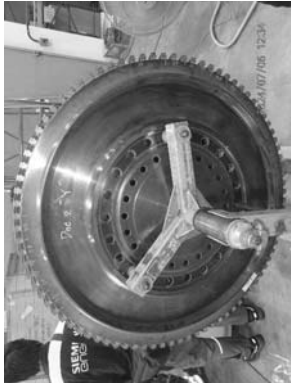
Disc 2 "Y" side overall condition.

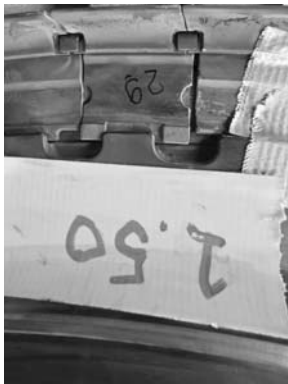
Example view for actual gap at Blade 2 downstream side.

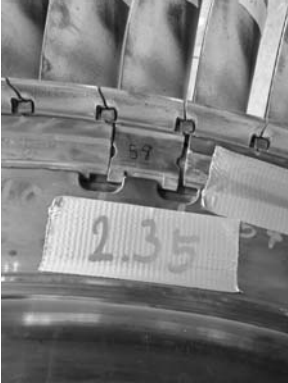
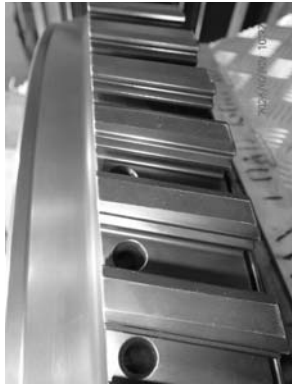
Example view of fir-free condition on Turbine disc#2 and fine dark particles found in the groove.

- All turbine discs and rotor hub are cleaned prior to assembly.
- PT test was performed on rotor hub no indication of crack found.
- NDT test was performed on turbine disc 2 by SE NDT Engineer.

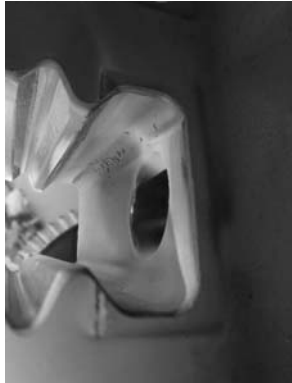
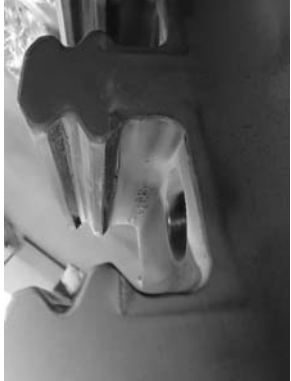
Example view for condition on blade root and groove on turbine disc#2.

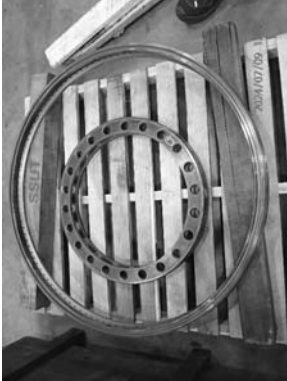
Sealing ring (Old) between disc 2-3 overall condition.

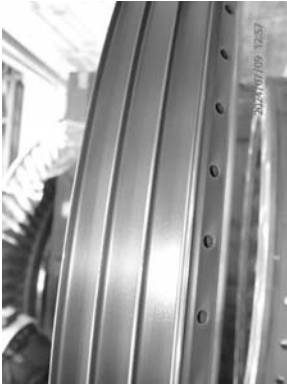
Close up on sealing ring 2-3 seating slot.

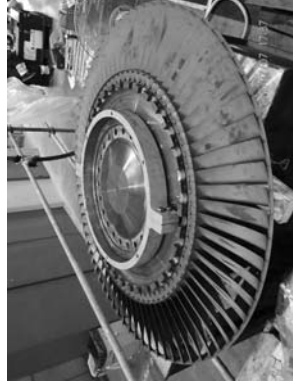
Disc 3 "Y" side overall condition.

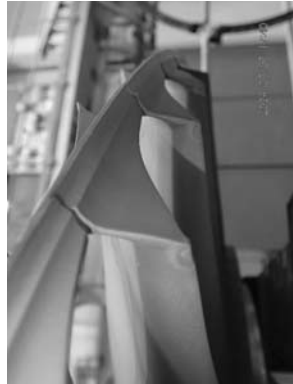
Disc 3 "X" side blade tip example condition.

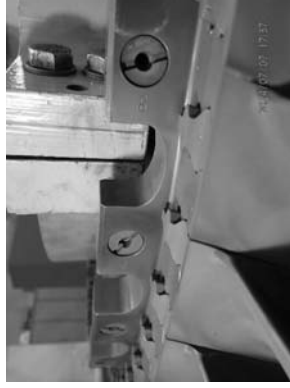
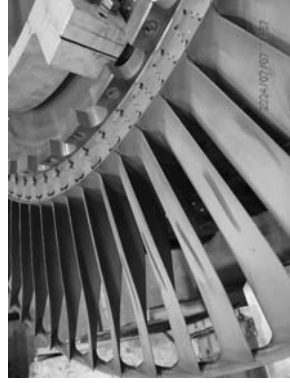
Example view for conditions of Balancing weights on Turbine disc#3.

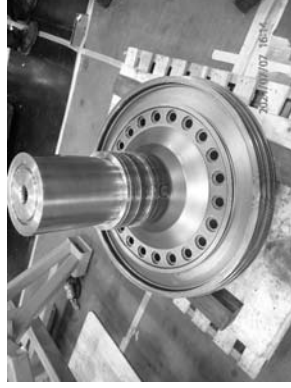
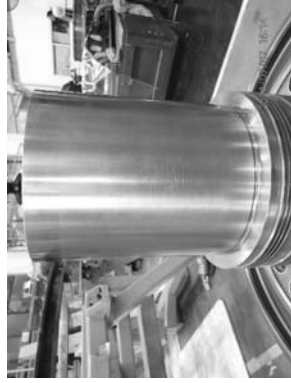
Rotor hub condition seen from against flow direction.

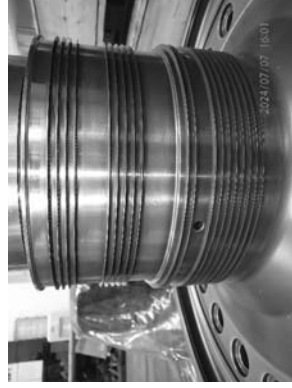
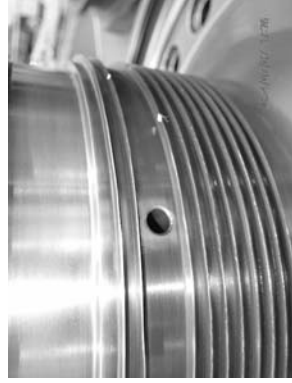
Caulked sealing edges rotor hub as found condition.

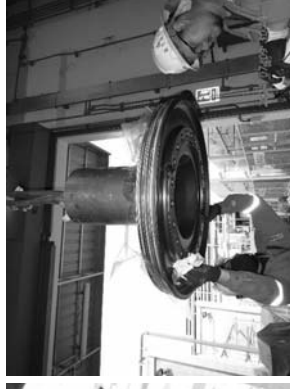
Turned sealing edges rotor hub as found condition.

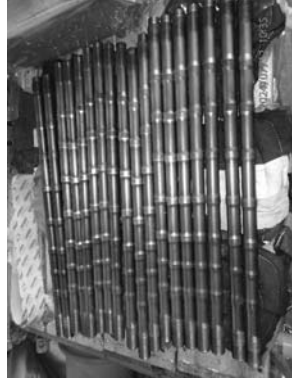
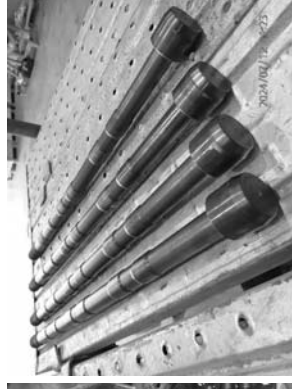
Tie-bolts overall condition.

Module bolts overall condition.

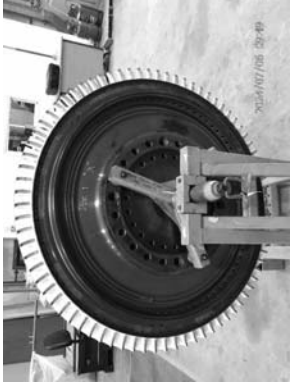
- TBC coating loss condition noticed on leading edge, blades tip and trailing edge and some on trailing edge base platform stage 1.
- Oxidation found on leading edge cooling holes, blade tip and rear platform of turbine blades stage 1.
- Oxidation and discoloration found on Turbine blade stage#2.
- Minor rubbing marks have observed at leading edge tip turbine blade stage 3.
- Turbine blades stage#1 and #2 have been replaced during this MO 60 inspection.

Turbine blade 1 condition "X" side.

- Turbine blades stages 1 and 2 replacements according to SGT-800 C-inspection maintenance plan.
- Follow up the conditions of rubbing marks at TB#3 tip during next inspection.
- Old blades are packed and ready for shipping back to Siemens Energy for further examination.

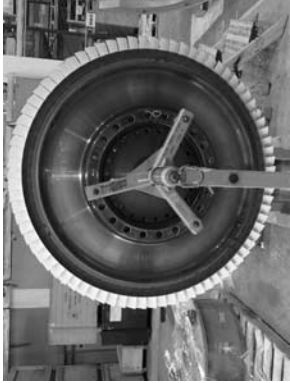
Turbine blade 1 condition "Y" side.

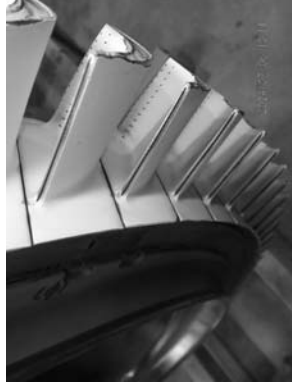
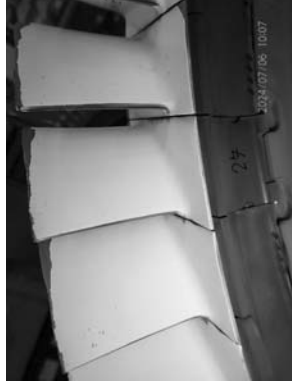
Example of blade 1 trailing side overall condition.

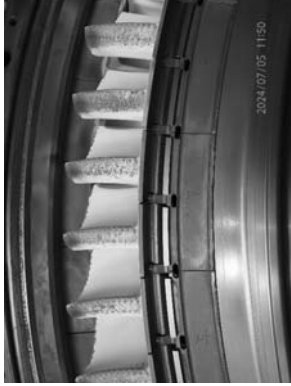
Example view of blade 1 leading side overall condition.

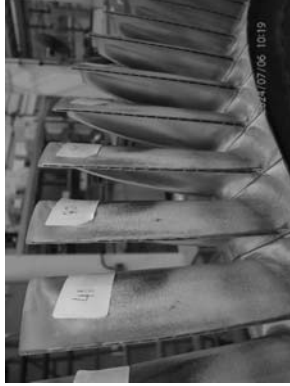
Turbine blade 2 condition before disassembled.

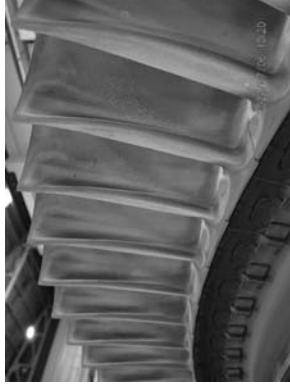
Discoloration on blade 2 leading side overall condition.

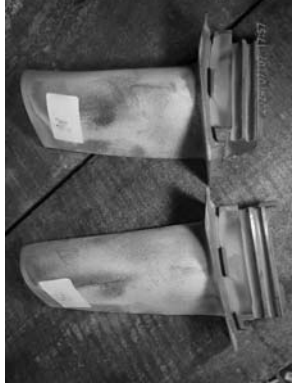
Example of blade 2 suction side overall condition.

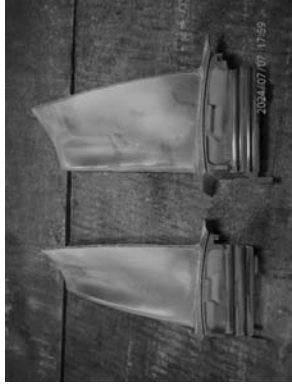
Example of blade 2 pressure side overall condition.

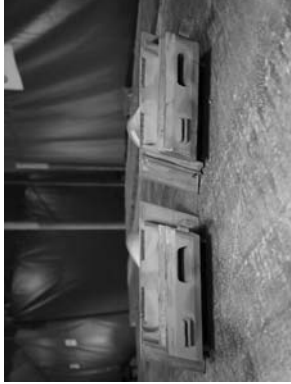
Example of internal cooling entrance condition.

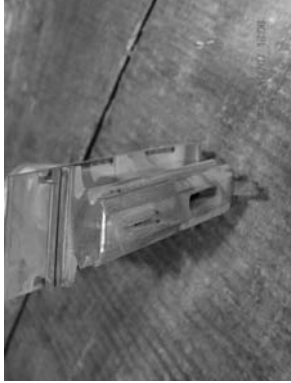
Example of blade 2 fir-tree as found conditions.

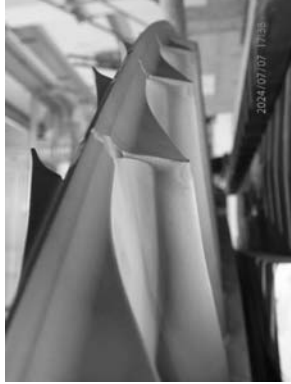
Example picture on blade 3 tip leading side.

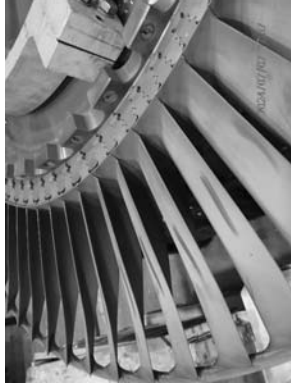
Example picture on blade 3 trailing side.

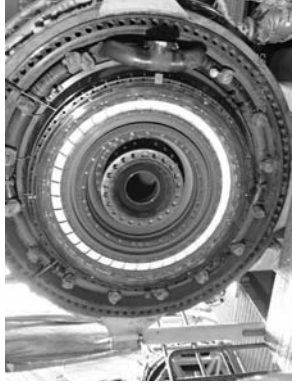
- Inner/Outer vane plates noticed with TBC coating loss and oxidation/cracks found at the lip of Outer vane plate.
- Minor fretting observed on all inner cooling air pipes fitting diameter and on inner ring.
- Fretting mark noticed on main inner ring at combustor contact surface and wear grooves on honeycomb seal noticed but within inspection criteria.
- Noticed a honeycomb radial wear grooves on swirl generator.
- Split e-seal GV1 stator front found deformation.
- Replacement parts subject to change as according to MO 60 maintenance plan which are, Turbine GV#1, Inner / Outer Vane plate, Heat shield#1 and rear hook#1.

GV1 as found condition before remove.

- Turbine GV#1, Inner/outer vane plates and HS#1 have been replaced according to SGT-800 MO-60 inspection maintenance plan.

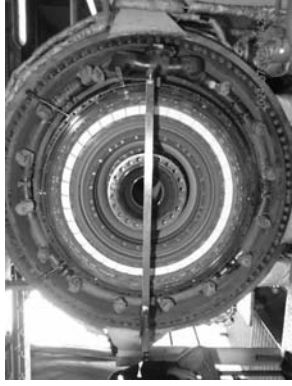
C&D measurement on GV1 stator and rotor.

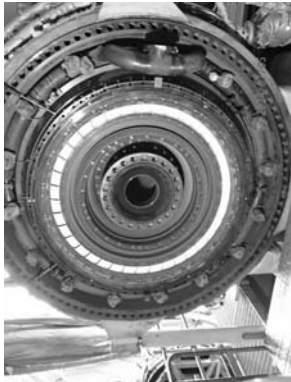
GVI Overall condition before dismantled (left) and after dismantled from gas turbine (right).

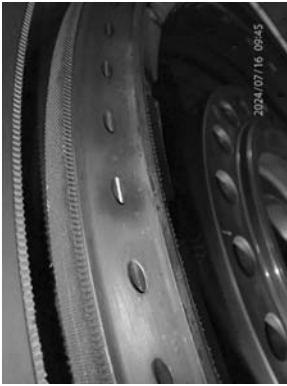
Honeycomb wear condition on swirl generation.

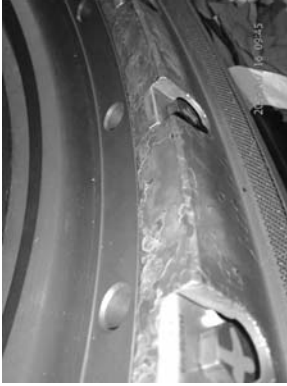
Honeycomb wear condition on swirl generation.

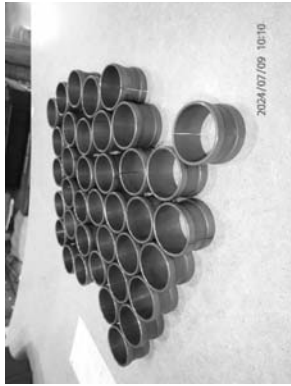
Example of cooling pipes overall condition.

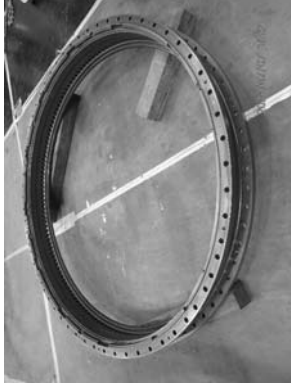
Overview conditions on Stator ring I.

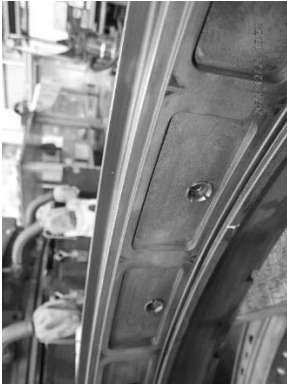
Heatshield I cooling hole overall condition.

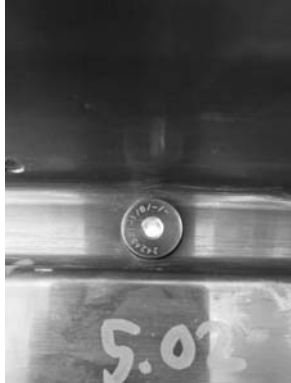
Heat shield cooling air supply plug after modified by add 45 deg chamfer.

- Visual inspection.
- Measurement honeycomb wear on main inner ring and on swirl generator.
- Measurement the orifice diameter of heat shield cooling air supply plug in the guide vane carrier and add 45 deg chamfer of minimum 1 mm. on the outside of orifice.
- B3 Upgraded on some component parts of turbine stator stage 1.

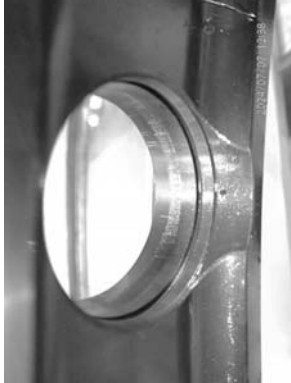
Cooling pipe seating slots overall condition.

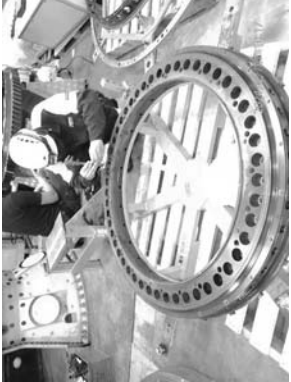
Main inner ring overall condition.

- Replace damaged split e-seal GV1 stator front with new spare part.
- Keep new set of Main inner ring for spare, in case replacement planned for next major overhaul.

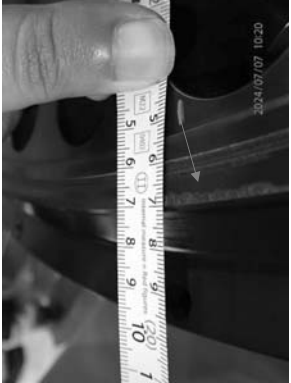
Pretting condition from contact with combustor.

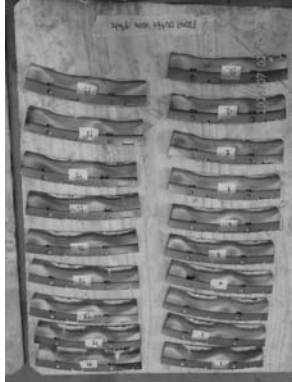
Outer vane plates overall condition.

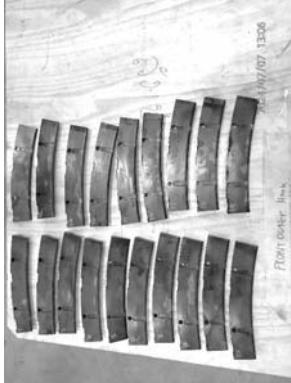
Front outer segments overall condition.

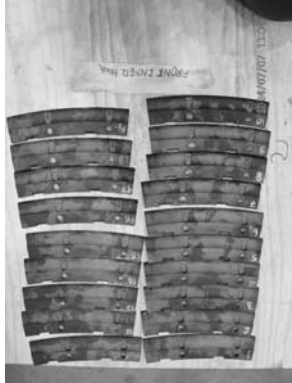
Front inner segments overall condition.

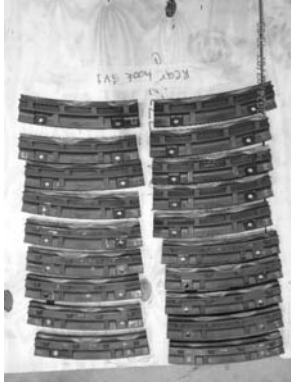
Rear hooks overall condition.

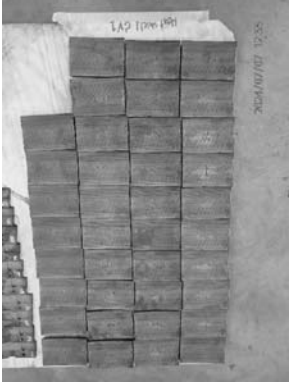
Heatshields 1 overall condition.

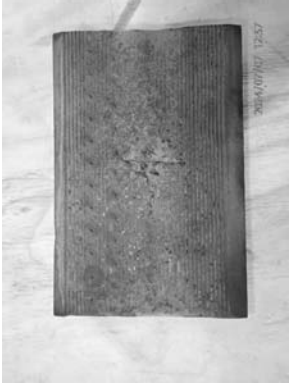
Heatshields 1 overall condition.

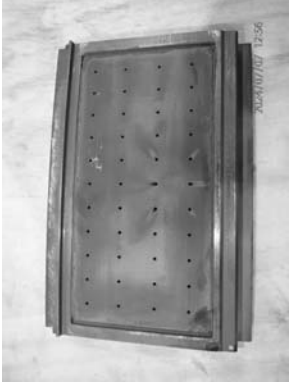
Example of back side of heatshield 1.

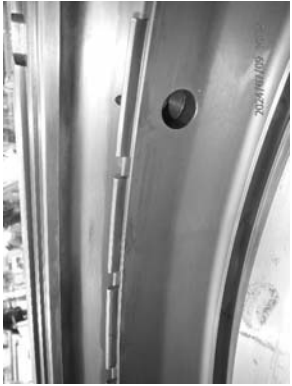
GV2 segments seating slot overall condition.

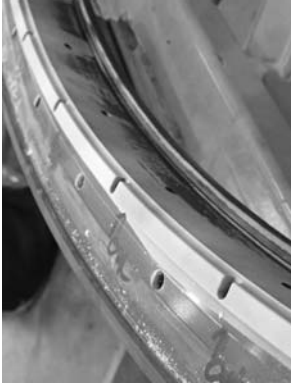
Rear hooks 2 overall condition.

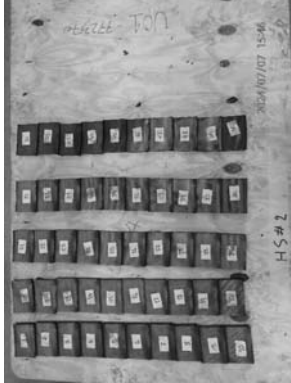
Overview condition on HS#2.

- Replaced new GV#2, HS#2 according to SGT-800 MO60 inspection maintenance plan.
- Replaced GV2 flexible hoses with a new spare set.
- All components will be cleaned prior to assembly.

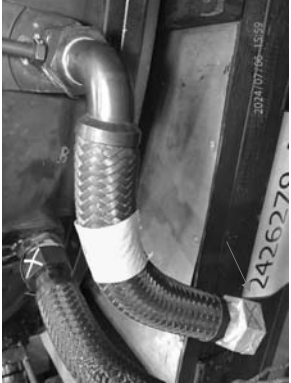
Example view on GV2 cooling hose, flexible thread damaged (left) and hose deformation (right).

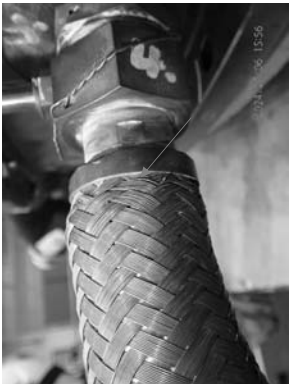
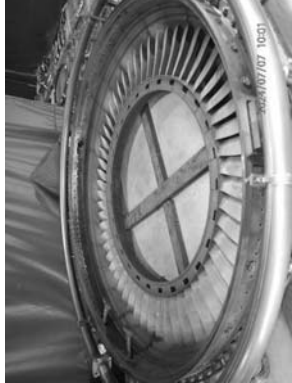
GV3 assembly overall condition against flow direction. Example view on condition of GV3 trailing side.

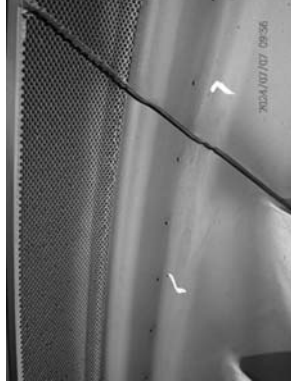
- Wear grooves on stage 3 heat shield honeycomb observed.
- Fretting observed on GV3 heat shield contact area with outlet casing and worm groove on E-sealing ring seating area.
- Observed minor fretting marks on GV#3 locking ring. Depth of contact marks are measured, and the result is in criteria.
- Observed 2 pieces of GV2 flexible hoses are damaged.
- Observed cracks indication from PT in area of HS#2 slot, about to 28 locations.
- Replacement parts subject to change as according to MO 60 maintenance plan which are, Turbine GV#2 and Heat shield#2.

Heatshield 3 honeycomb wear groove at outer platform.

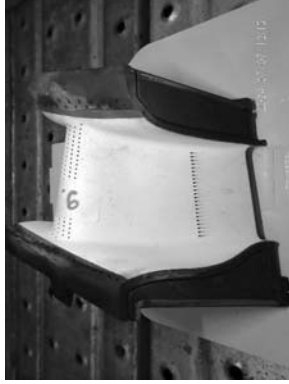
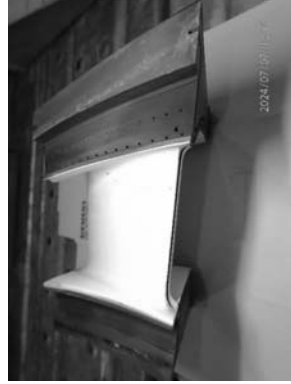
Mild oxidation conditions on CV1 suction side (left) and leading side (right).

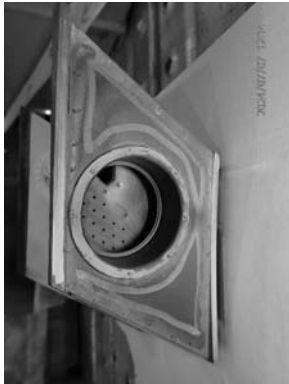
GV1 cooling pipe slot condition.

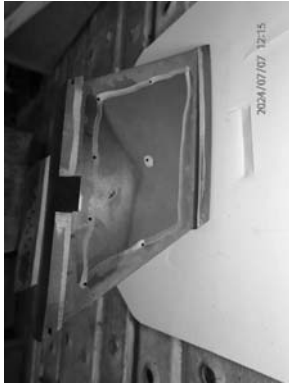
Outer platform of GV1 overall condition.

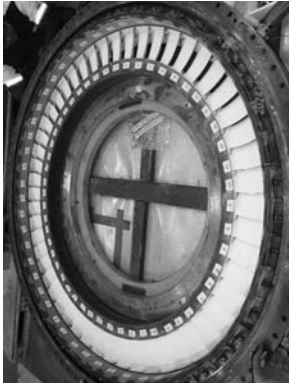
Example view on GV2 condition before dismantling.

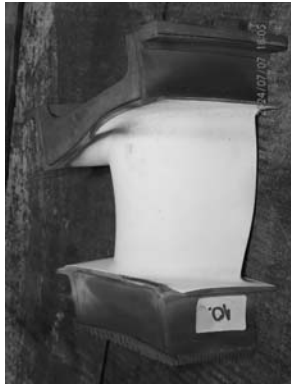
- Oxidation observed on pressure side of guide vanes stage 1 and inner platform cooling holes leading edge side.
- Oxidation found on leading edge inner platform on guide vanes stage 2.

Oxidation noticed on leading edge inner platform of GV42.

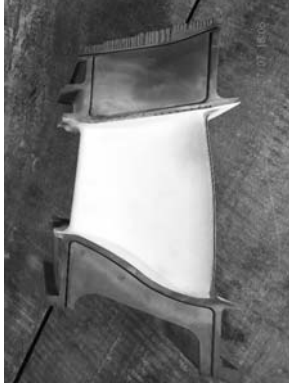
Example view for GV2 convex side overall condition.
