Inspection Report

Subject / Title:
BD000166U02 SSUT, MO-60 KEOH, 2024, Inspection report

: SSUT Bangpoo GT12

: SGT-800

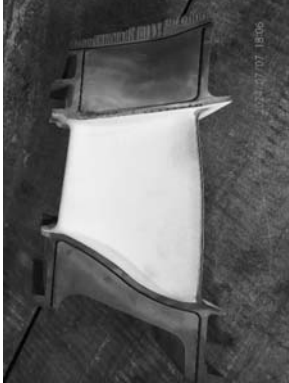
GV2 trailing edge cooling passages overall conditions.

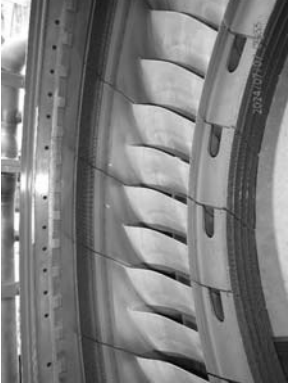
GV3 pressure side overall condition.

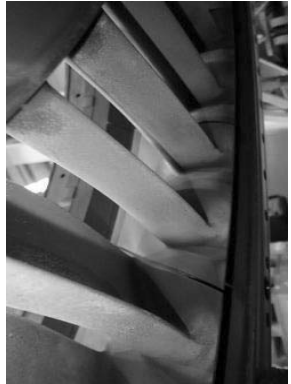
GV3 leading edges overall condition.

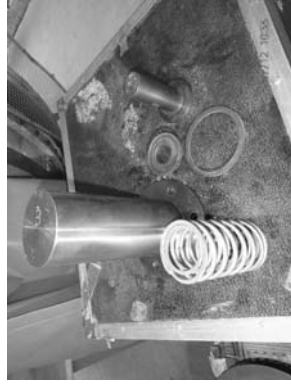
T-bar suspension housing overall condition.

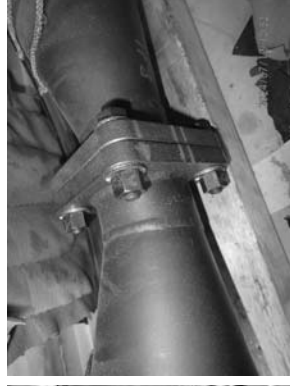
Big round pipe split line flange as found condition.

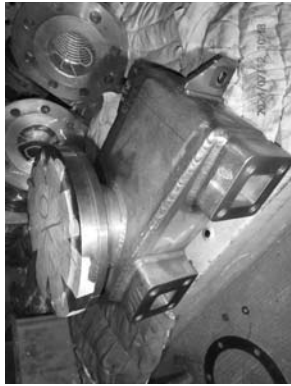
ESC housing as found conditions.

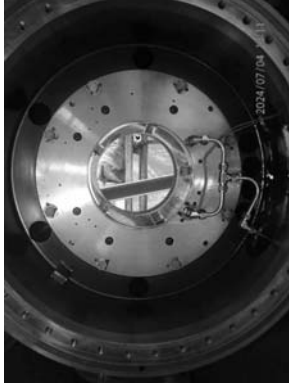
- Light oil varnish film found on all bearing journal pads.

Overall condition on turbine bearing before cleaning.

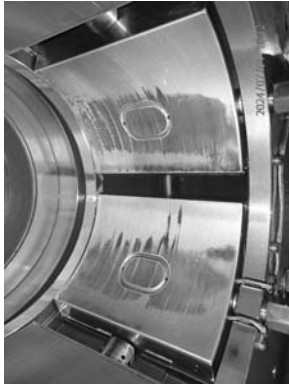
Jacking oil pad before clean condition.

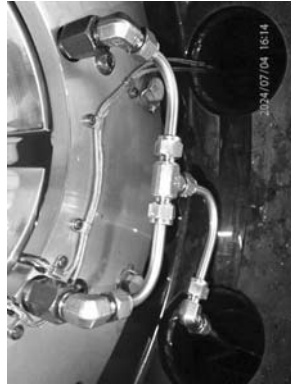
Jacking oil tube line to bearing2 lower pad condition.

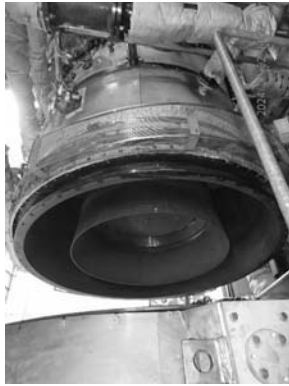
Outlet casing overall condition before dismantling. Observed double nuts missing and loose around fabric bellow.

- Repair outlet casing weld filled in L-profile.
- Replaced all broken / damaged insulation cassettes with new spare part.
- Replace / repair fabric bellow expansion joint.

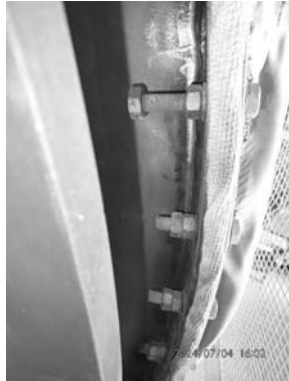
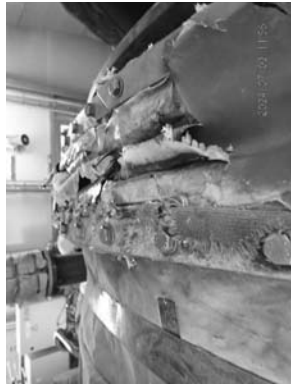
Example view on fabric bellow condition.

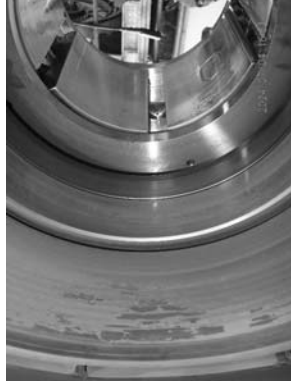
Sealing ring 1,2,3 area overall condition.

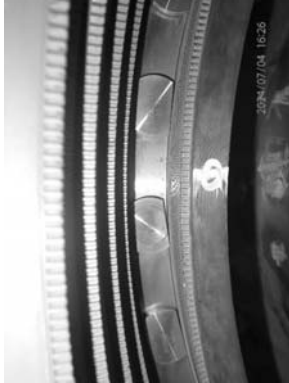
Inner sealing ring honeycomb overall condition.

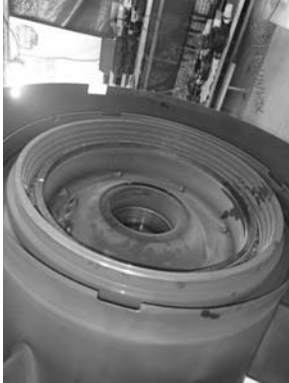
Rotor hub sealing area overall condition.

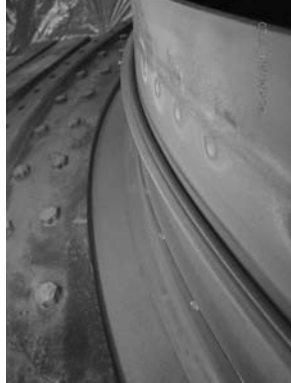
Front lip of outer heatshield overall condition.

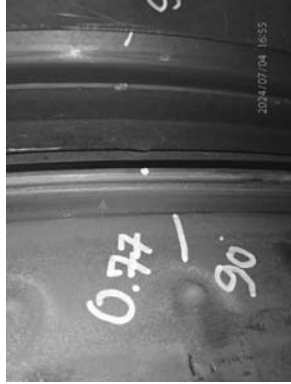
Example of wear groove at front L-shape condition.

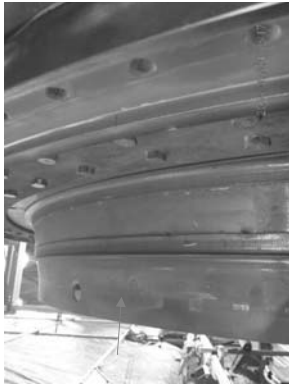
Example of fretting found at front lip area.

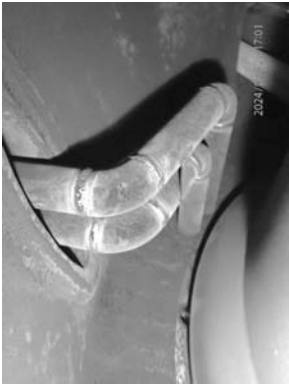
Balancing piston pipes overall condition.

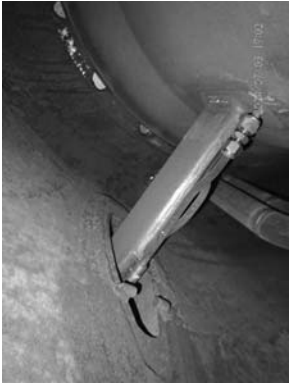
Balancing piston pipes and oil seal pipes

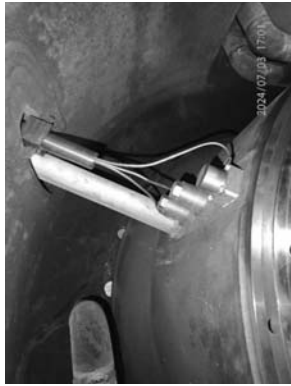
Vibration transducer bearing 2 conditions.

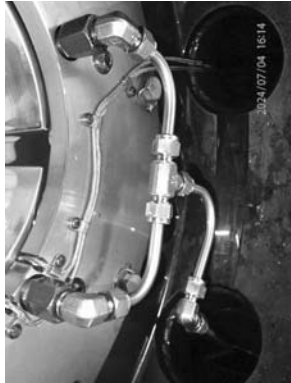
Jacking oil pipes connection ports condition.

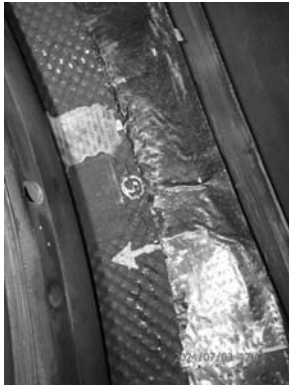
Example view for condition on Insulation cassette from previous repaired at cassette no. 3,4 (clockwise).

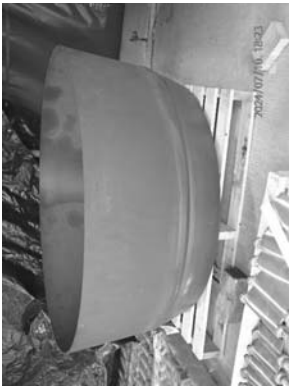
Outlet cone overall condition.

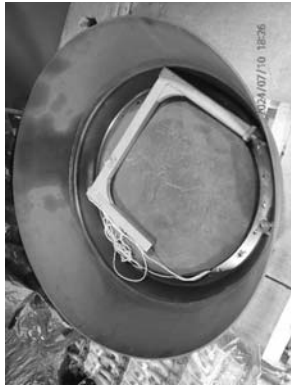
Outlet cone overall condition.

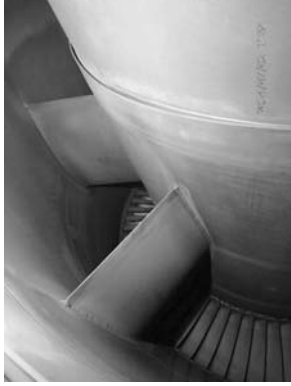
Example of front side exhaust gas channel condition.

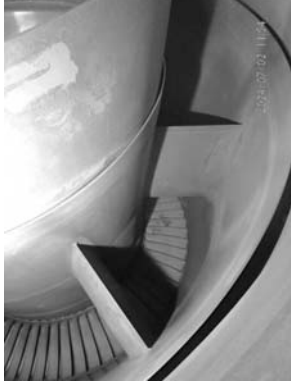
Example of bottom struts overall condition.

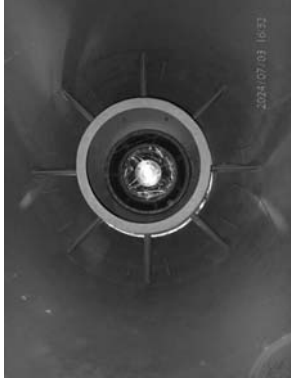
Exhaust diffuser seen against flow direction.

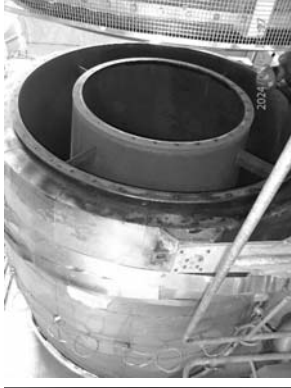
Exhaust diffuser seen follow flow direction.

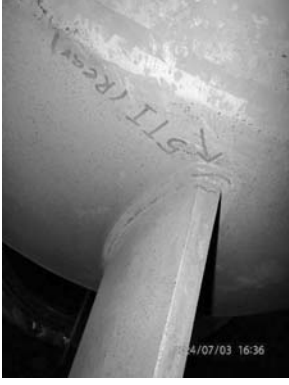
- Minor cracks were observed at front and rear support struts of the exhaust diffuser.

Example view for cracks on weld seam of rear support struts.

- Perform PT test on welded seams area on support struts to confirm start & end point of cracks before repair.
- Welds repair on exhaust struts is belonging to customer scope, all repaired methods must be complied with Siemens energy instruction.

- PT test on welded seams area to confirm starting & end point of cracks and weld repair cracks during MO 60 inspection has been performed by customer.

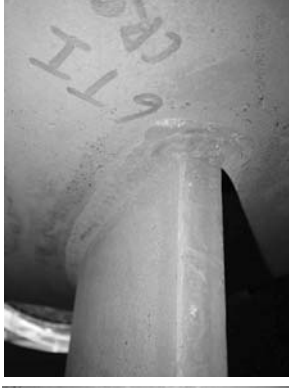
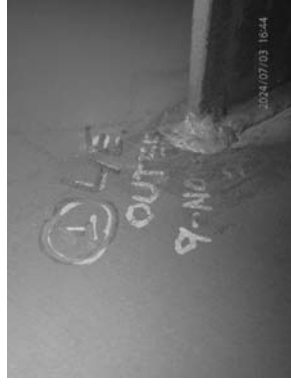
Example view for cracks on weld seam of front support struts.

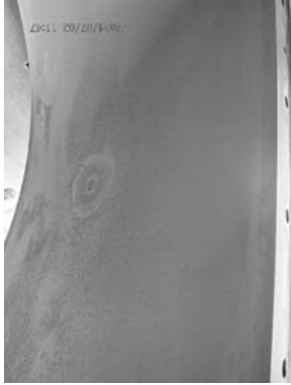
Example view for internal wall of intermediate cone.

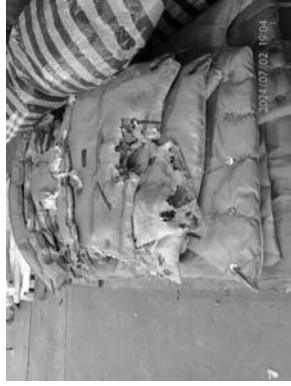
- Insulation blanket found damages from operation rubbing against casing due to vibration and heat.
- Insulation found punctured at compressor guide collar area.
- Insulation around bleed air pipes and cooling air pipes found some damages.

Damages insulation after dismantling from gas turbines.

- For any severely damages insulations, those has been replaced with a new insulation from customer.

After repaired, insulation will return to serviceable condition.

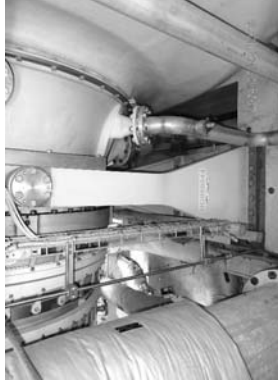
Front support condition on the left side.

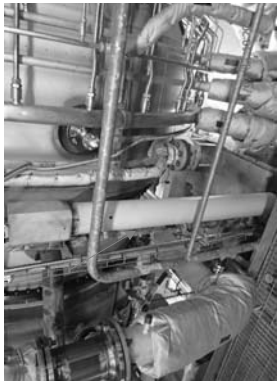
Left central casing side support condition.

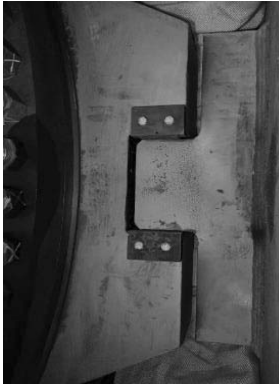
Central keys support overall condition.

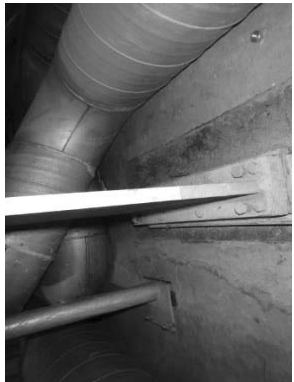
Left side support foundation condition.
