รายงานผลการตรวจสอบท่อดูดคอนกรีตเสริมเหล็ก

CORROSION UNDER SUPPORT (CUS)
PIPELINE INTEGRITY MANAGEMENT

CHEVRON SRT TERMINAL
SURATTHANI

29 June 2023
Report No: 2305047_Rev.00

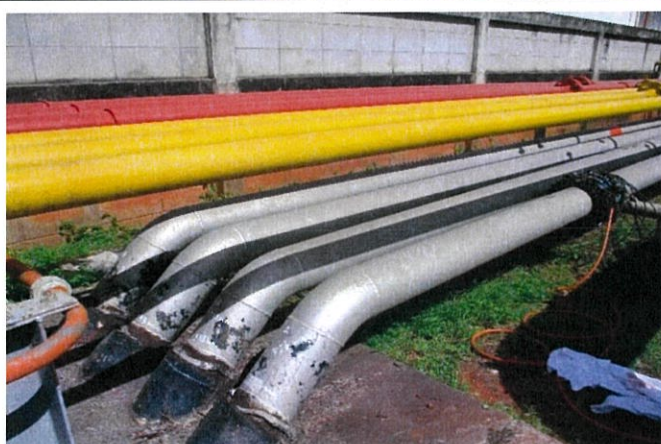
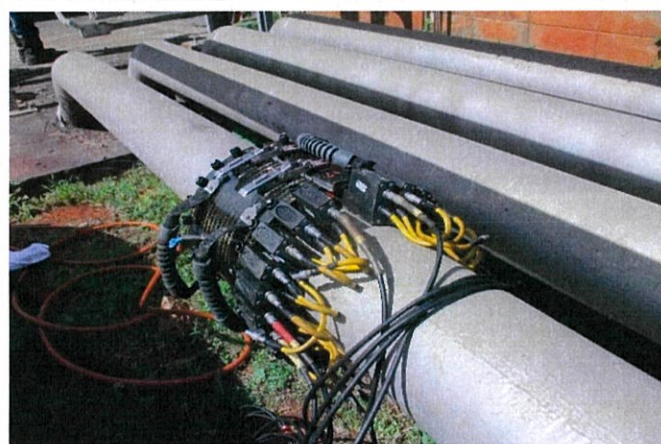
Normal condition

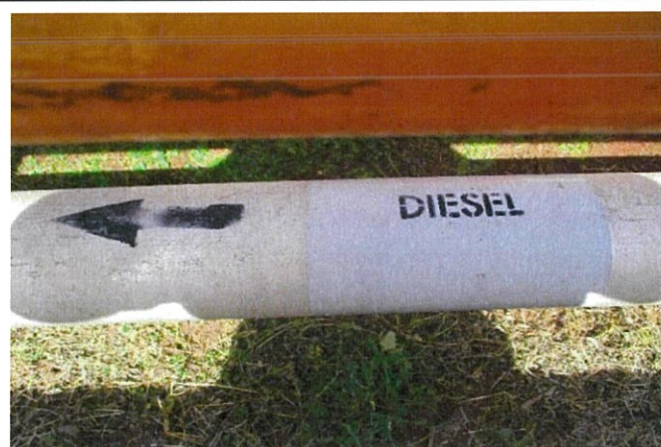
Normal condition

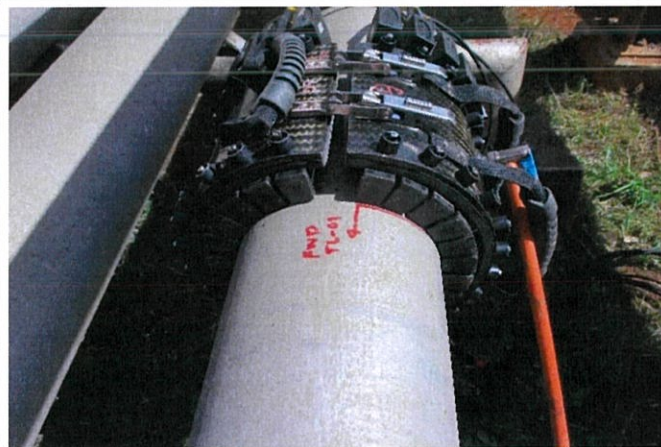
Normal condition

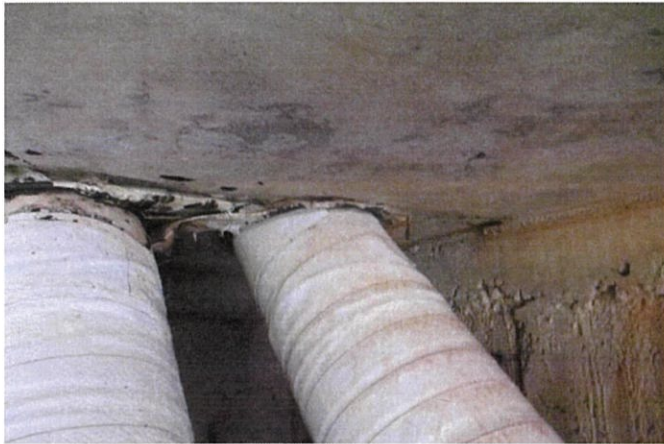
Name of part / Location	Findings	Name of part / Location	Findings
Underground pipe	Normal condition	Underground pipe	Normal condition

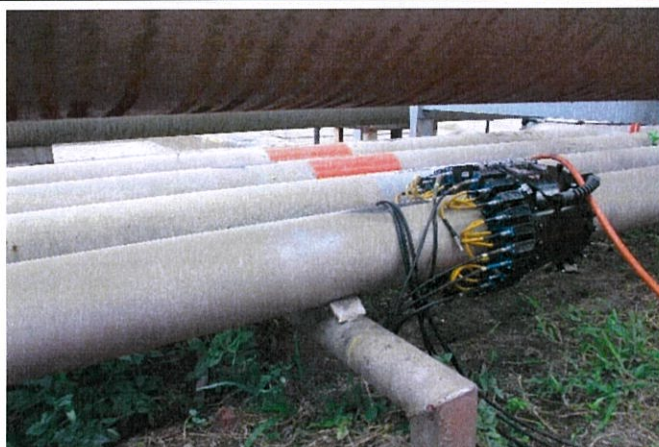
Normal condition

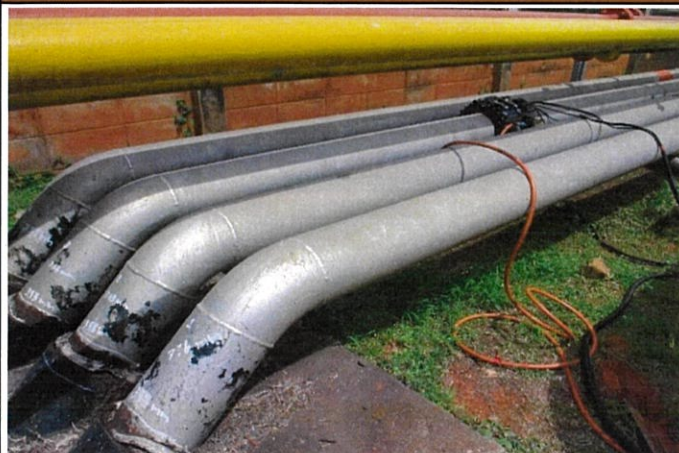
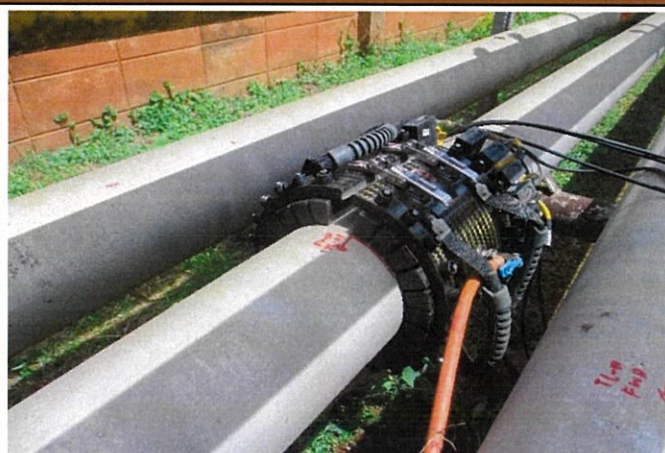
Normal condition

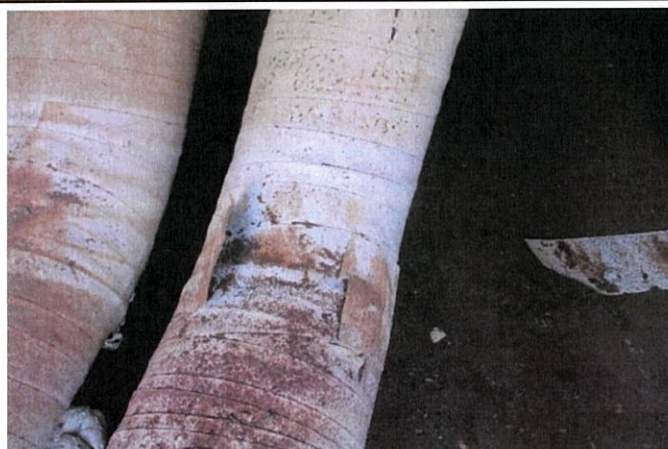
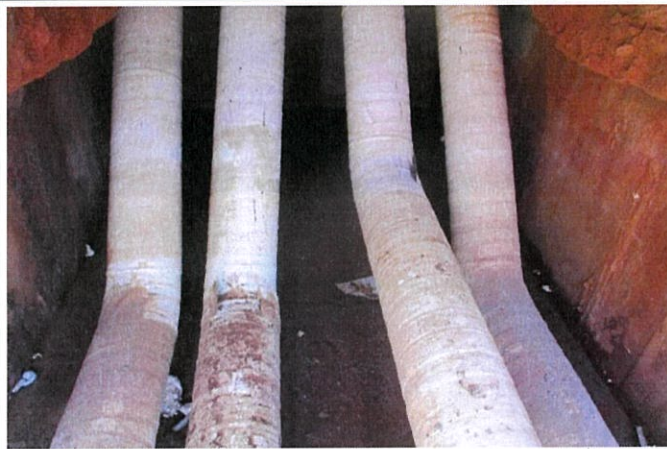
Normal condition

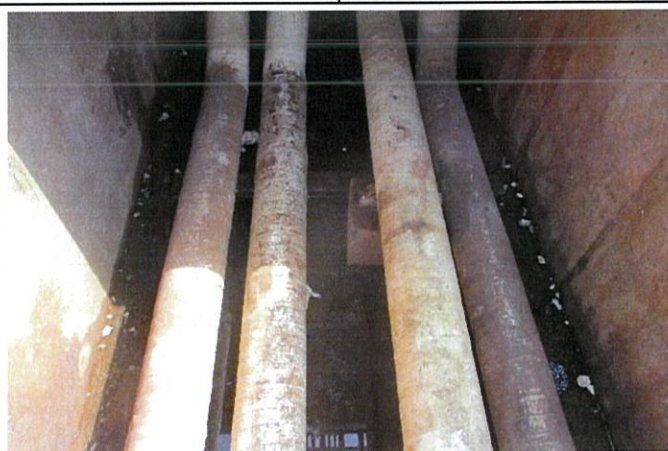
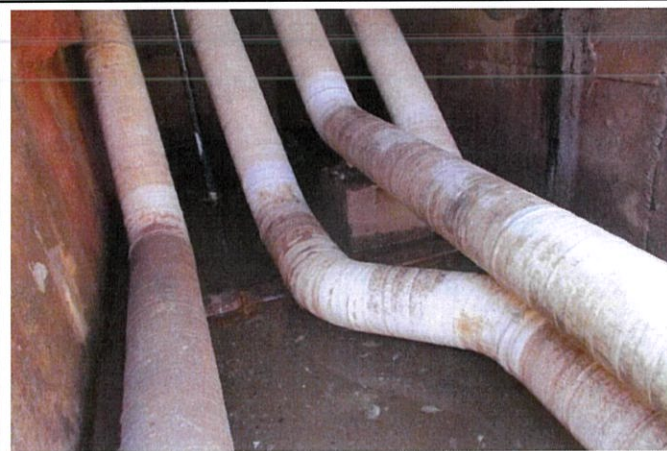
Normal condition

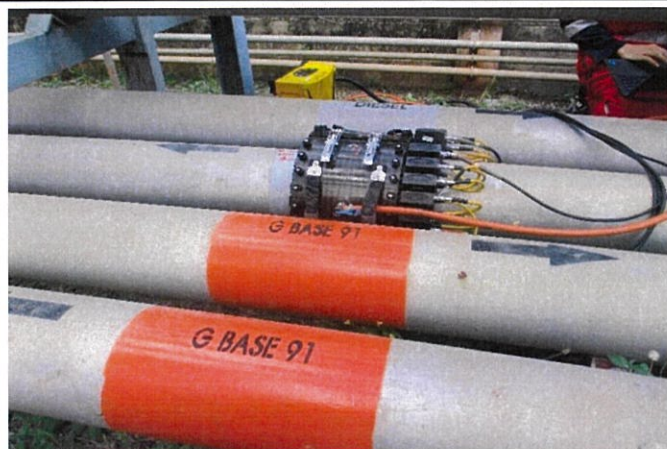
Name of part / Location	Findings	Name of part / Location	Findings
Pipe	Normal condition	Pipe	Normal condition

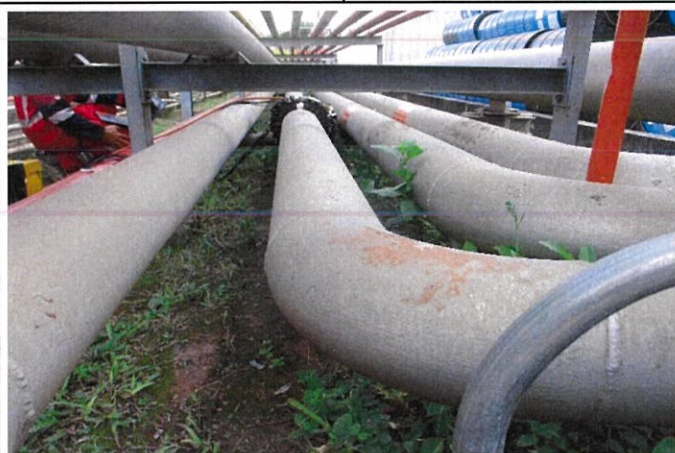
Name of part / Location	Findings	Name of part / Location	Findings
Pipe	Normal condition	Beneath pipe sleeve	Corrosion and painting deterioration

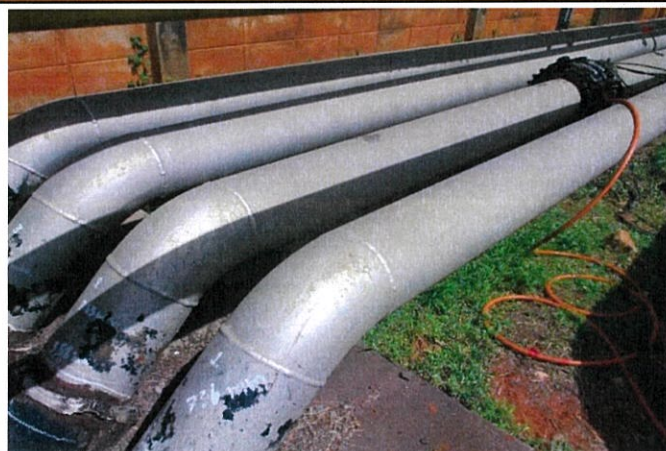
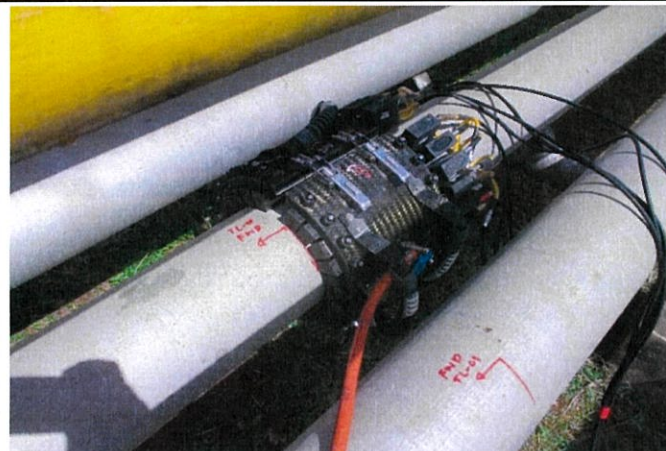
Normal condition

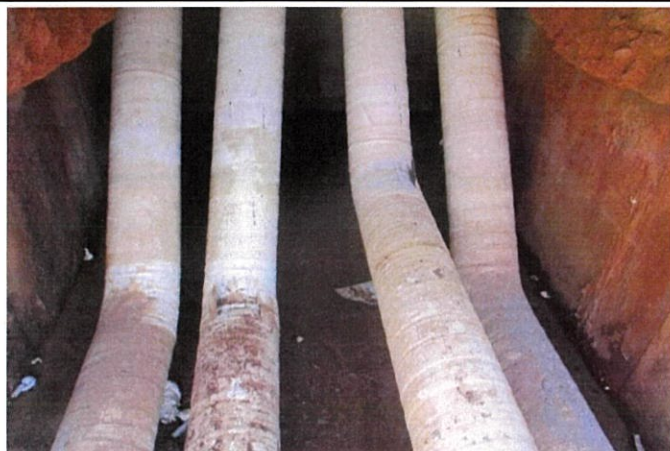
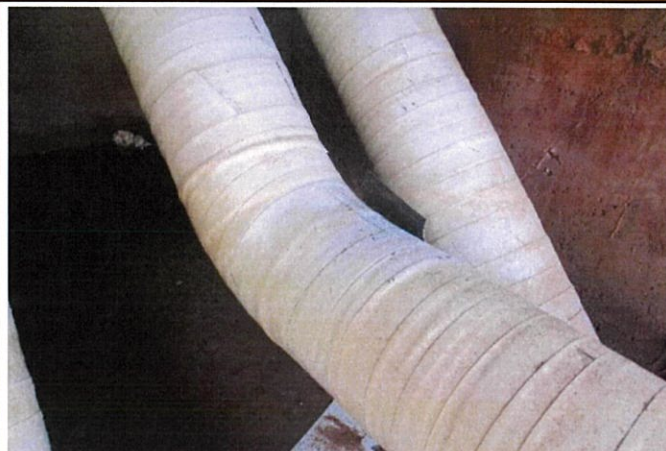
Name of part / Location	Findings	Name of part / Location	Findings
Underground pipe	Normal condition	Underground pipe	Normal condition

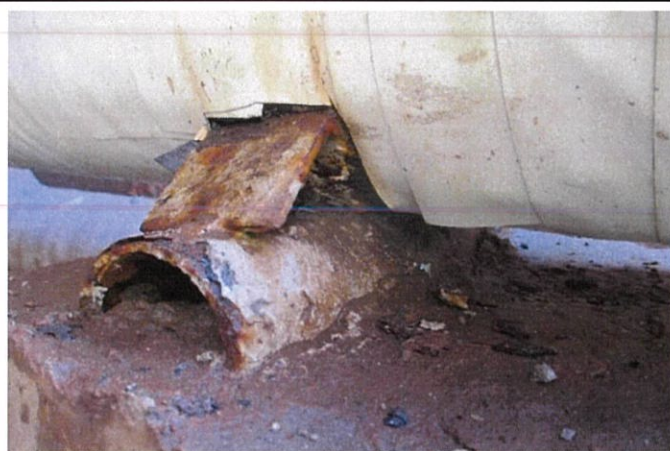
Name of part / Location	Findings	Name of part / Location	Findings
Underground pipe	Normal condition	Underground pipe	Normal condition

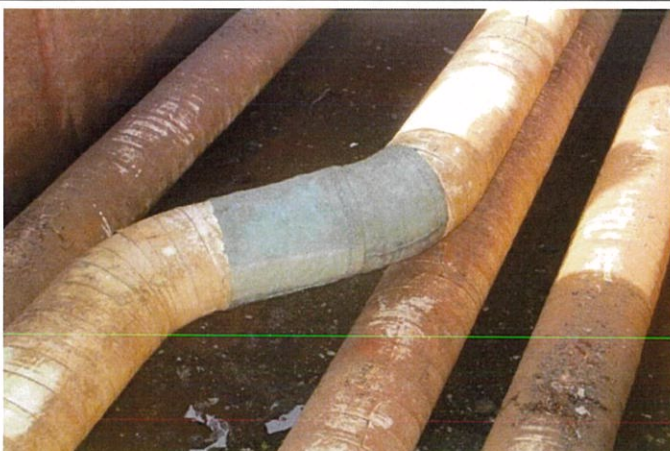
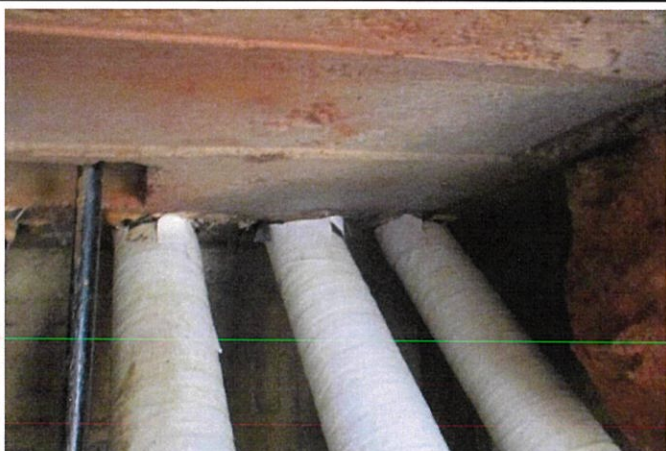
Name of part / Location	Findings	Name of part / Location	Findings
Underground pipe	Normal condition	Underground pipe	Normal condition

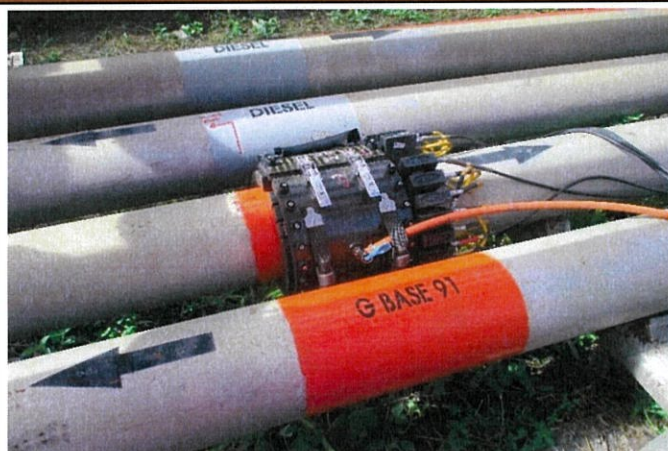
Name of part / Location	Findings	Name of part / Location	Findings
Pipe	Normal condition	Pipe	Normal condition

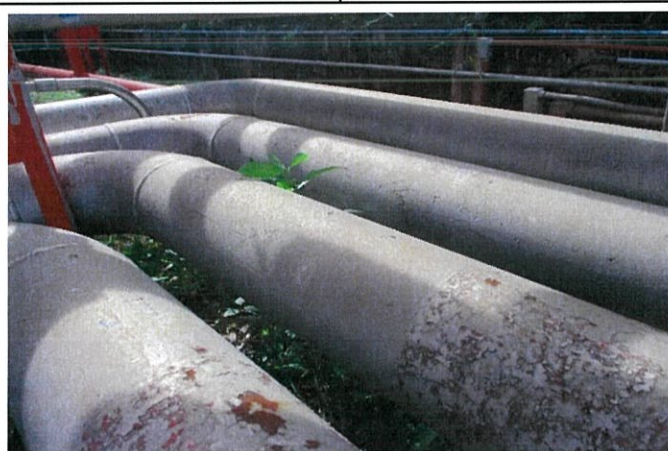
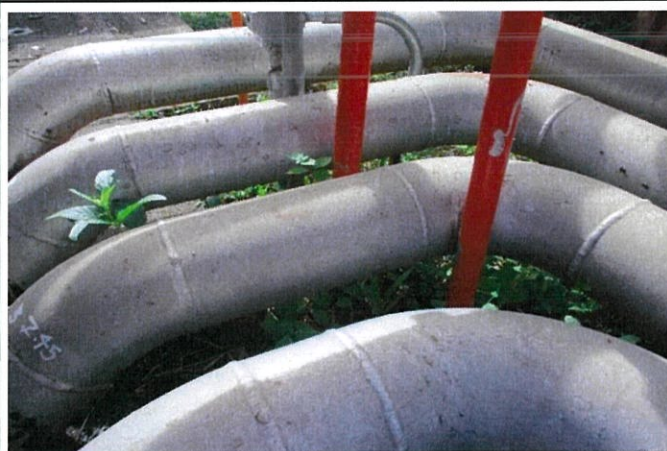
Name of part / Location	Findings	Name of part / Location	Findings
Pipe	Normal condition	Pipe	Normal condition

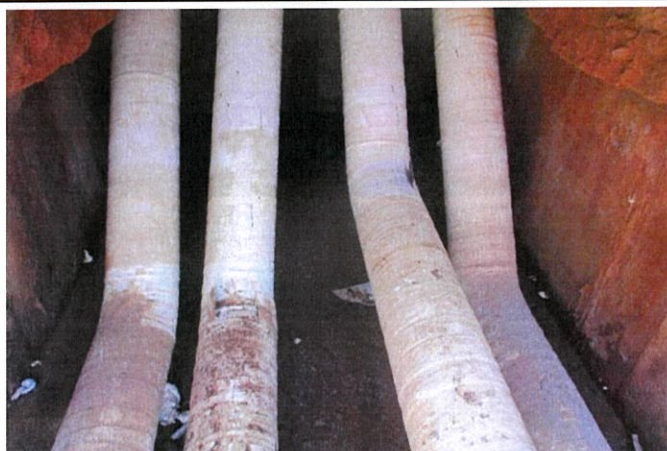
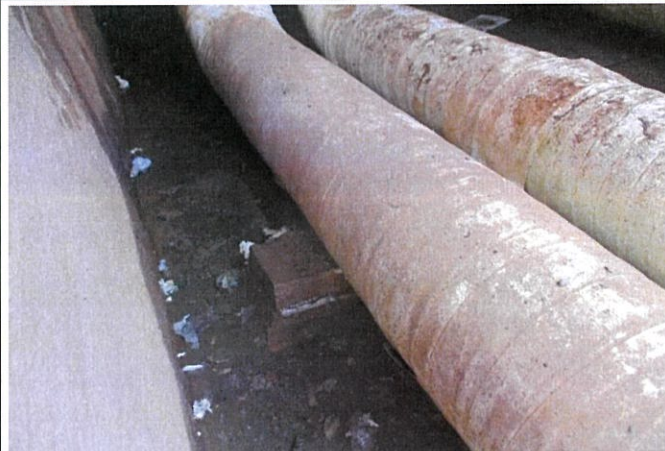
Name of part / Location

Findings

Normal condition

Underground pipe

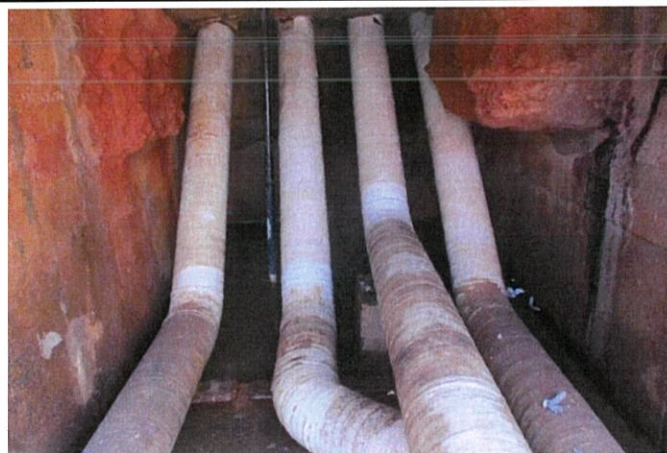
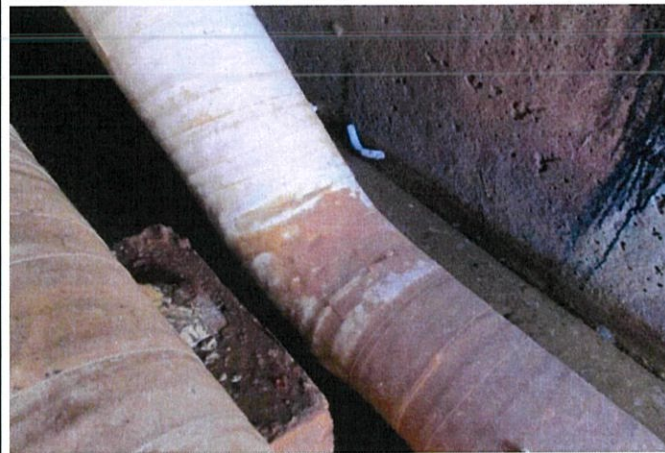
Normal condition

Underground pipe

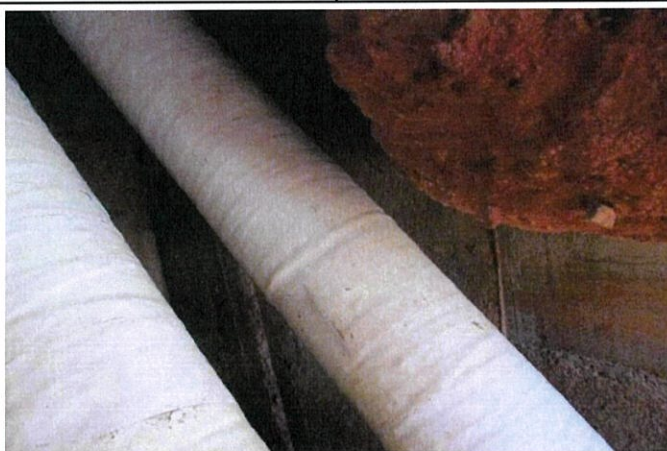
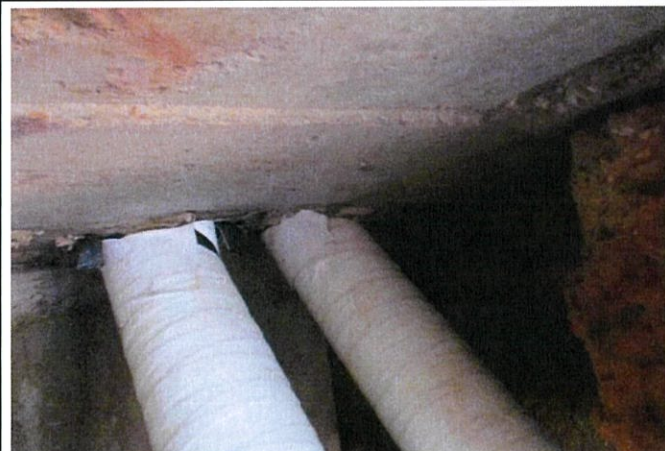
Normal condition

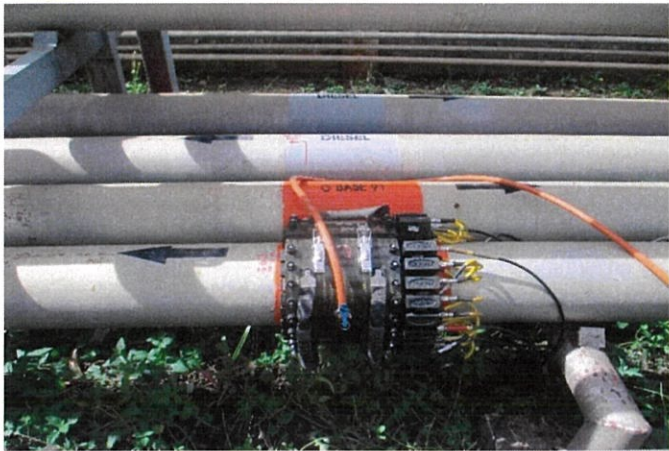
Name of part / Location	Findings	Name of part / Location	Findings	
Pipe	Normal condition	Pipe	Normal condition

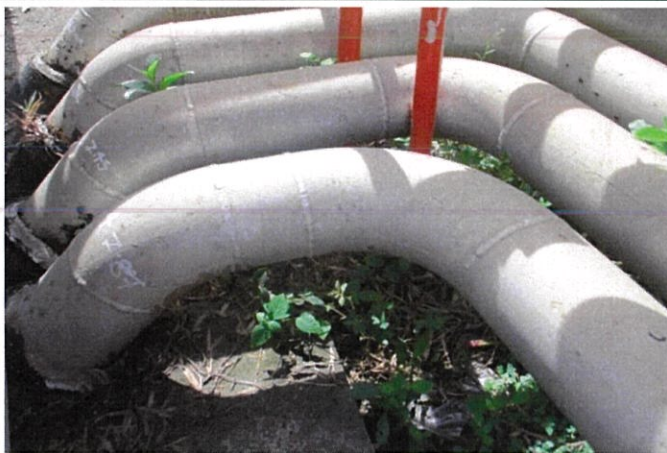
Name of part / Location	Findings	Name of part / Location	Findings	
Pipe	Normal condition	Pipe	Normal condition
